BEERS ELEMENTARY SCHOOL

3600 Alabama Avenue, S.E., Washington, DC

CONDITION ASSESSMENT

Condition Assessment

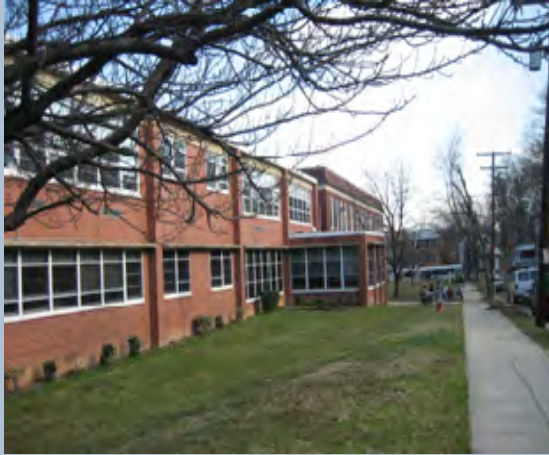
Building System	2008 Rating
ADA Compliance	Unsatisfactory
Conveying Systems	Unsatisfactory
Electrical	Poor
Exterior Finish	Fair
HVAC	Fair
Interior Finish	Fair
Plumbing	Poor
Roof	Good
Structure	Good
Technology	Poor

1 Conveying System	There is no elevator, escalator, or lift present in the building.
2 Electrical	Wiring condition is unknown, but is original. Electrical service should have a load analysis prior to adding any additional fixtures, HVAC upgrades, or technology. 2007: Exterior lighting replaced.
3 Exterior Finish	Windows are new this year. Two have yet to be replaced, and no caulking has been done. This needs to be completed. There is some exterior cracking, spalling, and graffiti. The expansion joints between the buildings need to have the expansion material replaced.
4 Structure	Structure is in good condition. There are some areas of cracking that need repair, both inside and outside.
5 HVAC	The older portion of the building is a different HVAC system than the newer portion. New portion - hot water via steam conversion. Old portion - steam. Chiller and boilers have recently been upgraded; however, unit ventilators, convectors, and radiators are beyond their average life span. Window air conditioning units are missing or not working. The newer portion of the building has A/C through the unit ventilators. The HVAC system should be upgraded, and A/C could be added at that time. There is no emergency lighting or emergency generator. 2008: New Boiler replacement and 12 classroom units replaced.

6 Interior Finish	Ceilings and floors need to be repaired or replaced throughout. Asbestos tile is a health hazard and should be covered or removed. There is asbestos floor tile throughout the school. Most rooms need to be repainted, and the floors are chipped or the carpet is stained. Interior finishes need to be updated or upgraded and replaced. 2007: Various Classrooms painted, ACT replaced.
7 Plumbing	Plumbing is original and galvanized and probably rusted. Its condition is unknown, and further inspection of the plumbing system is needed for an accurate assessment. There are no sprinklers in the building, and the fire alarm system is inadequate.
8 Roof	Modified bitumen roof average life is ten years, and this roof is approximately three years old. It is in good condition, with a few leaks at some vents. This can probably be repaired by replacing the flashing.

9 ADA Compliance	Building is not accessible, and there is no accessible parking. There is no elevator in this building. Bathrooms and other facilities are not accessible. The only way to access the newer wing of the building from the older wings requires going to the first floor. There is no visible or audible fire alarm system. This is both a building code and life safety issue.
10 Technology	There are only a few data drops throughout the school. However, many of the classrooms appear to have adequate equipment, particularly in the computer lab. The school should be networked to achieve school standards.
11 Grounds	There is no ADA available parking, and no curb cuts for sidewalk access. Parts of the fields are eroding away. Sidewalks are settling, leaving the curbs at the original heights, creating trip hazards
