DAVIS ELEMENTARY SCHOOL

4430 H Street, S.E., Washington, DC

CONDITION ASSESSMENT

Condition Assessment

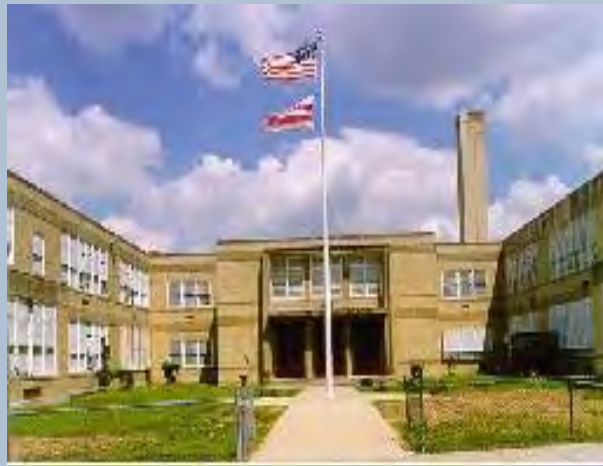
Building System	2008 Rating
ADA Compliance	Unsatisfactory
Conveying Systems	Unsatisfactory
Electrical	Poor
Exterior Finish	Poor
HVAC	Poor
Interior Finish	Fair
Plumbing	Fair
Roof	Poor
Structure	Poor
Technology	Poor

1 Conveying System	There is no elevator, escalator, or lift present in the building.
2 Electrical	Wiring condition is unknown, but is original. Original lighting is not energy efficient, and several contain PCB's (which is a health hazard). The lighting should be upgraded to energy efficient fixtures. Service should have a further inspection to verify that there is no corrosion in the lines or panels. Electrical service should also have a load analysis prior to adding any additional fixtures, HVAC upgrades, or technology. 2008: The fire alarm system is inadequate.
3 Exterior Finish	Brick angle is rusting, causing the joint to open and water to leak in. The joint should be cleaned and repainted. There are other areas requiring repainting also. There are several spalling areas on the precast concrete on the exterior. The handrails on all the exterior steps are rusted and need replaced. 2007: Interior lighting repairs. 2008: Replaced exterior lighting.

4 Structure	Structure is in poor condition. There are some areas of minor cracking that need repair, both inside and outside. There are a few major cracks, with separation warrant further investigation. Additionally, when the windows were replaced in 2000, the CMU around the windows sustained damage that should be corrected.
5 HVAC	While the boiler has been replaced, the unit ventilators and convectors/radiators are beyond their average life span. Air conditioning units are missing or not working. There is no emergency lighting or emergency generator. The HVAC system should be overhauled and upgraded (and A/C could be added at that time). 2007: water fountain blitz, radiator replacement, A/C units. 2008: Repairs to boilers and classroom units. Installed 84 window A/C units with electrical upgrades.
6 Interior Finish	Ceilings and floors need to be replaced throughout. Asbestos tile is a health hazard and should be removed. There is asbestos floor tile throughout the school. Most rooms need to be repainted, and the floors are chipped or the carpet is stained. Many of the ceilings have broken, stained, or moldy tiles. 2007: Painting; replace ceiling tiles, flooring, lighting and doors and hardware.

7 Plumbing	Plumbing is original and galvanized. Its condition is unknown, and further inspection of the plumbing system is needed for an accurate assessment. There are no sprinklers in the building. 2007: plumbing repairs.

8 Roof	Roof is currently approximately 10 years old. It is modified bitumen, which has an average life span of ten years. Replacement of it should be considered within a year. 2007: Roof repair completed.
9 ADA Compliance	Building is not accessible, and there is no accessible parking. There is no elevator in this building. Bathrooms and other facilities are not accessible. The only way to access the newer wing of the building from the older wings is by going to the first floor. There is no visible or audible fire alarm system. This is both a building code and life safety issue.
10 Technology	There are only a few data drops, and the computers and other equipment that does exist appears deficient. There are acceptable computers in the computer lab only.
11 Grounds	Parking is on an old portion of the playground. There are no handicapped spaces. Sidewalks, curbs, drainage, play structure, and playgrounds are all in poor condition and should be updated. There is a small non-code ramp, leading to one wing of the building. There are no athletic fields.
