EMERY EDUCATIONAL CENTER

1720 1st Street, N.E., Washington, DC

CONDITION ASSESSMENT

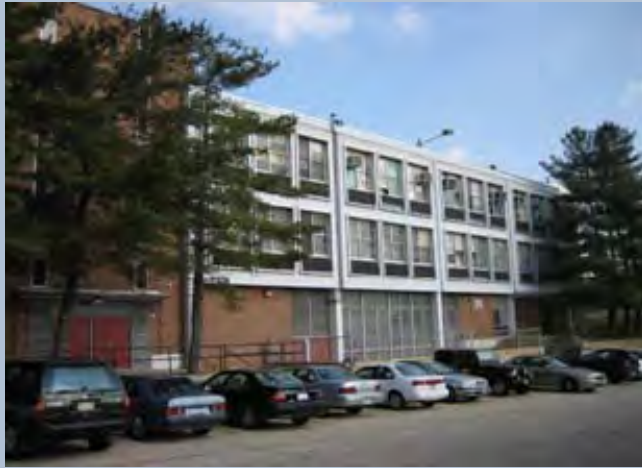
<i>Building System</i>	<i>2008 Rating</i>
ADA Compliance	Poor
Conveying Systems	Fair
Electrical	Good
Exterior Finish	Unsatisfactory
HVAC	Good
Interior Finish	Fair
Plumbing	Poor
Roof	Fair
Structure	Fair
Technology	Fair

1 Conveying System	There is no elevator, escalator, or lift present in the building.
2 Electrical	The fire alarm system is obsolete and should be replaced with a modern system. Major components are beginning to reach expected service lifetimes. Lighting should be upgraded throughout. 2008: Electrical replacement and repairs completed.
3 Exterior Finish	Some windows are leaking and should be replaced or repaired. Brick veneer appears to be in fair condition around the building. Routine maintenance, such as sealing and repointing will help prolong service life. 2008: Replaced exterior lighting, Re-glazing, Caulking, Roofing, Masonry. Pre-cast panels cracked (extensive) and leaking.
4 Structure	No major deficiencies were observed. Minor cracking, typical for concrete framing, can be repaired as part of routine building maintenance. The presence of water infiltration suggests further structural investigation take place.

5 HVAC	The HVAC systems were upgraded four years ago. They currently have no control of the dual temperature system because the required software was never purchased. An outside contractor comes in that has the software required to adjust the system every so often. This causes half the building to freeze and the other half to boil. System balancing may eliminate the disparate temperatures. 2006: Chiller replaced. 2008: Repairs to boilers, chillers and classroom units. Installed 34 window A/C units with electrical upgrades.
6 Interior Finish	Interior windows are in poor condition and should be replaced. Small amounts of ceiling tile and plaster finishes need repair work. Flooring is generally in fair condition. 2008: Doors, Ceilings, Paint.
7 Plumbing	There are no fire suppression systems present. Fixtures are old and do not conform to ADA guidelines. Modern fixtures should be installed. Visible piping appears to be in fair condition. 2008: Plumbing repairs.

8 Roof	Water was observed leaking from roof outside and on the left side of main entrance. The built-up roof system should be inspected for bubbling and additional leaks.
9 ADA Compliance	The building generally does not satisfy ADA criteria. There is poor access, no ramps, handrails, or appropriate fixture within the building or on the grounds.
10 Technology	Network cables are running in hallways in plastic chase ways that are falling apart. PCs and other equipment appear to be in good condition, based on visual inspection. 2008: Added new data for new computer lab, upgrade equipment (new switches).
11 Grounds	There is a need to replace stairs leading to main entrance to building, also repair patches where ever necessary in stairs going to playground. 2008: Remove dead tree at front entry, replace concrete walkway at front entry.
