HEARST ELEMENTARY SCHOOL

3950 37th Street, N.W., Washington, DC

CONDITION ASSESSMENT

Condition Assessment

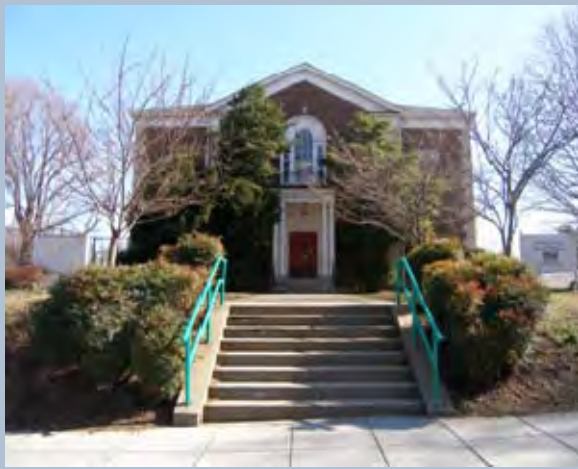
<i>Building System</i>	<i>2008 Rating</i>
ADA Compliance	Unsatisfactory
Conveying Systems	Unsatisfactory
Electrical	Unsatisfactory
Exterior Finish	Poor
HVAC	Fair
Interior Finish	Poor
Plumbing	Poor
Roof	Fair
Structure	Good
Technology	Poor

1 Conveying System	There is no elevator for access to upper floor.
2 Electrical	Switchboard and panel boards are old and no parts are available for repairs. 3000 Amp incoming power board cabinet and switchgear feeders are severely corroded. Branch wiring is mostly concealed and can not be inspected; visible portions indicate replacement is likely. Lighting fixtures are old and their light output is below code and school requirements. They are also not energy efficient.
3 Exterior Finish	Brick on north side needs replacement/repainting. Once wetted, wall does not dry and moisture is migrating through to the interior. Windows and doors appear worn; replacement will be required in the near term. 2008: Exterior Lighting replaced.
4 Structure	No major deficiencies were observed. Minor cracking, typical for concrete framing, can be repaired as part of routine building maintenance.
5 HVAC	The existing heating system, starting with the boiler, is approaching the end of its life expectancy. The control system for the radiators. The HVAC system needs to be upgraded to one that meets the present standards of ventilation and energy conservation. The toilet exhaust systems need to be upgraded to meet present code requirements as well. 2007: Repairs to the central A/C system, replaced filters, boiler repairs 2008: Repairs to boilers and classroom units completed. 2008: 16 Window A/C units installed.

6 Interior Finish	Exterior walls are routinely wetted by moisture from gutters, damaging the plaster; repairs will not be lasting until gutter condition is corrected. All doors need replacement. Toilet rooms need complete gutting and replacement. Multiple problems with accessibility, plumbing, sanitation and finishes.
7 Plumbing	Most faucets are in poor working conditions and need to be replaced. Water supply piping needs to be checked for any lead solder or any lead residue in the distribution system. Toilet Facilities need to be upgraded to meet ADA requirements. 2007: Plumbing fixture and valve repairs, and water cooler installation/repairs.
8 Roof	Slate tiles are in good condition, but gutters need to be replaced.
9 ADA Compliance	There is no handicapped entrance into the building. Toilet rooms are non-compliant. Doors and stairs have multiple code deficiencies.
10 Technology	School does not meet district standards. Generally, the equipment observed appears to be in poor condition. Upgrades should include software, networking, and dedicated climate controlled spaces to house equipment.

11 Grounds	Asphalt paving is beyond useful life; cracks, deterioration, unevenness make it hazardous to running children. Some plantings, a thorough cleaning and routine maintenance would make a big difference. Concrete stairs are deteriorating and need to be replaced.
