PLUMMER ELEMENTARY SCHOOL

4601 Texas Avenue, S.E., Washington, DC

CONDITION ASSESSMENT

Condition Assessment

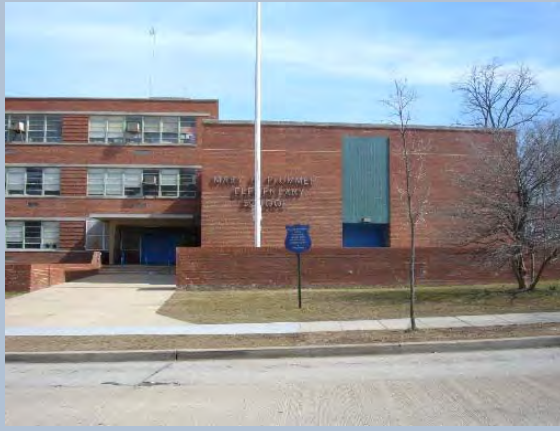
Building System	2008 Rating
ADA Compliance	Unsatisfactory
Conveying Systems	Unsatisfactory
Electrical	Poor
Exterior Finish	Unsatisfactory
HVAC	Poor
Interior Finish	Fair
Plumbing	Fair
Roof	Fair
Structure	Good
Technology	Poor

1 Conveying System	No conveying system exists at this facility.
2 Electrical	The electrical system was installed with the original building; some panels and distribution upgraded in 1989. The building should have a complete electrical system upgrade. The fire alarm and emergency lighting are original and do not comply with current codes. The lighting system has had some renovations but should be replaced with modern fixtures providing proper light levels in all areas. A recent lighting upgrade utilized low cost ballast that resulted in approximately 30% light fixture failure.
3 Exterior Finish	Much of the brick structure is in poor condition and needs major renovation. Additionally, all of the exterior windows should be replaced. 2007: exterior brick pointing completed.
4 Structure	Although the facility is nearly fifty years old, the structure of the facility is sound as it was constructed using CMU and bricks.

5 HVAC	The burners for the boilers were replaced in 1990, but the boilers are original 1957 equipment and require replacement. The distribution and terminal equipment is original and requires a system renovation. The building relies on window units for air conditioning; these should be replaced as part of any renovation. The ventilation and exhaust systems typically are not functioning properly. When the window air conditioning is operating, little or no outside air is circulated. 2008: Repairs to boiler(s) and Classroom heating units completed. Installed 31 A/C window units. HVAC servicing completed.
6 Interior Finish	The interior of the facility is in generally fair condition. Asbestos tiles are present and should be removed. Large areas of ceiling tile are in poor condition and should be replaced. Sections of VCT flooring are beginning to wear and should be replaced. 2007: Painting, flooring, completed.

7 Plumbing	The piping and plumbing fixtures for this facility should be replaced entirely since most of the equipment is in poor condition and outdated. Water fountains and bathroom fixtures do not meet code requirements. 2007: Water fountain blitz, plumbing fixture replacement completed
8 Roof	The roof is in fair condition although there are some issues with leaks that need to be addressed. Remediation will prevent further damage to interior finishes and delay the need to replace the roof entirely. 2008: Roofing repair completed.
9 ADA Compliance	The facility is not in compliance with ADA due to the absence of appropriate conveying, ramps, door hardware, parking, and fixtures in the school facility.
10 Technology	The building's internet and telephone connections have had various upgrades in recent years, but placing the head end systems in climate controlled rooms would provide greater reliability. The security and camera systems appear to be functioning properly. The intercom system appears to be approximately thirty years old and should be replaced.

11 Grounds	The asphalt pavement in the playground needs resurfacing.
