RIVER TERRACE ELEMENTARY SCHOOL

420 34th Street, N.E., Washington, DC

CONDITION ASSESSMENT

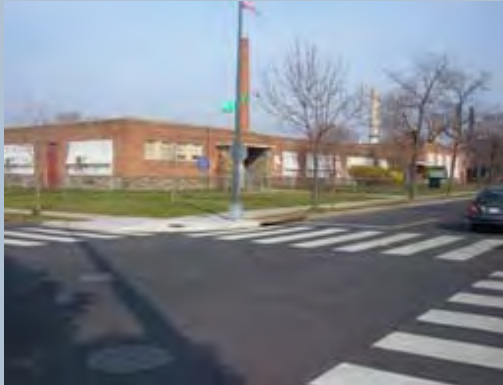
Building System	2008 Rating
ADA Compliance	Good
Conveying Systems	Good
Electrical	Poor
Exterior Finish	Unsatisfactory
HVAC	Poor
Interior Finish	Fair
Plumbing	Fair
Roof	Unsatisfactory
Structure	Poor
Technology	Good

1 Conveying System	An ADA compliant conveying system exists at this facility.
2 Electrical	The electrical system was installed with the original building, with some panels and distribution upgraded in 1999. The building should have a complete electrical system upgrade. The fire alarm and emergency lighting were upgraded in 1999 and 1994, respectively. The lighting system had some renovations in 1994 but should be replaced with modern fixtures providing proper light levels in all areas. Additional distribution panels were provided in 2004 for window air conditioning units to be placed in the south wing.
3 Exterior Finish	Much of the brick structure is in poor condition and needs major renovation. Additionally, all of the exterior windows should be replaced. 2007: Replaced exterior lighting.
4 Structure	The steel lintels at the majority of exterior door and window openings are corroded and need to be replaced. The cavity wall (brick and CMU) are not performing properly and approximately half of the existing brick façade should be replaced.

5 HVAC	The boilers are original equipment with burners replaced in 2001. The boilers and boiler feed system should be replaced. The distribution and terminal equipment is original and requires renovation. The building relies on window units for air conditioning; these should be replaced as part of any renovation. The ventilation and exhaust systems typically are not functioning properly; when the window air conditioning is operating little or no outside air is provided. 2007: HVAC servicing. 2008: Repairs to boiler(s) and Classroom heating units completed. Installed 15 window A/C units.
6 Interior Finish	The building skin is failing at the majority of lintels and at the roof flashing, resulting in water infiltration which is damaging the interior finishes. There are several locations where there is black mold forming above the lintels. The existing terrazzo and tile floors are in good condition. 2007: Painting, flooring, window pane replacement completed.

7 Plumbing	The plumbing fixtures are original equipment and should be replaced with reduced water flow type fixtures. The piping distribution system should also be replaced to provide higher quality water. 2007: Plumbing repairs.
8 Roof	The existing roofing material and flashing should be replaced immediately. There are locations where water is under the existing roofing material and infiltrating the building skin.

9 ADA Compliance	The majority of facility is in compliance with ADA due to the presence of ramps inside and outside the school building. There are some faculty bathrooms that do not have grab bars and are too small.
10 Technology	The building internet and telephone connections have had various upgrades in recent years, but placing the head end systems in climate controlled rooms would provide greater reliability. The security and camera systems appear to be functioning properly. The intercom system appears to be a 1980's vintage and should be included in renovation plans.
11 Grounds	The asphalt pavement in parking lot and playground needs resurfacing and the concrete pavement needs repair.
