LOGAN SCHOOL

SCHOOL WITHOUT WALLS AT LOGAN

215 G. Street, N.E., Washington, DC

CONDITION ASSESSMENT

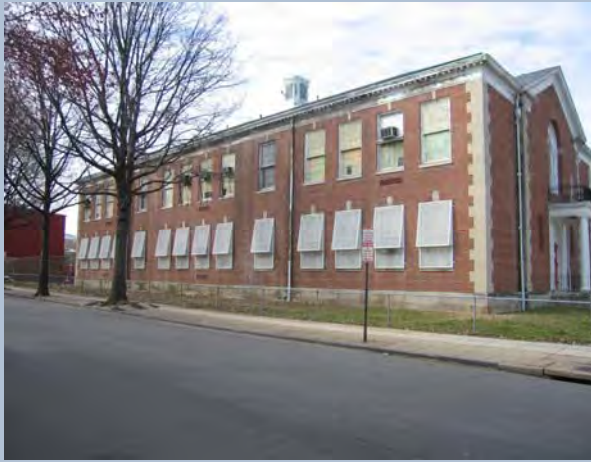
<i>Building System</i>	<i>2008 Rating</i>
ADA Compliance	Unsatisfactory
Conveying Systems	Unsatisfactory
Electrical	Poor
Exterior Finish	Poor
HVAC	Fair
Interior Finish	Fair
Plumbing	Fair
Roof	Good
Structure	Poor
Technology	Poor

1 Conveying System	There are no elevators, escalators, or lift systems in the building.
2 Electrical	The electrical distribution system in the original building was upgraded relatively recently. The overall quality and functionality of the electrical system installation ranges from fair to poor. The conduit is unsightly. At a number of rooms, surface-mounted conduit and receptacles on the floor are a tripping hazard. There are numerous penetrations through walls and floors that should be fire-rated (as well as smoke partitions). Circuit breakers frequently trip; there is an insufficient number of receptacles. Major components appear to be in good condition, as is most of the electrical distribution system. The existing fire alarm system is obsolete and needs to be replaced. There is an emergency generator, probably installed as part of the upgrade. 2007: Fire alarm system, PA enhancement, electrical, lighting replacement.

3 Exterior Finish	At the main building, wood trim is deteriorating and in unsatisfactory condition due to water damage. The windows are typically in unsatisfactory condition. About 25% of the brick and 100% of the limestone on the main building needs repainting. The exterior of the demountable building is in fair condition. Exterior metal siding was painted over peeling paint, which continues to peel. 2007: Fencing, Fire Alarm system enhancement, PA enhancement. Exterior – paint doors, windows.
4 Structure	Overall, the structure at the main building appears to be sound. The east wing has some settlement cracks in the CMU at both the north and south ends. The stone veneer at the foundation of the main building is in poor condition. Some of the stone is spalling and 100% needs repainting.
5 HVAC	The main building has a steam heating system consisting of a mixture (often all in the same room) of radiators, cabinet unit heaters, and aluminum finned heat convectors. All classrooms are over-heated, particularly at the east wing (some rooms are around 95°F). The excess heat, combined with moisture penetration, is highly conducive to mold growth; a stale odor prevails. The survey team is concerned as to the suitability of these conditions for a learning environment for either children or adults. All heating system piping is old. It appears that only steam boilers are reusable. Window air conditioners and portable air conditioner units are used. 2008: Repairs to boilers and classroom heating units. Installed 46 window A/C units.

6 Interior Finish	<p>At the main building, the interior condition ranges from poor to unsatisfactory. Water damage at the west wing and auditorium has caused significant damage to the plaster walls and ceilings which in some areas is an immediate life safety issue. Moisture penetration at the east wing has caused extensive peeling paint and mold growth on painted brick walls. Plaster ceilings at the east wing were repaired within the past 2-3 years; however, the leaks causing the plaster damage were reportedly not repaired, as evidenced by paint that is again starting to peel. Classroom carpeting ranges from poor to unsatisfactory condition. 2007: Plaster repair, painting, flooring and whiteboards.</p>
7 Plumbing	<p>Generally speaking, school plumbing fixtures are in poor condition. Some water closets and fountains are not working. Domestic water service is made of galvanized steel in violation of current DC Code requirements. 2007: Plumbing improvements. Repair and replace toilet partitions.</p>

8 Roof	<p>The slate roofs on the main building are in fair condition, with cracked, missing, or broken slates that need to be replaced. The built-in gutters, copper gutter liners, and downspouts at the perimeter of the slate roofs are in unsatisfactory condition, resulting in extensive interior wall leakage and deterioration of the exterior wood cornice and dentils. The flat roofs on the main building are modified bitumen roof membranes applied over built-up membranes. There appear to be a number of active leaks under these roofs in the auditorium and central hallway. The modified bitumen roofs are in poor condition and were poorly flashed. The two cupolas located at the center of each side wing are in urgent need of maintenance and painting. The flat locked and soldered seam copper roofs on the top of the cupolas are in fair condition. The flat locked and soldered seam copper roofs over the entrance porches and bay windows are in fair condition.</p>

9 ADA Compliance	<p>The main building has one accessible entry at the north side; however the majority of the doors and therefore the adjacent spaces do not comply with ADA. The second floor is completely inaccessible.</p>
10 Technology	<p>The telephone and data system needs major renovation at the main building. There is loose cabling and wiring throughout the building, with a number of conduits detached from walls and ceilings. There is no wireless computer network at the main building.</p>
11 Grounds	<p>The grounds are generally in poor condition. Sidewalks, curbs, and paving are deteriorating and should be repaired in the near future. There are no athletic fields and only one small playground. This play structure is in overall good condition; however the padding surface has localized damage.</p>
