ADAMS ELEMENTARY SCHOOL

2020 19th Street, N.W., Washington, DC

CONDITION ASSESSMENT

Condition Assessment

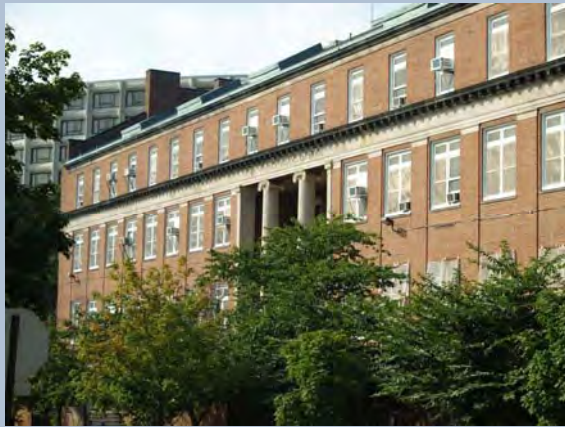
<i>Building System</i>	<i>2008 Rating</i>
ADA Compliance	Poor
Conveying Systems	Unsatisfactory
Electrical	Fair
Exterior Finish	Poor
HVAC	Poor
Interior Finish	Fair
Plumbing	Poor
Roof	Poor
Structure	Fair
Technology	Poor
