# AMIDON - BOWEN ELEMENTARY SCHOOL

401 I Street, S.W., Washington, DC

## CONDITION ASSESSMENT

### Concept Plans

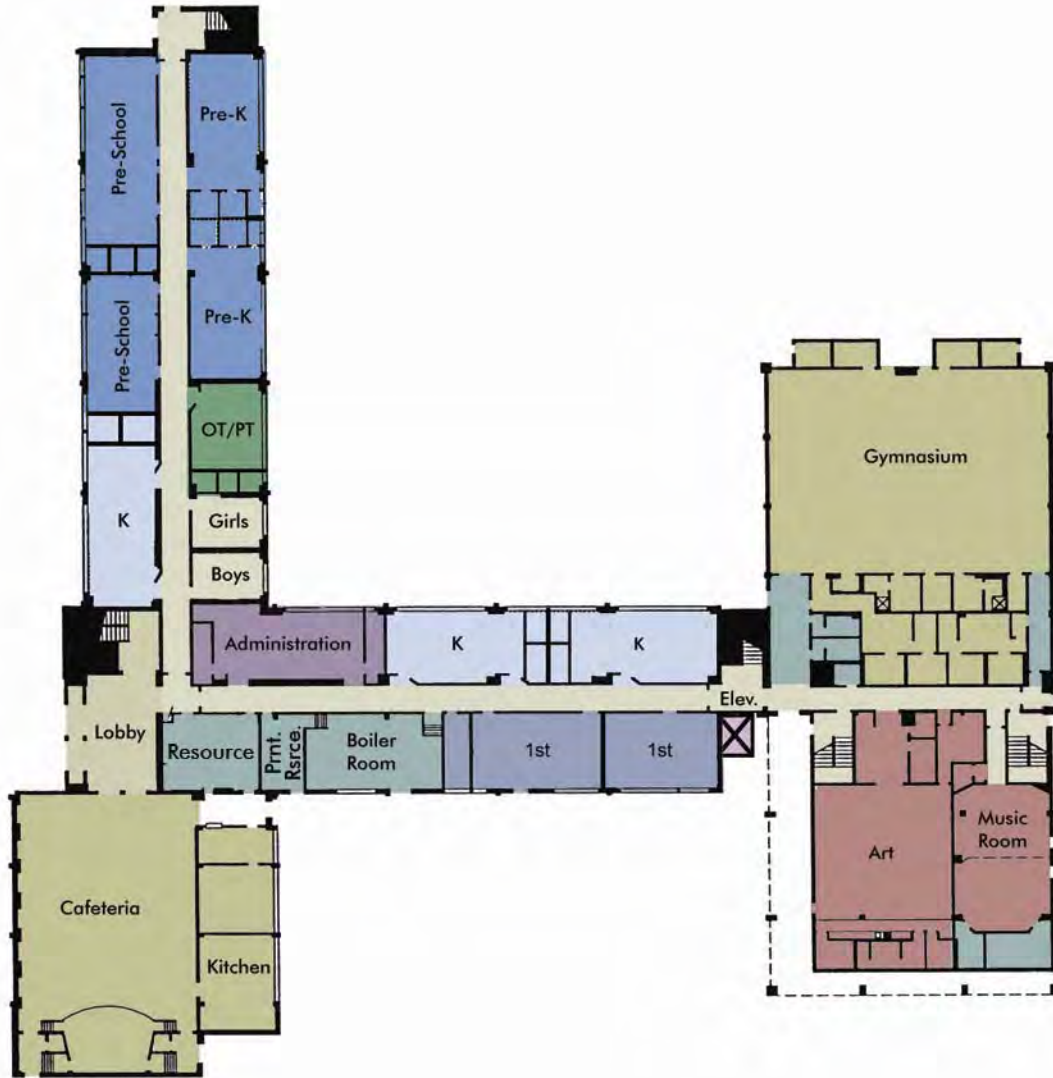
First Floor

These floor plans represent planning concepts for proposed facility use, aligning the proposed program capacity, the proposed planning profiles, and the conceptual reconfiguration of the building. Each project is subject to a formal design process, incorporating input from the School Improvement team at the time of project initiation.
