# BIRNEY ELEMENTARY SCHOOL

## SAVOY AT BIRNEY ELEMENTARY SCHOOL

2505 Martin Luther King Jr. Avenue, S.E., Washington, DC

### CONDITION ASSESSMENT

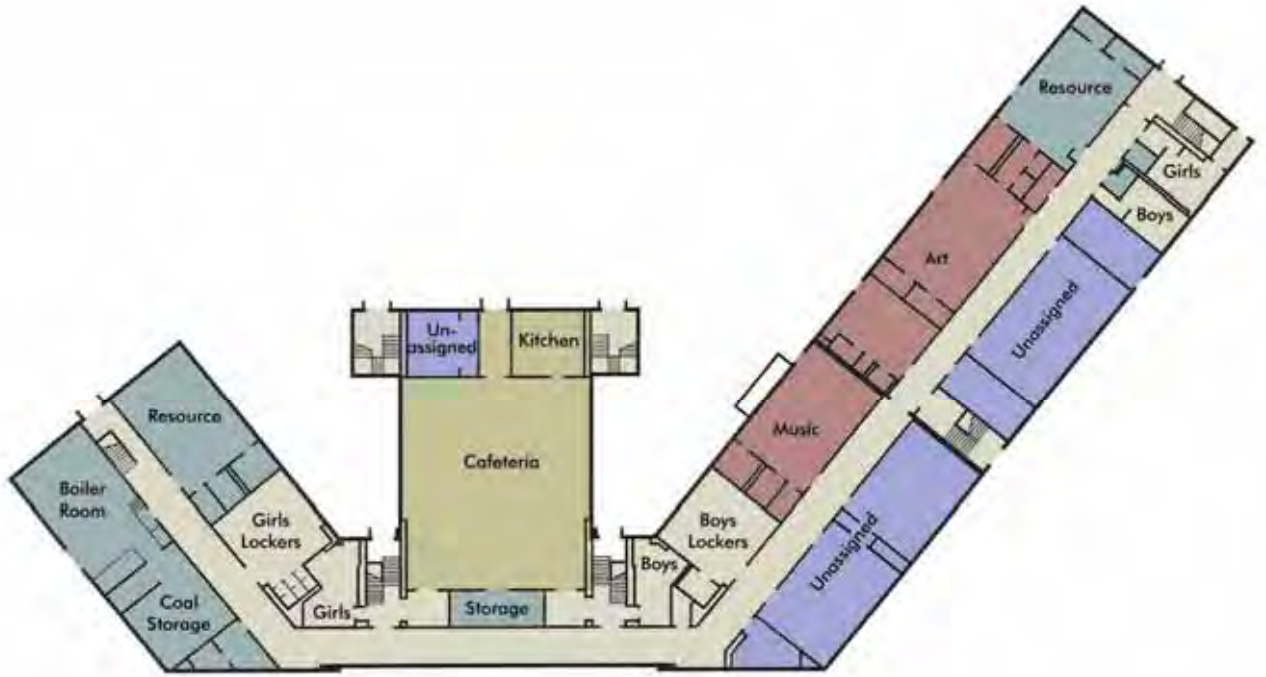
Basement

These floor plans represent planning concepts for proposed facility use, aligning the proposed program capacity, the proposed planning profiles, and the conceptual reconfiguration of the building. Each project is subject to a formal design process, incorporating input from the School Improvement team at the time of project initiation.

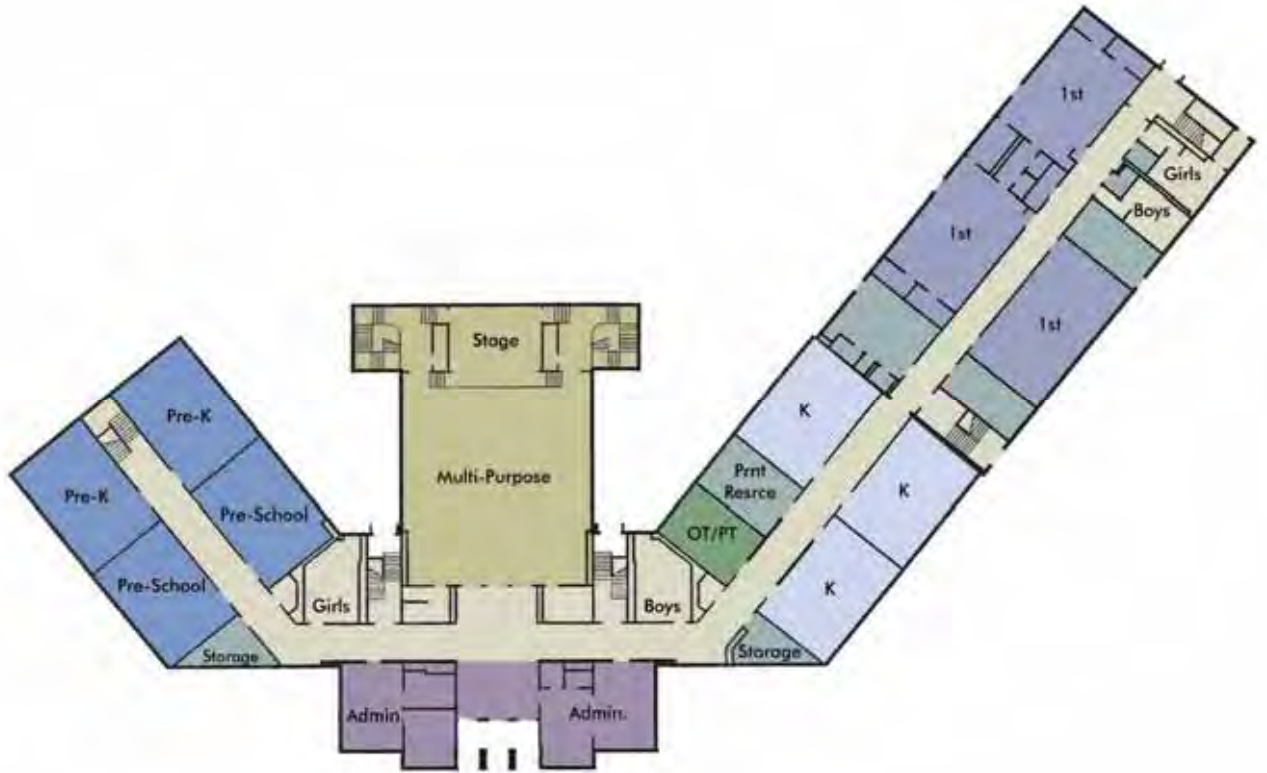
First Floor

These floor plans represent planning concepts for proposed facility use, aligning the proposed program capacity, the proposed planning profiles, and the conceptual reconfiguration of the building. Each project is subject to a formal design process, incorporating input from the School Improvement team at the time of project initiation.

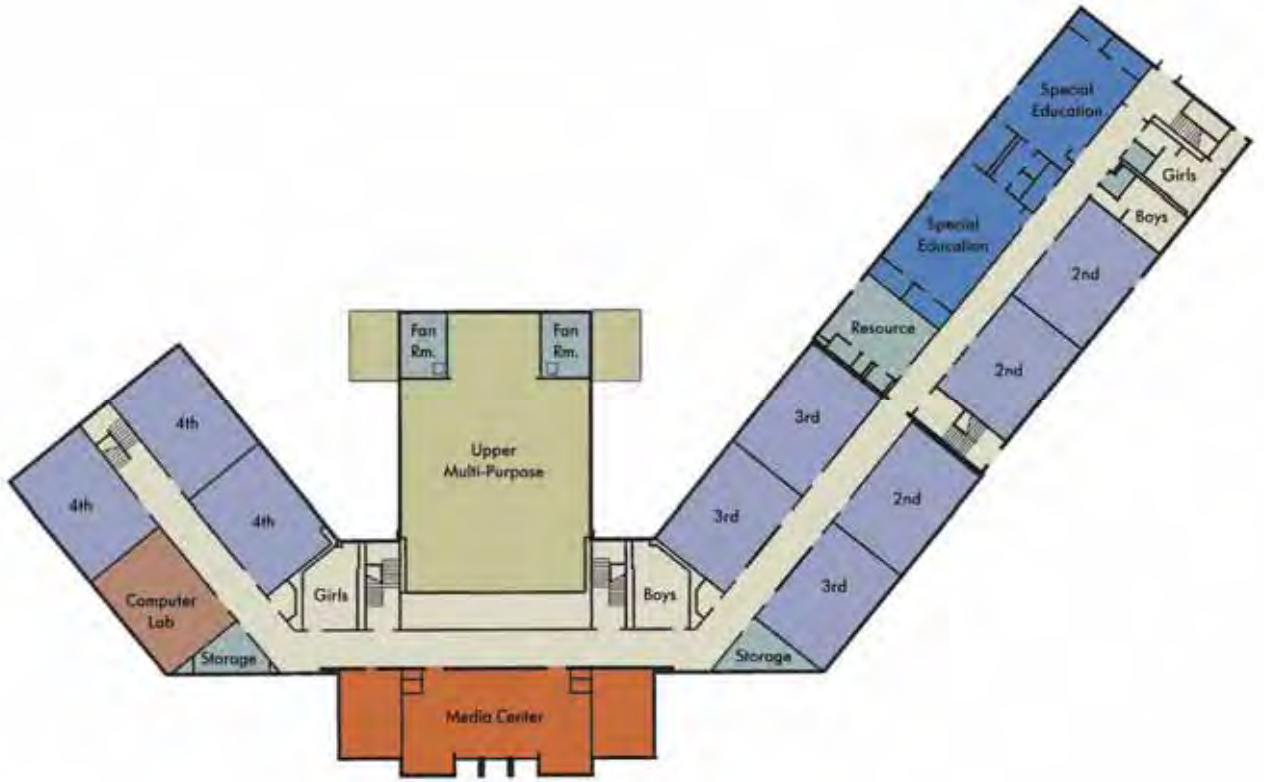
Second Floor

These floor plans represent planning concepts for proposed facility use, aligning the proposed program capacity, the proposed planning profiles, and the conceptual reconfiguration of the building. Each project is subject to a formal design process, incorporating input from the School Improvement team at the time of project initiation.

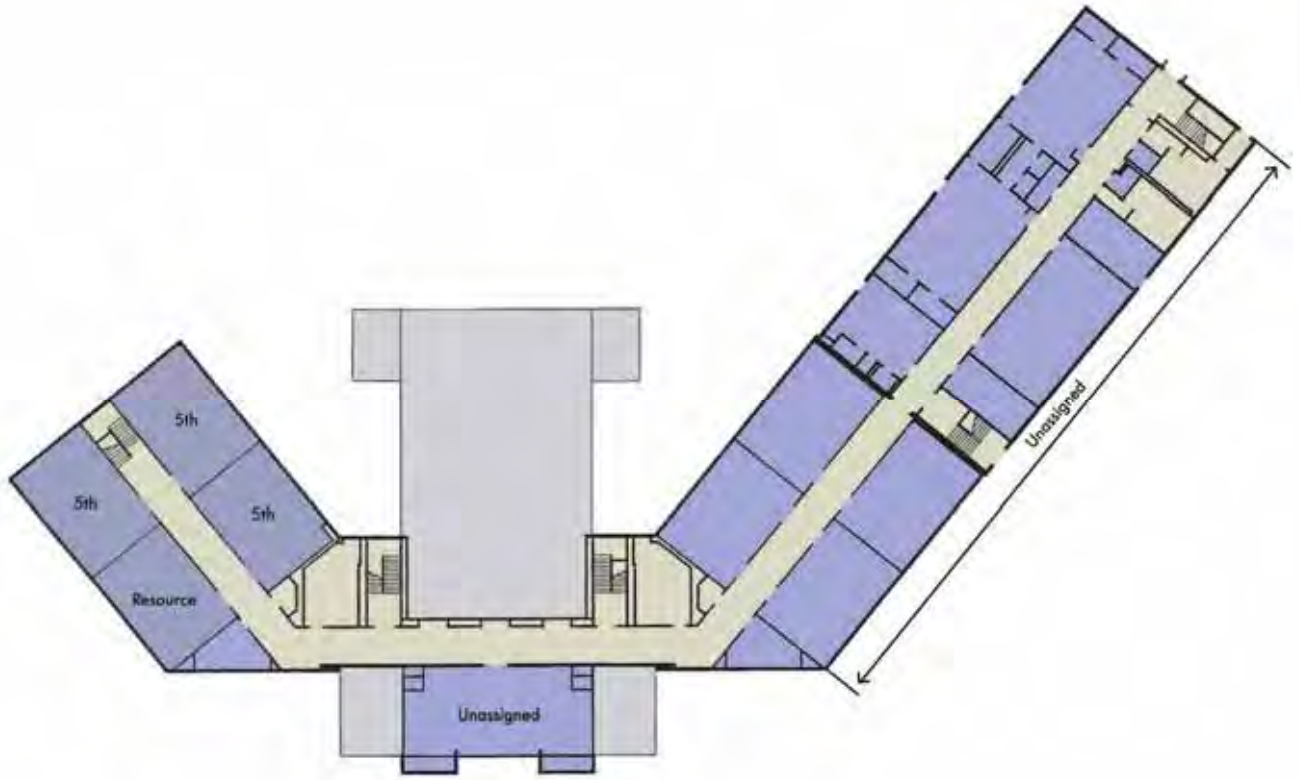
Third Floor

These floor plans represent planning concepts for proposed facility use, aligning the proposed program capacity, the proposed planning profiles, and the conceptual reconfiguration of the building. Each project is subject to a formal design process, incorporating input from the School Improvement team at the time of project initiation.
