BURRVILLE ELEMENTARY SCHOOL

801 Division Avenue, N.E., Washington, DC

CONDITION ASSESSMENT

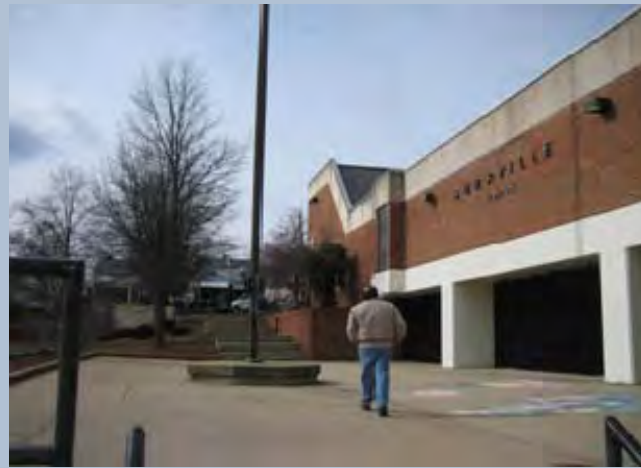
Building System	2008 Rating
ADA Compliance	Unsatisfactory
Conveying Systems	Fair
Electrical	Fair
Exterior Finish	Poor
HVAC	Good
Interior Finish	Good
Plumbing	Good
Roof	Good
Structure	Fair
Technology	Poor

Condition Scorecard
These ratings reflect the overall condition and level of replacement need for an entire system, in adherence with the **Facility Condition Index (FCI) System**, categorizing systems as "Good" (FCI < .25), "Fair" (FCI 0.25 – 0.50), "Poor" (FCI 0.51 – 0.85), or "Unsatisfactory" (FCI > .86).

1 Conveying System	Elevator cab should be updated for aesthetics and for ADA compliance.
2 Electrical	The lighting needs to be updated. The electrical system as a whole seems to be in fair condition. 2007: General power repairs, light fixtures, bulbs and ballasts.
3 Exterior Finish	There are many areas of spalling concrete and graffiti, which need to be cleaned and repaired. The lower covered area needs to be cleaned and repaired. 2007: Tuck painting. 2008: Replace exterior lighting.
4 Structure	Structure is in fair condition. There are some areas of cracking that need repair, both inside and outside.
5 HVAC	The heating and A/C systems are in fair and working condition. The systems are reaching the end of their average life, however, and costing should be associated with replacing the systems in a few years. 2007: Chiller and AHU repairs, boiler repairs. 2008: Chiller replacement. Repairs to boilers and classroom units. Installed A/C window units.

6 Interior Finish	There are several areas that need to be cleaned and updated, repaired or replaced - flooring, ceiling, and walls. 2007: door repairs, drywall repairs, door hardware, replace damaged carpet and VCT, classroom painting,
7 Plumbing	Copper piping for plumbing appears to be in good condition. Sprinklers are not present in entire building. 2007: Repair/replace plumbing fixtures and valves, water coolers, snaking of clogged drains.
8 Roof	Roof is approximately ten years old. There are no significant leaks.
9 ADA Compliance	Building is not accessible, and there is no accessible parking. There are many areas of varying elevation within the building which are not accessible. Bathrooms and other facilities are not accessible. The ramp that is present does not meet code. There is no visible or audible fire alarm system. This is both a building code and life safety issue.
10 Technology	There are only a few data drops, and the computers and equipment that exist appear to be old and deficient.

11 Grounds	The exterior lighting is non-existent. ADA accessibility is limited to a small non-code ramp to lead only to the cafeteria entrance. Fields and play structures need to be updated.

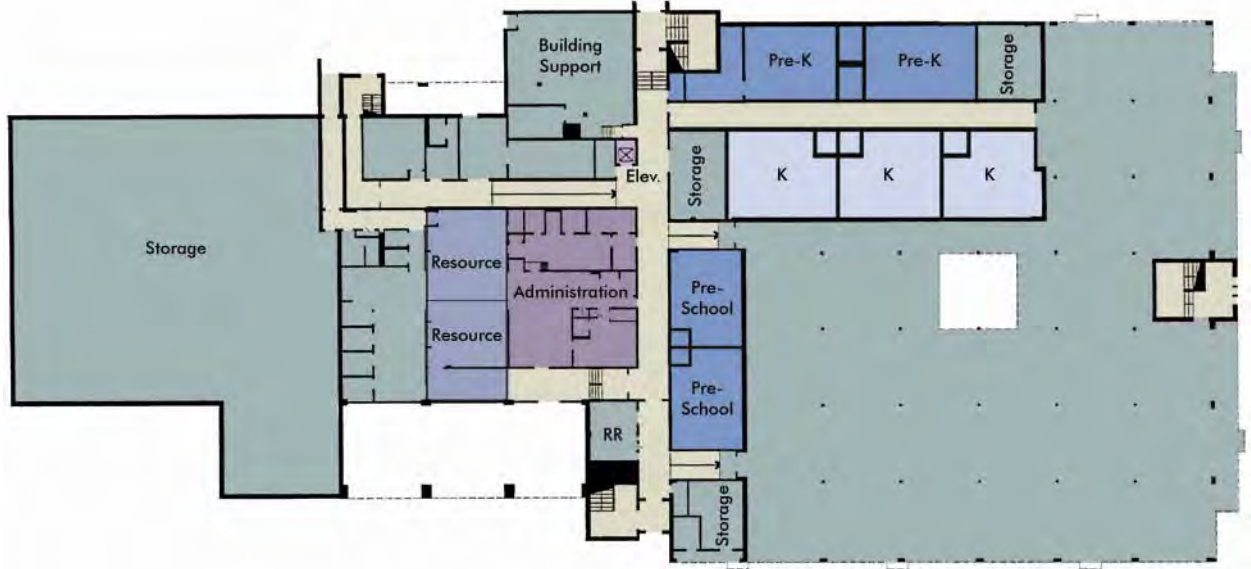
First Floor

These floor plans represent planning concepts for proposed facility use, aligning the proposed program capacity, the proposed planning profiles, and the conceptual reconfiguration of the building. Each project is subject to a formal design process, incorporating input from the School Improvement team at the time of project initiation.
