DRAPER ELEMENTARY SCHOOL

908 Wahler Road, S.E., Washington, DC

CONDITION ASSESSMENT

Condition Assessment

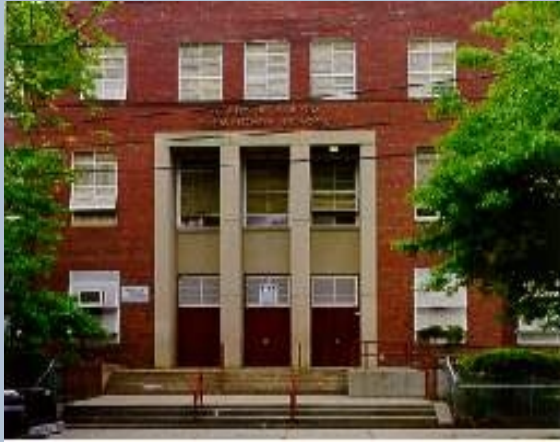
Building System	2008 Rating
ADA Compliance	Unsatisfactory
Conveying Systems	Poor
Electrical	Good
Exterior Finish	Unsatisfactory
HVAC	Fair
Interior Finish	Good
Plumbing	Fair
Roof	Good
Structure	Good
Technology	Poor

These ratings reflect the overall condition and level of replacement need for an entire system, in adherence with the **Facility Condition Index (FCI) System**, categorizing systems as "Good" (FCI < .25), "Fair" (FCI 0.25 – 0.50), "Poor" (FCI 0.51 – 0.85), or "Unsatisfactory" (FCI > .86).

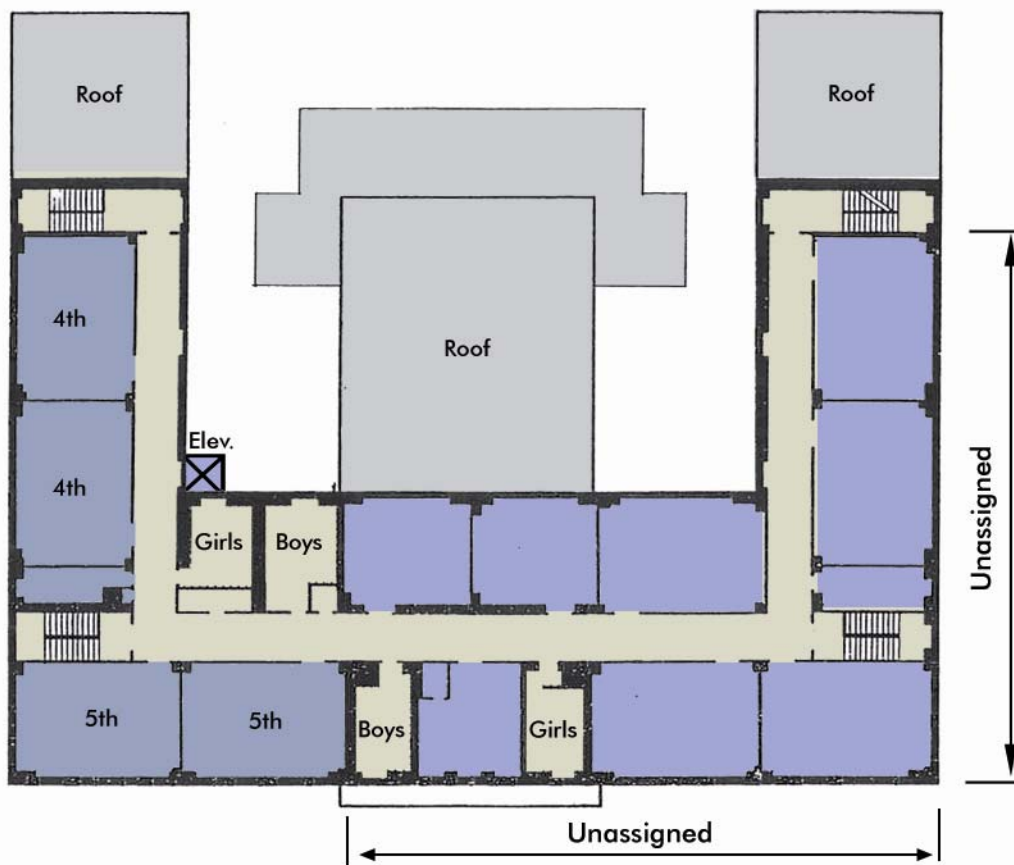
Third Floor

These floor plans represent planning concepts for proposed facility use, aligning the proposed program capacity, the proposed planning profiles, and the conceptual reconfiguration of the building. Each project is subject to a formal design process, incorporating input from the School Improvement team at the time of project initiation.
