HARRIS, C.W. ELEMENTARY SCHOOL

301 53rd Street, S.E., Washington, DC

CONDITION ASSESSMENT

Condition Assessment
The body of information summarized below is based on a detailed facility condition assessment completed in 2006 and updated by visual observations conducted in 2007. Improvement initiatives completed by OPEFM in 2007 and 2008 are noted in red text in each section. An overall summary of work completed under various OPEFM programs is provided at the end of the condition assessment.

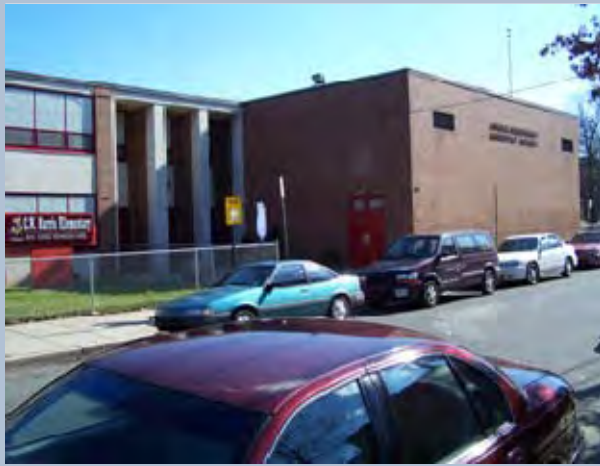
| <i>Building System</i> | <i>2008 Rating</i> |
| ADA Compliance | Unsatisfactory |

| 2 Electrical | Emergency lighting is present but inadequate. Fluorescent lighting is obsolete and should be upgraded with new. Panel boards need to be replaced. Switchgear should be replaced. Service should be upgraded for improved load capacity. Public address, telephone, and fire alarm systems are obsolete and should be replaced. 2007: Lighting ballast replacement. |
| 3 Exterior Finish | All finishes look good, with the exception of exterior doors. Most need to be replaced or repaired to function properly. 2007: Exterior lighting replaced. |
| 4 Structure | No major deficiencies were observed. Minor cracking, typical for concrete framing, can be repaired as part of routine building maintenance. |
| 5 HVAC | The A/C system was upgraded in 1993 and most major components are within expected service lifetimes. However, ancillary component such as unit heaters, ductwork, and small exhaust systems need to be repaired or replaced. 2006: Chiller replacement. Cooling tower replaced new inivents, and new conveyors. 2008: Repairs to boilers and classroom units completed. 2008: 2 Window A/C units installed. |
| 6 Interior Finish | Many of the interior spaces need to be renovated. Vinyl flooring is worn and should be replaced. Large areas of ceiling tile are damaged and should be replaced with new. Interior doors are in generally in poor condition. Concrete and CMU walls need to be repainted. Drywall, ceiling repairs, door frame and hardware repair and replacement, painting. |
| 7 Plumbing | Sinks and toilets are outdated and do not comply with code. All should be replaced. Visible piping does not look deficient. Drinking fountains should be replaced with code compliant models. 2007: Plumbing fixture and flush valve replacement. |
| 8 Roof | The built-up roof system, including all flashing and membranes, is in poor condition. The underlying concrete framing appears to be in good condition. A complete tear-off and replacement is recommended. 2007: Re-roof completed. |
| 9 ADA Compliance | The building does not comply with ADA codes. Access is poor; fixtures, grab bars, and hand rails are missing; ramps and doors are inadequate. |
| 10 Technology | Visual inspection is a limited tool for technology assessments. Generally, the equipment observed appears to be in fair condition. Upgrades should include new televisions, software, networking, and dedicated climate controlled spaces to house equipment. |
| 11 Grounds | Paved areas require significant repair work. Sidewalks are cracked and curb cuts need to be added. Parking area should be resurfaced. Playground should be removed and repaved. 2008: Teachers need secure parking area. |
