HOUSTON ELEMENTARY SCHOOL

1100 50th Place, N.E., Washington, DC

CONDITION ASSESSMENT

Condition Assessment

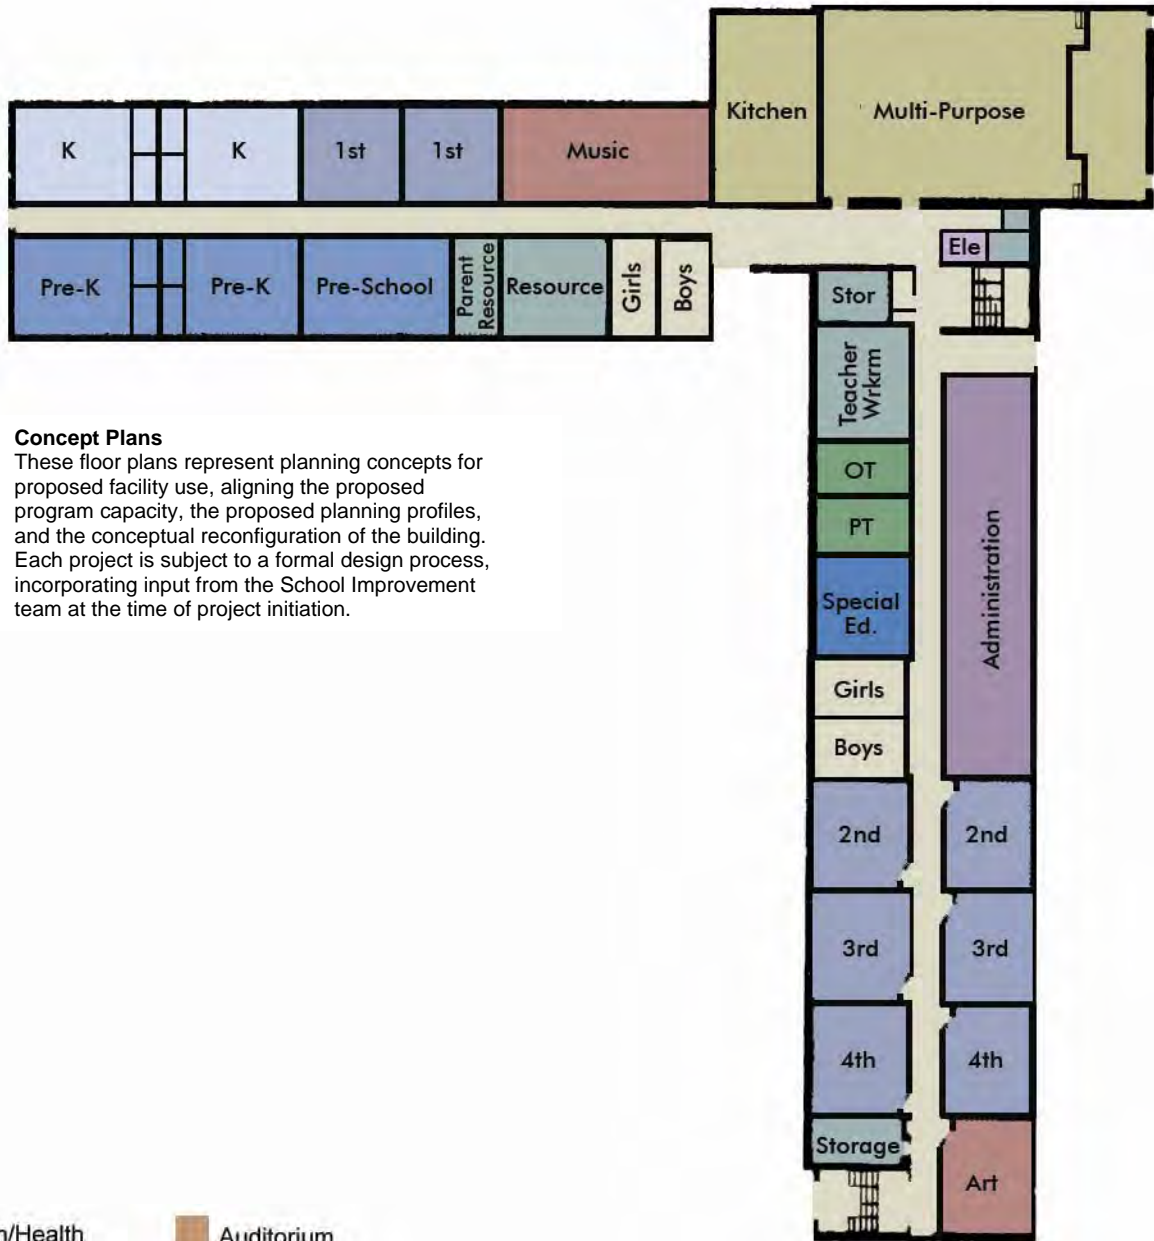
First Floor

These floor plans represent planning concepts for proposed facility use, aligning the proposed program capacity, the proposed planning profiles, and the conceptual reconfiguration of the building. Each project is subject to a formal design process, incorporating input from the School Improvement team at the time of project initiation.
