JANNEY ELEMENTARY SCHOOL

4130 Albermarle Street, N.W., Washington, DC

CONDITION ASSESSMENT

Condition Assessment

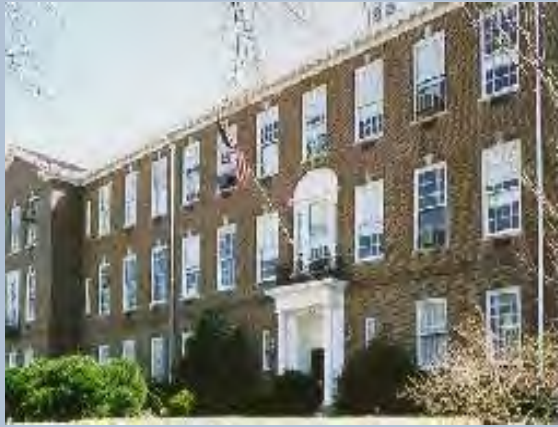
Building System	2008 Rating
ADA Compliance	Unsatisfactory
Conveying Systems	Unsatisfactory
Electrical	Poor
Exterior Finish	Poor
HVAC	Fair
Interior Finish	Fair
Plumbing	Poor
Roof	Fair
Structure	Good
Technology	Fair

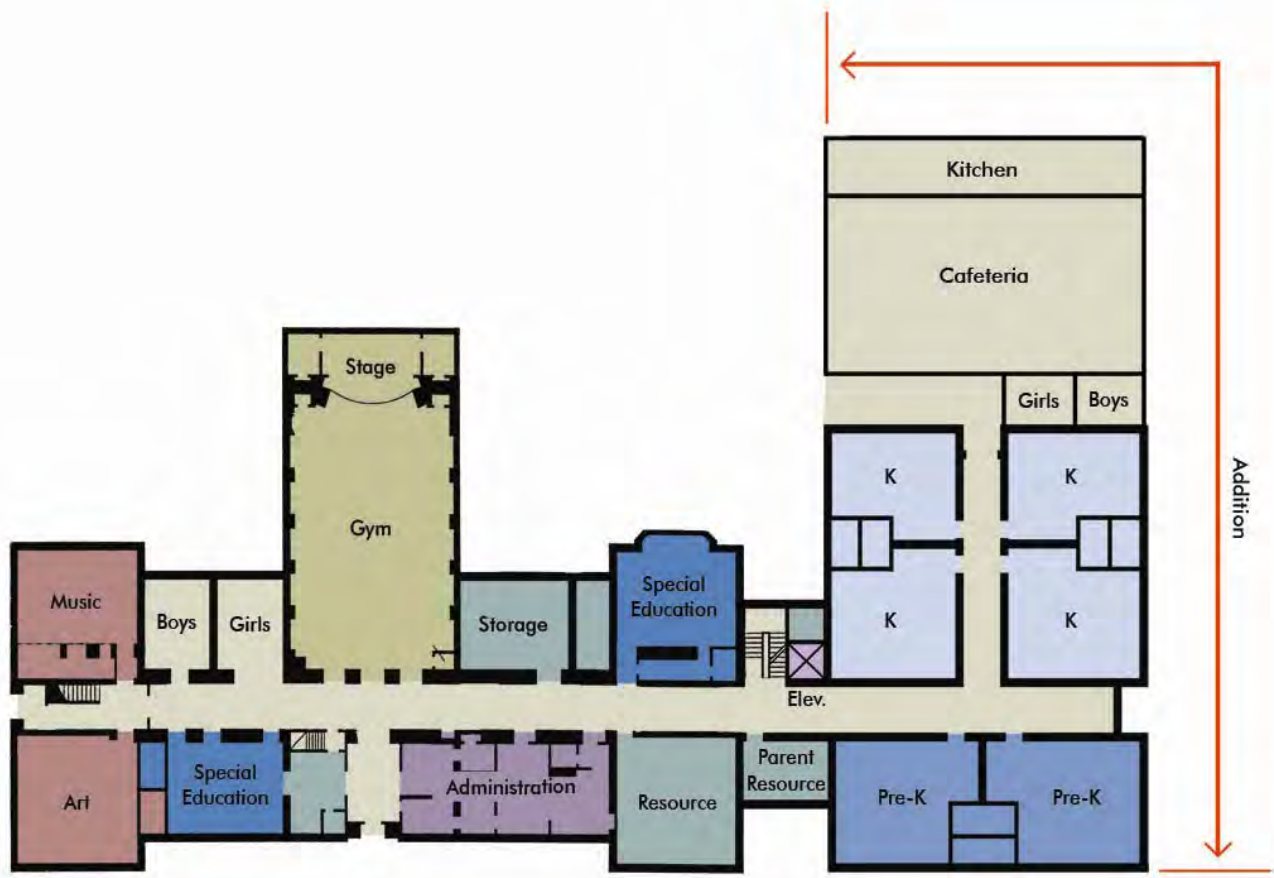
First Floor

These floor plans represent planning concepts for proposed facility use, aligning the proposed program capacity, the proposed planning profiles, and the conceptual reconfiguration of the building. Each project is subject to a formal design process, incorporating input from the School Improvement team at the time of project initiation.
