KETCHAM ELEMENTARY SCHOOL

1919 15th Street, S.E., Washington, DC

INITIAL YEAR BUILT	1909
BUILDING AREA	88,300 SF
CURRENT PROGRAM CAPACITY	461
ENROLLMENT 2008	283
WARD	8
PROPOSED PROGRAM CAPACITY	325

CONDITION ASSESSMENT

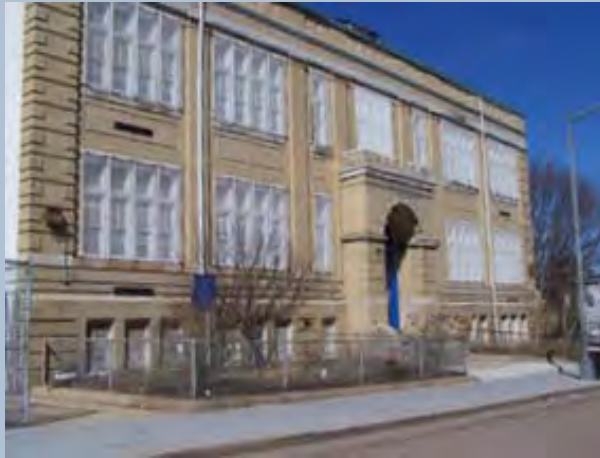
Condition Scorecard

Building System	2008 Rating
ADA Compliance	Unsatisfactory
Conveying Systems	Unsatisfactory
Electrical	Unsatisfactory
Exterior Finish	Poor
HVAC	Fair
Interior Finish	Fair
Plumbing	Poor
Roof	Fair
Structure	Fair
Technology	Poor

These ratings reflect the overall condition and level of replacement need for an entire system, in adherence with the **Facility Condition Index (FCI) System**, categorizing systems as "Good" (FCI < .25), "Fair" (FCI 0.25 – 0.50), "Poor" (FCI 0.51 – 0.85), or "Unsatisfactory" (FCI > .86).

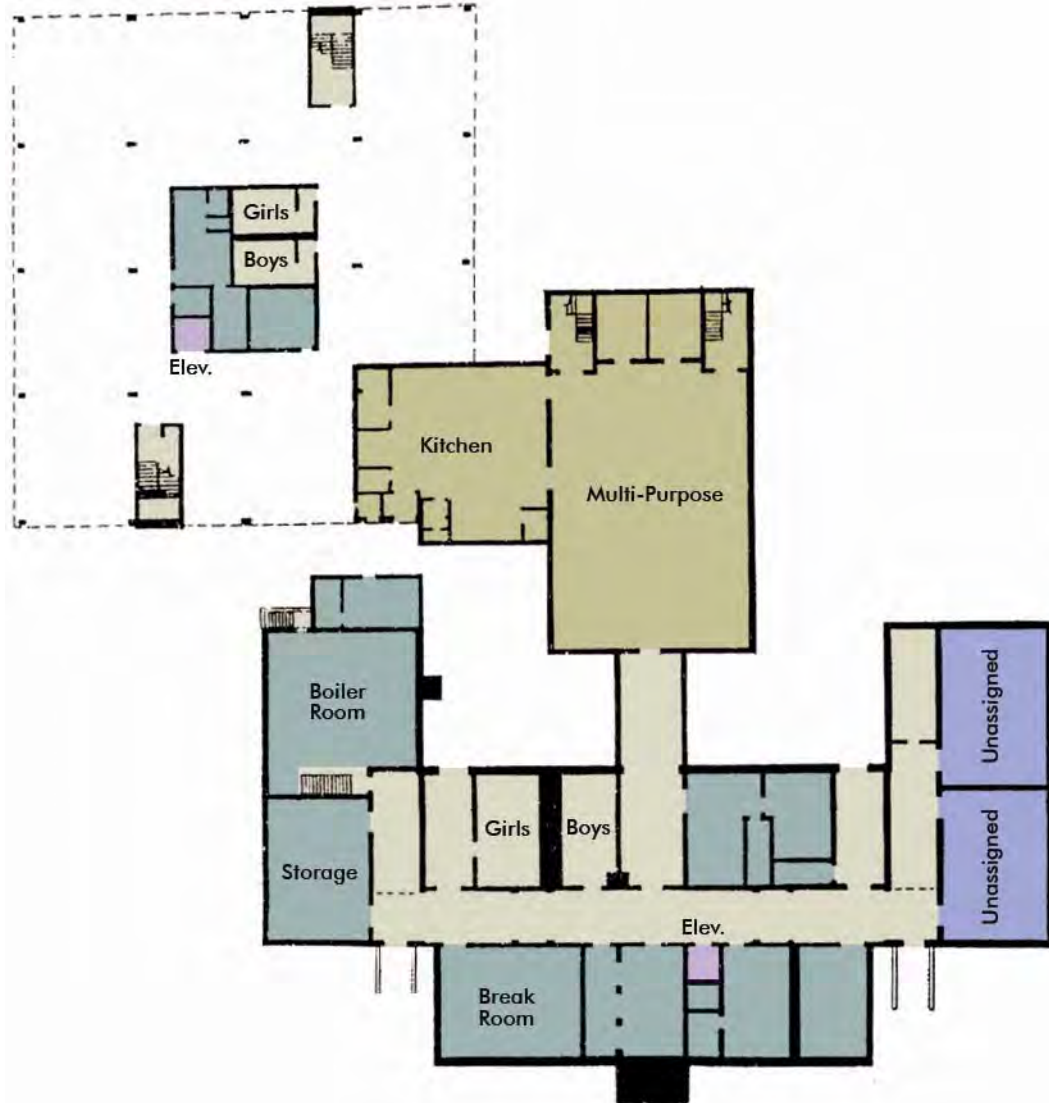
Ground Floor

These floor plans represent planning concepts for proposed facility use, aligning the proposed program capacity, the proposed planning profiles, and the conceptual reconfiguration of the building. Each project is subject to a formal design process, incorporating input from the School Improvement team at the time of project initiation.

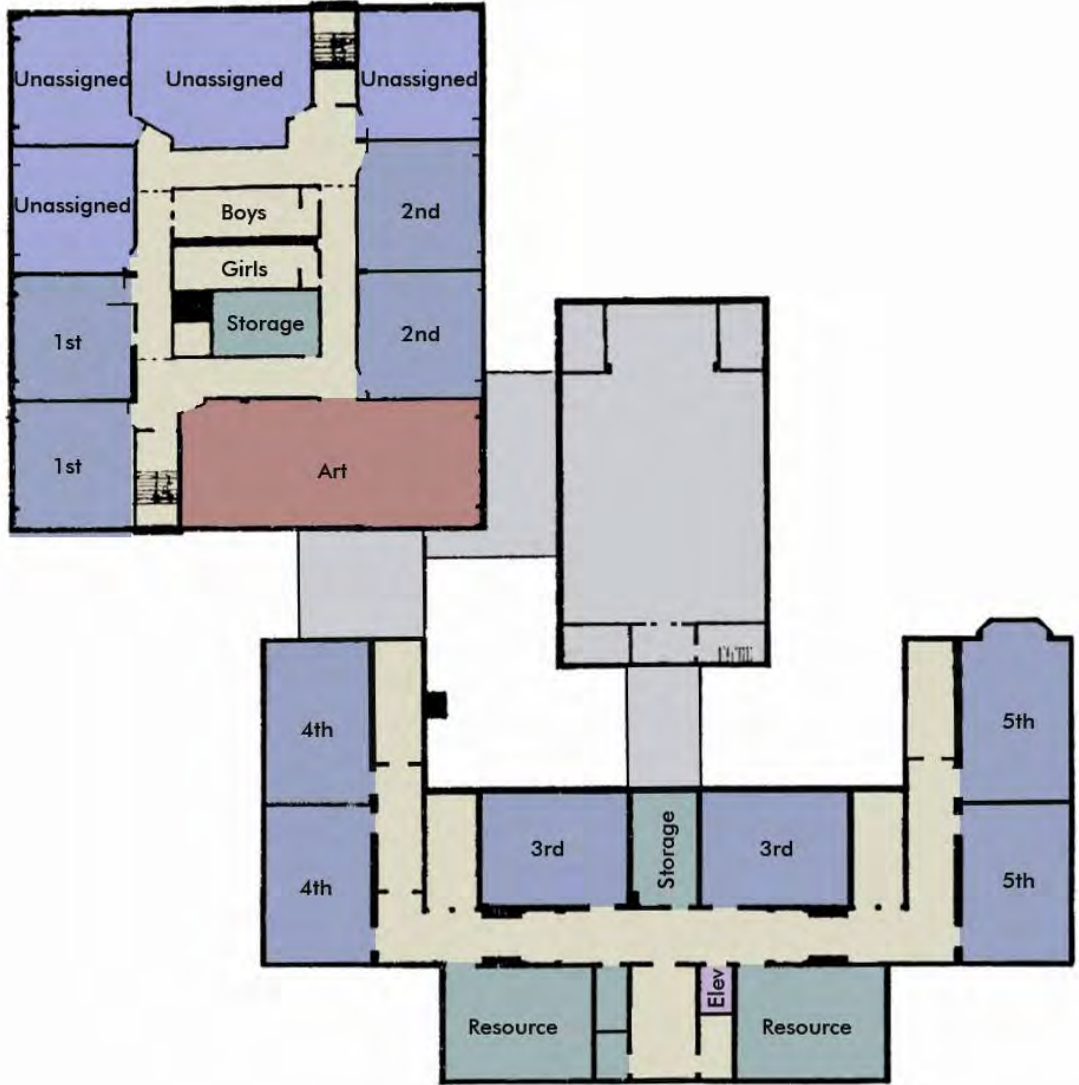
Second Floor

These floor plans represent planning concepts for proposed facility use, aligning the proposed program capacity, the proposed planning profiles, and the conceptual reconfiguration of the building. Each project is subject to a formal design process, incorporating input from the School Improvement team at the time of project initiation.
