KING, M.L. ELEMENTARY SCHOOL

3200 6th Street, S.E., Washington, DC

CONDITION ASSESSMENT

Condition Assessment

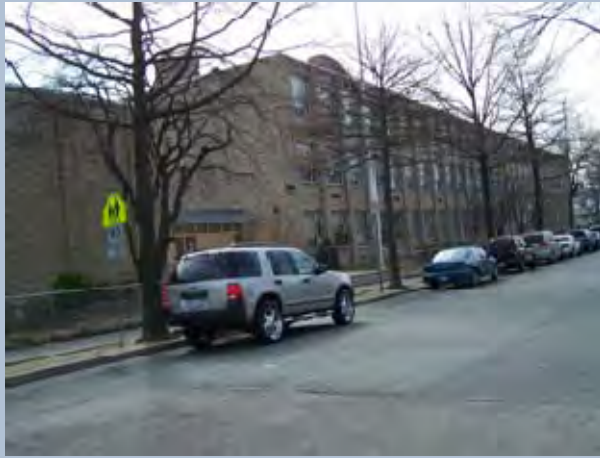
Building System	2008 Rating
ADA Compliance	Unsatisfactory
Conveying Systems	Unsatisfactory
Electrical	Unsatisfactory
Exterior Finish	Fair
HVAC	Fair
Interior Finish	Fair
Plumbing	Poor
Roof	Unsatisfactory
Structure	Unsatisfactory
Technology	Fair
