LEWIS ELEMENTARY SCHOOL

COOKE, H.D. AT LEWIS ELEMENTARY SCHOOL

300 Bryant St. N.W., Washington, DC

CONDITION ASSESSMENT

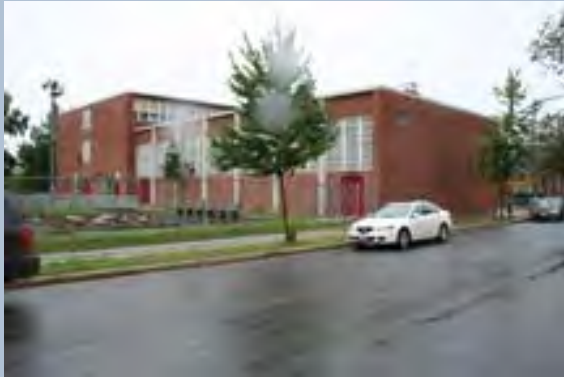
<i>Building System</i>	<i>2008 Rating</i>
ADA Compliance	Unsatisfactory
Conveying Systems	Unsatisfactory
Electrical	Poor
Exterior Finish	Fair
HVAC	Fair
Interior Finish	Poor
Plumbing	Poor
Roof	Fair
Structure	Fair
Technology	Fair

1 Conveying System	There is no escalator, elevator, or lift system present in the building.
2 Electrical	Lighting systems need to be replaced with more energy efficient models. The fire alarm is not up to code and needs to be replaced. Existing smoke detectors are in poor condition.
3 Exterior Finish	Exterior doors are in fair condition. Minor repair work should be performed to keep the doors operating properly. A few exterior windows leak and should be replaced. <i>2007: Replace exterior lighting.</i>
4 Structure	No major deficiencies were observed. Minor cracking was seen, but is not atypical for concrete framing.
5 HVAC	Major components have reached the end of useful life. Radiators are in poor condition. Large sections of distribution piping have corroded and need to be replaced. <i>2007: Replaced boiler. 2008: Repairs to boiler and classroom heating units. Installed 11 A/C window units.</i>

6 Interior Finish	Ceiling finishes and flooring are in disrepair. Large areas require replacement. A few interior windows need to be replaced.
7 Plumbing	Waste systems and fixtures are all in poor condition. New systems should be installed. Code compliant fixture should be installed as well.
8 Roof	A built-up roof system sits atop concrete decking. This roof has a great deal of blueberry blistering which indicates imminent failure. Over half of the flashings were pulling away from the gravel stop. This needs to be fixed immediately. Other scattered blistering of membrane. Coal Tar Pitch, 25% of roof has blueberry blisters.
9 ADA Compliance	The facility needs numerous upgraded in order to conform to ADA code. Wet fixtures should be replaced; access needs to be improved, inside the building and out.
10 Technology	Visual inspection of equipment found most is in fair condition; most hardware and software is outdated and should be upgraded. Similarly, networking capability should be improved.

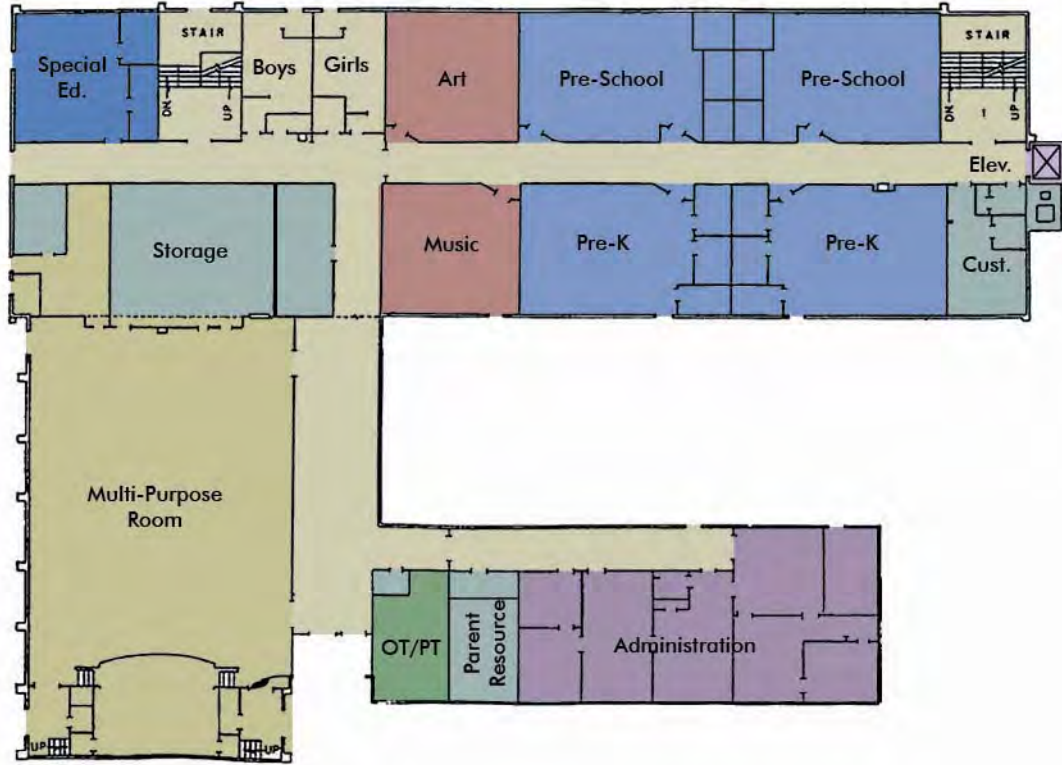
First Floor

These floor plans represent planning concepts for proposed facility use, aligning the proposed program capacity, the proposed planning profiles, and the conceptual reconfiguration of the building. Each project is subject to a formal design process, incorporating input from the School Improvement team at the time of project initiation.
