MURCH ELEMENTARY SCHOOL

4810 36th Street, N.W., Washington, DC

CONDITION ASSESSMENT

Condition Assessment

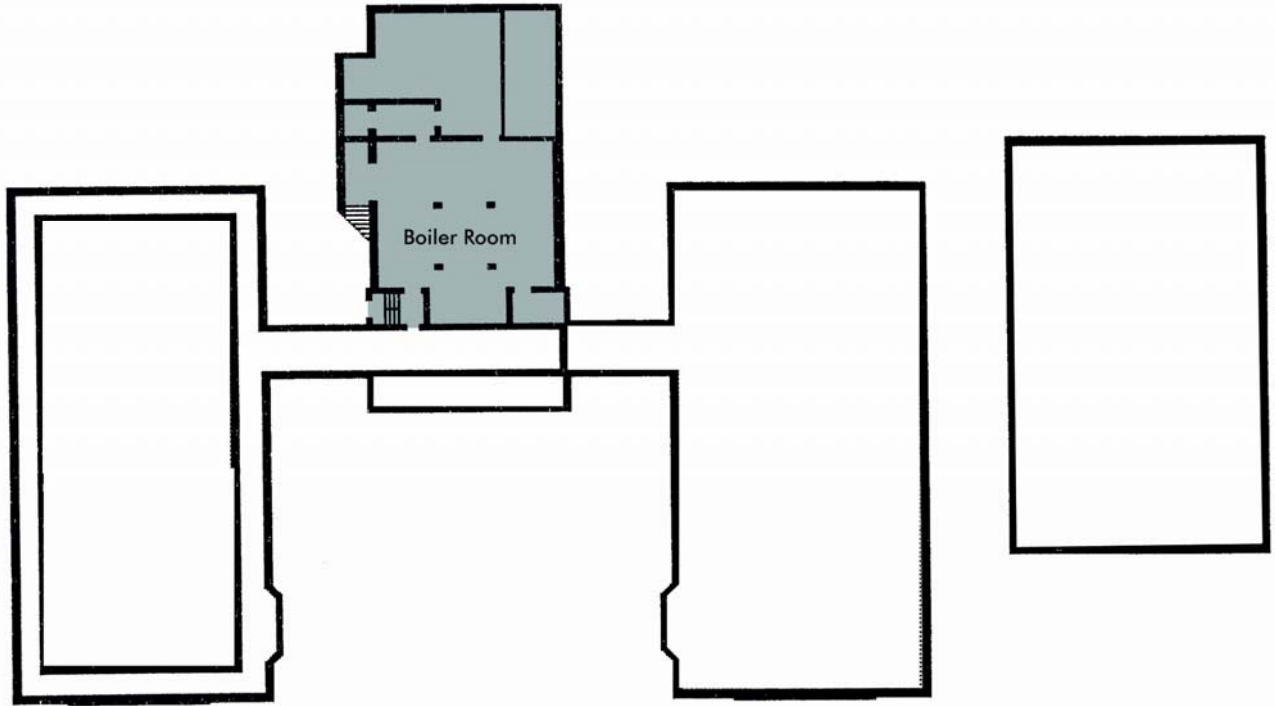
Basement

These floor plans represent planning concepts for proposed facility use, aligning the proposed program capacity, the proposed planning profiles, and the conceptual reconfiguration of the building. Each project is subject to a formal design process, incorporating input from the School Improvement team at the time of project initiation.

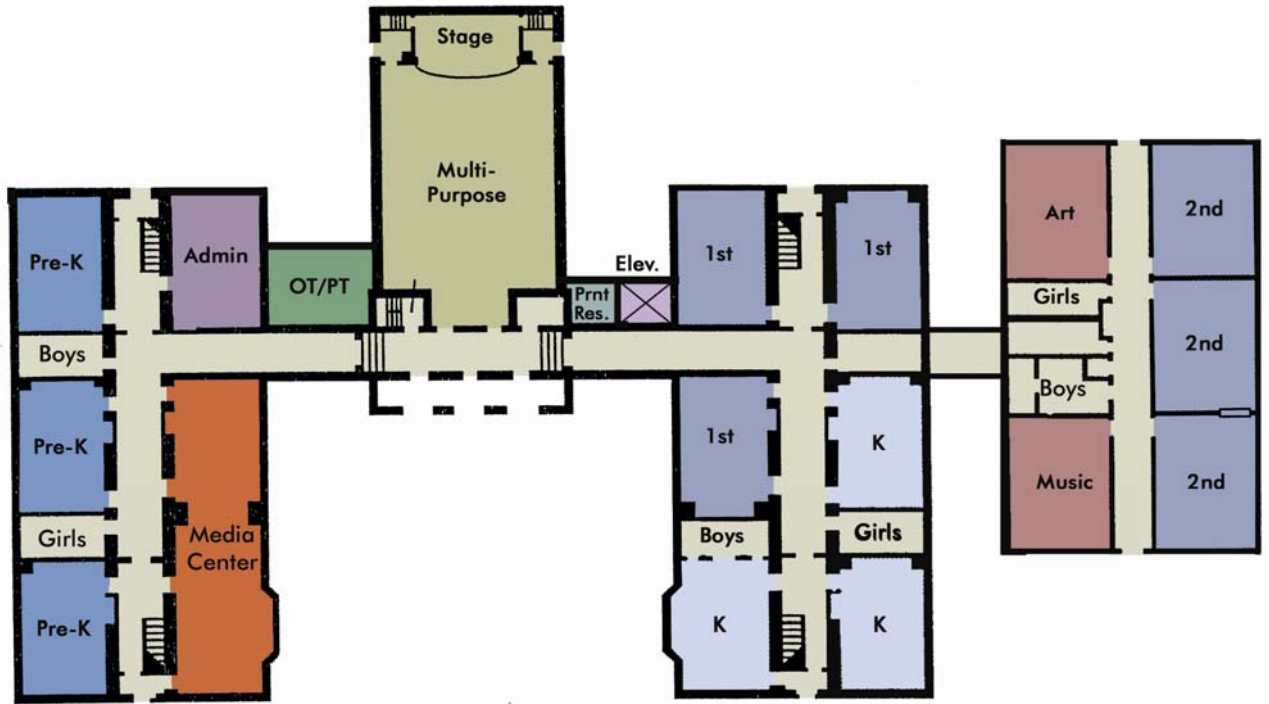
First Floor

These floor plans represent planning concepts for proposed facility use, aligning the proposed program capacity, the proposed planning profiles, and the conceptual reconfiguration of the building. Each project is subject to a formal design process, incorporating input from the School Improvement team at the time of project initiation.

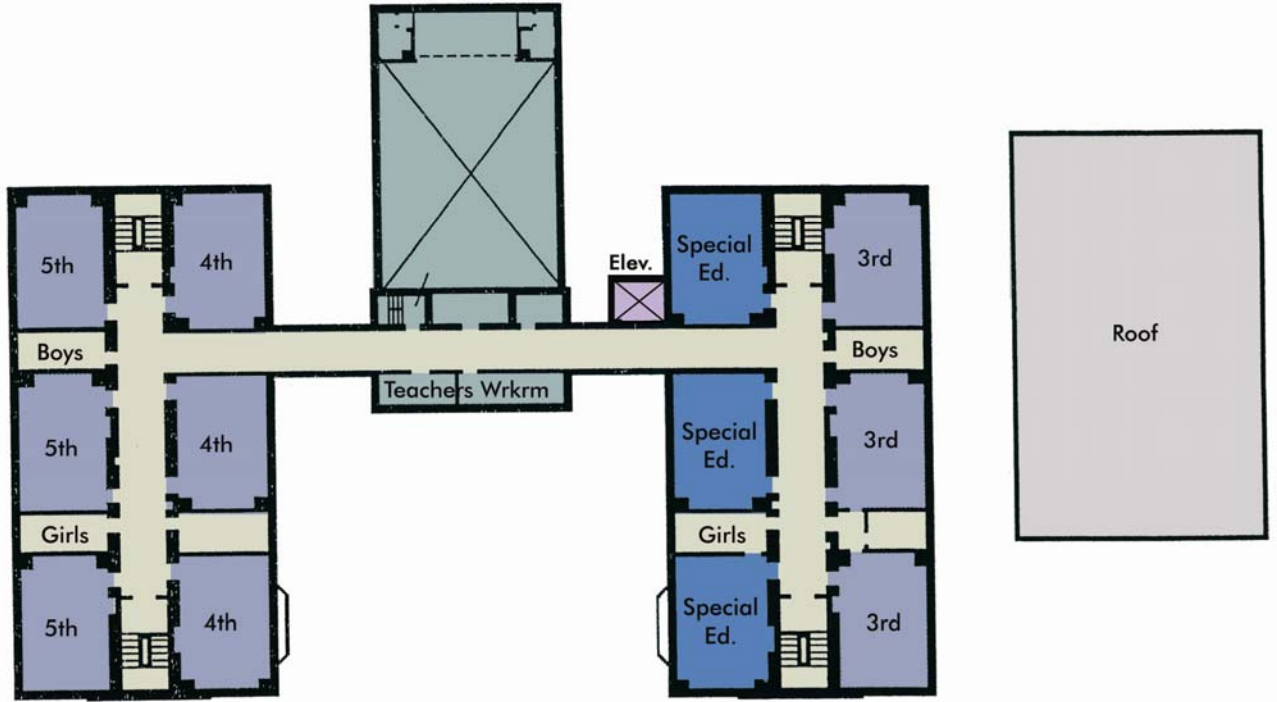
Second Floor

These floor plans represent planning concepts for proposed facility use, aligning the proposed program capacity, the proposed planning profiles, and the conceptual reconfiguration of the building. Each project is subject to a formal design process, incorporating input from the School Improvement team at the time of project initiation.
