PAYNE ELEMENTARY SCHOOL

305 15th Street, S.E., Washington, DC

CONDITION ASSESSMENT

Condition Assessment

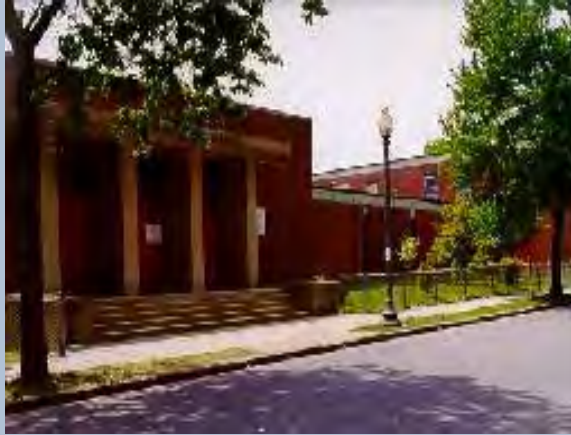
Building System	2008 Rating
ADA Compliance	Unsatisfactory
Conveying Systems	Unsatisfactory
Electrical	Poor
Exterior Finish	Fair
HVAC	Poor
Interior Finish	Unsatisfactory
Plumbing	Fair
Roof	Poor
Structure	Poor
Technology	Poor

These ratings reflect the overall condition and level of replacement need for an entire system, in adherence with the **Facility Condition Index (FCI) System**, categorizing systems as "Good" (FCI < .25), "Fair" (FCI 0.25 – 0.50), "Poor" (FCI 0.51 – 0.85), or "Unsatisfactory" (FCI > .86).

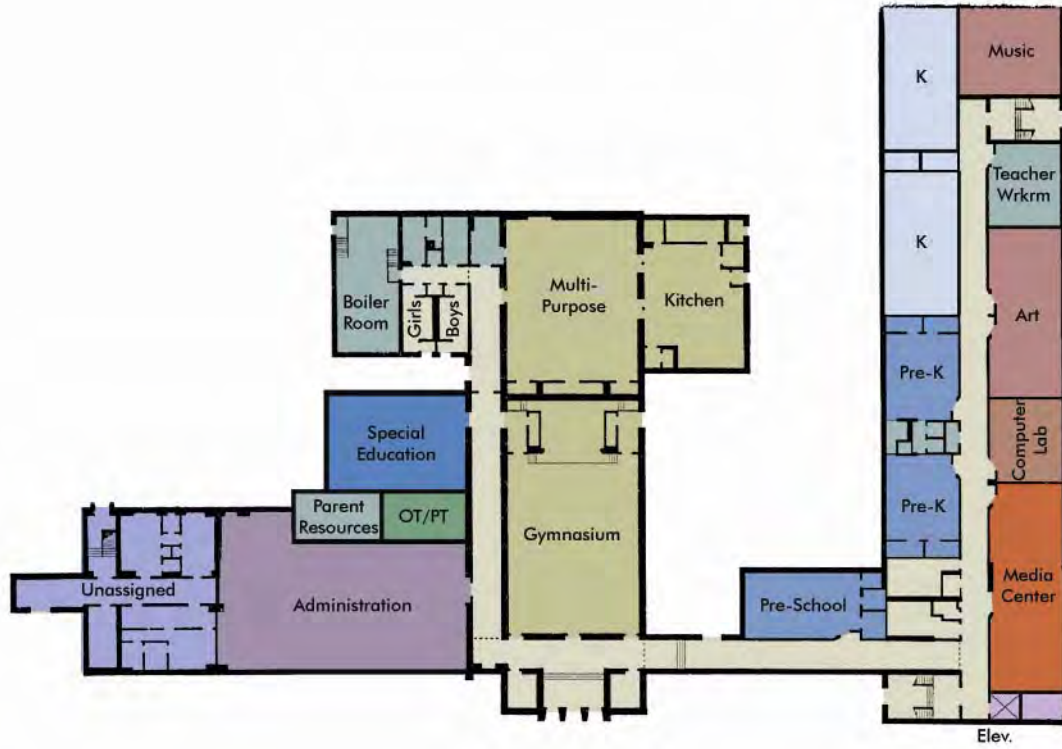
First Floor

These floor plans represent planning concepts for proposed facility use, aligning the proposed program capacity, the proposed planning profiles, and the conceptual reconfiguration of the building. Each project is subject to a formal design process, incorporating input from the School Improvement team at the time of project initiation.
