RAYMOND EDUCATION CAMPUS

915 Spring Road, N.W., Washington, DC

CONDITION ASSESSMENT

Condition Assessment

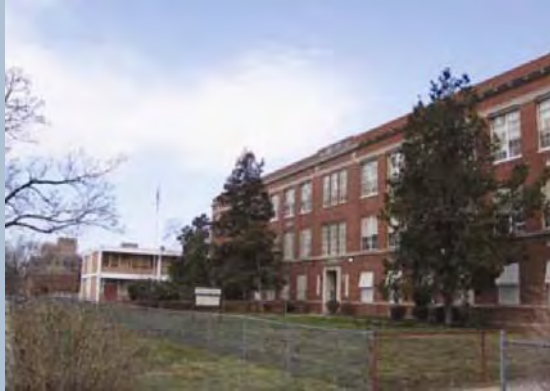
Building System	2008 Rating
ADA Compliance	Fair
Conveying Systems	Good
Electrical	Fair
Exterior Finish	Unsatisfactory
HVAC	Fair
Interior Finish	Good
Plumbing	Fair
Roof	Fair
Structure	Good
Technology	Poor

1 Conveying System	There is no elevator, escalator, or lift system present in the building. 2008 Receiving School (R/S): Elevator addition to exterior 1928 Wing.
2 Electrical	Panelboards and switchboards are too old and need to be replaced. Circuit breakers trip due to overloading; upgrades are needed. Classroom outlets are deficient in both number and proper grounding. Light fixture lenses are broken or missing. The fire alarm is old and does not meet code. To install air water coolers, need upgrade of electric power. 2008 R/S: Upgraded electrical outlets throughout building, replaced expired fluorescent ballast, tubes, replaced cracked, missing or broken light lens covers. Repaired and or installed new lighting fixtures in lavatories, classrooms, and other locations.
3 Exterior Finish	Single glass windows leaking, need replaced. Replace damaged foundation vent louvers. 2007: Replace exterior lighting. 2008 R/S: Repointing & repair of brick walls, repair/replacement of gutters, downspouts, and cornice. Window replacement scheduled to complete by Thanksgiving.

4 Structure	No major deficiencies were observed. Minor cracking, typical for concrete framing, can be repaired as part of routine building maintenance.
5 HVAC	The existing two pipe heating/cooling system is in fair condition. Many of the unit ventilator controls need to be repaired to function properly. The existing ventilation systems are beyond the service life and need to be replaced. There is no central A/C in the building. 2008: Repairs to boiler(s) and Classroom heating units completed.
6 Interior Finish	Asbestos floor tiles are not permitted. Most acoustic ceiling tiles should be repaired. Floor carpet may be encapsulating asbestos floor tiles below. 2007: Painting, window shades, plumbing, ceiling replacements, flooring, wall tile, stage curtain, misc. repairs. 2008 R/S: Patch and plaster with painting as required, new VCT flooring, repaired hardwood floors, new ceiling tiles, replaced damaged/defective doors and hardware.

7 Plumbing	Most of the plumbing fixtures are working, but the existing plumbing piping needs to be replaced. There is no fire sprinkler system in this building. 2008 R/S: New Pre-K and K area restrooms, existing restrooms and fixtures repaired and renovated.
8 Roof	Roof systems of both main building and auditorium require replacement. Flashing and gutters will require additional work as well. Metal roof cap in good condition. 2008 R/S: Repaired / replaced leaking roof portions, including shingles, flashing, gutters, downspouts and roofing membrane.

9 ADA Compliance	Steel stair railings do not have extensions required by code. No strobe fire alarms in building. Conveying, access, door hardware, parking, and bathroom fixtures are all deficient per code standards. 2008 R/S: New door hardware, new restrooms are ADA-compliant, new exterior ramp at main entry.
10 Technology	Inadequate outlets in classrooms; need additional, better receptacles. Computer labs have too many computers on one circuit- breakers trip. 2008 R/S: Added computer connectivity to new classrooms and spaces.
11 Grounds	Play area needs repaved. Ball fields and park owned and maintained by Department of Parks and Recreation. 2008 R/S: New parking area and driveway A/C paving and striping, new Pre-K playground area.
