SEATON ELEMENTARY SCHOOL

1503 10th Street, N.W., Washington, DC

CONDITION ASSESSMENT

Condition Assessment

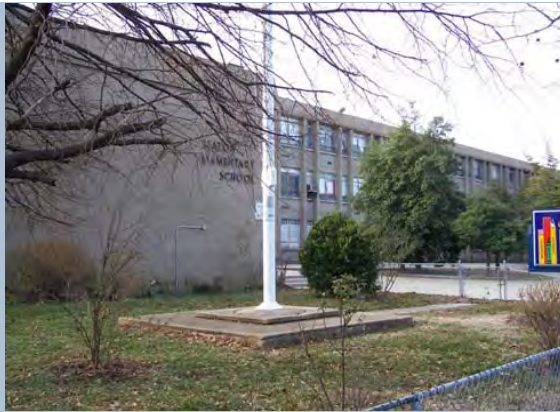
Building System	2008 Rating
ADA Compliance	Unsatisfactory
Conveying Systems	Unsatisfactory
Electrical	Fair
Exterior Finish	Good
HVAC	Fair
Interior Finish	Good
Plumbing	Fair
Roof	Unsatisfactory
Structure	Good
Technology	Fair

1 Conveying System	Elevators and wheelchair lifts are completely lacking throughout the building.
2 Electrical	Electrical service is substandard. Other major equipment appears to be in working condition. Wiring and conduit have exceeded expected service lifetimes. Fire alarms are obsolete and not up to code. Numerous light fixtures are in poor condition and need to be replaced. 2008: Repair and Replace receptacles, switches and data outlets (as required). Repair all lighting for entire building.
3 Exterior Finish	The exterior finish was found to be in good condition although preventative maintenance is needed to preserve the exterior of the building. 2007: Replaced exterior lighting. 2008: Repair broken window glazing and browned out windows.
4 Structure	No major deficiencies were observed during assessment.
5 HVAC	The HVAC system is in need of modernization. Boilers, chillers, and exhaust systems are in poor condition due to age and need to be upgraded. Most unit heaters are also reaching the end of their expected service lifetimes. 2008: Boiler replacement in progress. 2008: Repairs to Classroom heating units. Installed window A/C units. Repair Univent condensate pans, leaking pipes as required.

6 Interior Finish	Interior finishes need to be updated or replaced in many cases. Ceiling tiles are obsolete and need to be replaced. Flooring is generally in fair condition although worn. Walls need to be repaired, from simple painting to larger patching and replacement. 2007: Door, frame, and hardware repair and replacement. 2008: paint all interior spaces. Add new white boards for all classrooms. Repair and replace (20) new doors. Abate ceilings in (10) classrooms and multipurpose room.
7 Plumbing	Fixtures are in poor condition and do not meet current code requirements. No significant deterioration to piping systems was noted. 2008: Repair and Replace all plumbing fixture, cleared all drains (as required). Add four (4) new water fountains, new fixtures in new science labs.
8 Roof	The entire roof is in need of replacement. Membrane systems and flashing should be replaced to prevent water infiltration into the building. 2008: Repair entire roof, install new coping and flashing.

9 ADA Compliance	The building does not comply with code requirements. Accessibility, hand rails, door hardware, alarms, grounds, parking, and bathroom fixtures are some of the deficiencies.
10 Technology	Overall, the equipment appears to be in fair to good condition. Upgrades to networking, software, and climate control systems are recommended. 2008: Repair all data.
11 Grounds	Building grounds are in good shape. The only deficiency is poor ADA access. Curb cuts, railings, and parking are all in need of attention. 2008: Trim and cut landscaping, new fences, restripe parking lot, replace concrete for entire building entry, flag pole and steps
