STANTON ELEMENTARY SCHOOL

2701 Naylor Road, S.E., Washington, DC

CONDITION ASSESSMENT

Condition Assessment

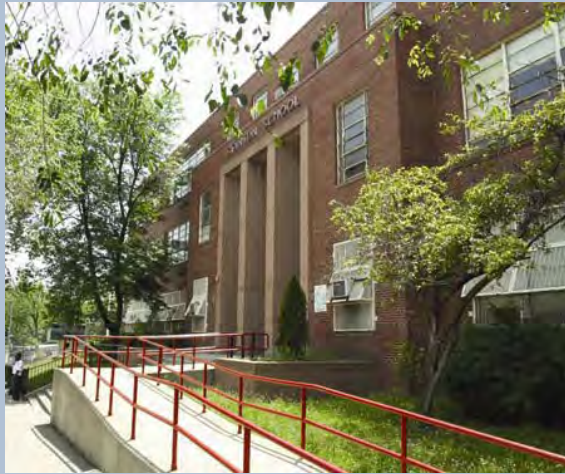
Condition Scorecard

Building System	2008 Rating
ADA Compliance	Unsatisfactory
Conveying Systems	Unsatisfactory
Electrical	Poor
Exterior Finish	Fair
HVAC	Poor
Interior Finish	Poor
Plumbing	Poor
Roof	Fair
Structure	Fair
Technology	Fair

These ratings reflect the overall condition and level of replacement need for an entire system, in adherence with the **Facility Condition Index (FCI) System**, categorizing systems as "Good" (FCI < .25), "Fair" (FCI 0.25 – 0.50), "Poor" (FCI 0.51 – 0.85), or "Unsatisfactory" (FCI > .86).

1 Conveying System	There is no elevator, escalator, or lift system present in the building.
2 Electrical	It's an older building with an annex and a combination of old and renovated electrical systems. In general, the electrical equipment, raceways, wiring, some fixtures, power outlets, fire protection, public address system, security system, telephone wiring, technology devices and life safety equipment/devices and their upgrades are in poor condition. Need bigger size emergency generator. The main service, main board, distribution board, panel boards, disconnect, and starters are a mix of old and renovated systems. In general electrical system is in poor condition. 2007: Electrical upgrades.
3 Exterior Finish	The exterior face brick on the building is in good sound condition with tight mortar joints. There were no signs of major cracks or failure in the exterior envelope. 2007: Replaced exterior lighting.

4 Structure	The exposed concrete structure that is visible to the eye appears to be in fairly sound condition for a sixty two year old structure with no signs of differential settlement and cracking.
5 HVAC	Systems were generally observed to be in poor condition. Nearly all equipment is at or past the end of its useful service life. Toilet exhaust was rarely observed to be adequate, and in most cases, was not provided. General lack of cooling when outside air temperatures are above 76-80 degrees, and overheating in the winter months. The spot coolers that have been provided are generally under-sized. 2007: AC Units repairs completed. 2008: Repairs to boilers and classroom units completed.
6 Interior Finish	Due to the age of the building, the interior finishes are outdated and in a worn condition. Though some floor tiles have been replaced with vinyl composition tiles, there still remains large quantities of asbestos containing tiles where most likely the adhesives used to set these tiles contain asbestos fibers. Also with the period that the building was constructed, most likely the plaster finishes contain asbestos fibers. These finishes could pose a health hazard when disturbed. 2007: Plaster repair, paint.

7 Plumbing	Systems were generally observed to be in poor condition. The main building has no fire suppression; however the annex building contains a dry pipe sprinkler system.

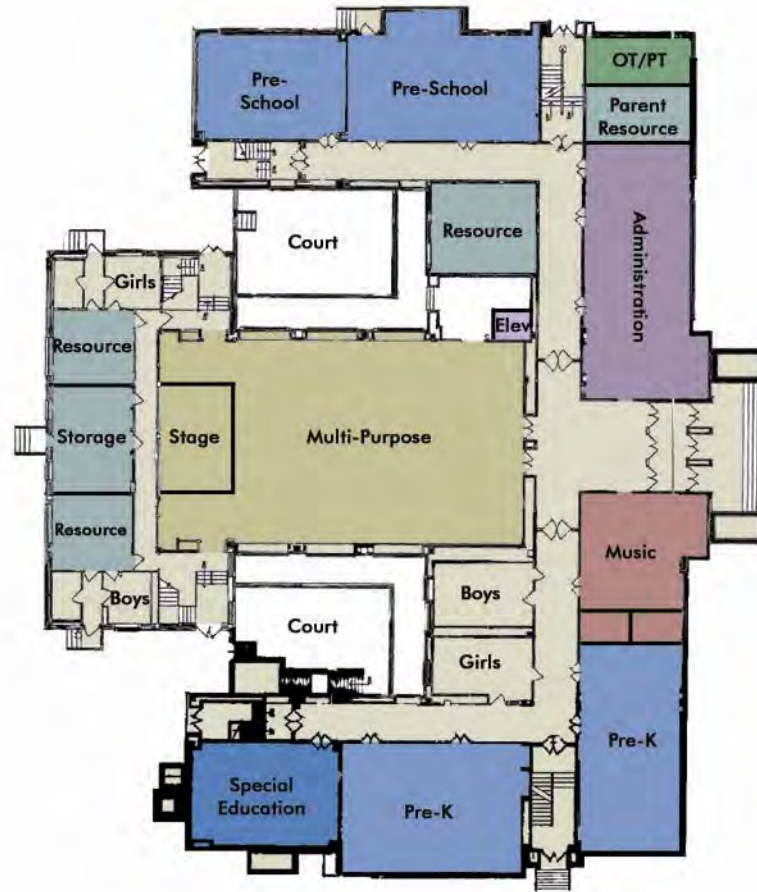
First Floor

These floor plans represent planning concepts for proposed facility use, aligning the proposed program capacity, the proposed planning profiles, and the conceptual reconfiguration of the building. Each project is subject to a formal design process, incorporating input from the School Improvement team at the time of project initiation.

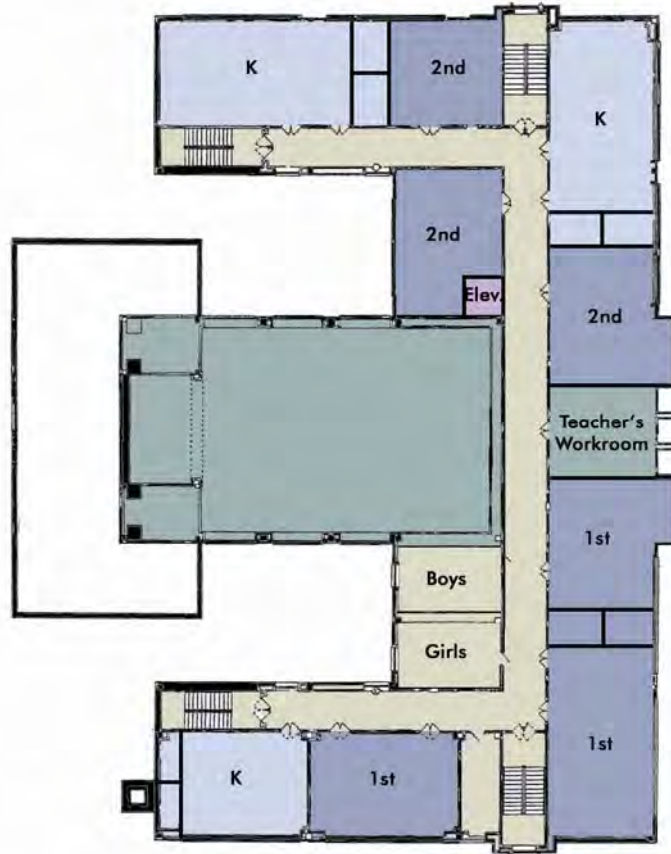
Second Floor

These floor plans represent planning concepts for proposed facility use, aligning the proposed program capacity, the proposed planning profiles, and the conceptual reconfiguration of the building. Each project is subject to a formal design process, incorporating input from the School Improvement team at the time of project initiation.

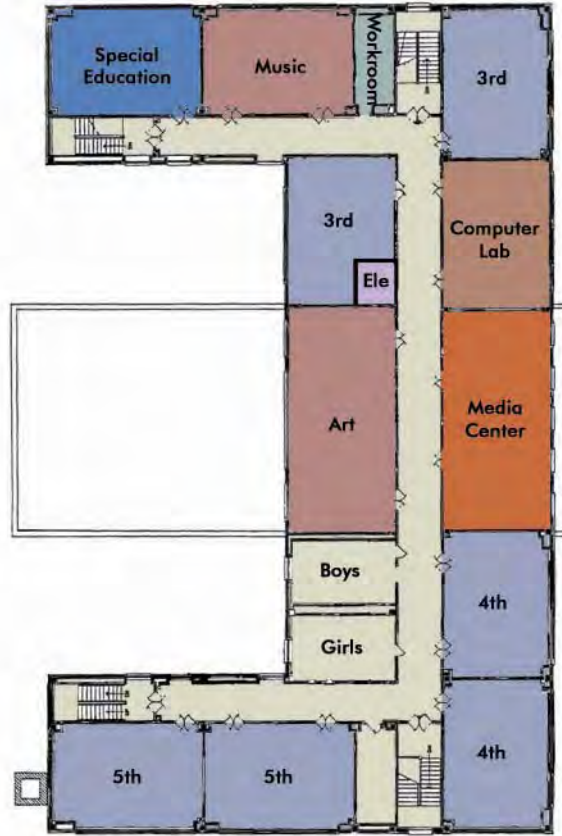
Third Floor

These floor plans represent planning concepts for proposed facility use, aligning the proposed program capacity, the proposed planning profiles, and the conceptual reconfiguration of the building. Each project is subject to a formal design process, incorporating input from the School Improvement team at the time of project initiation.
