# STODDERT ELEMENTARY SCHOOL

4001 Calvert Street, N.W., Washington, DC

## CONDITION ASSESSMENT

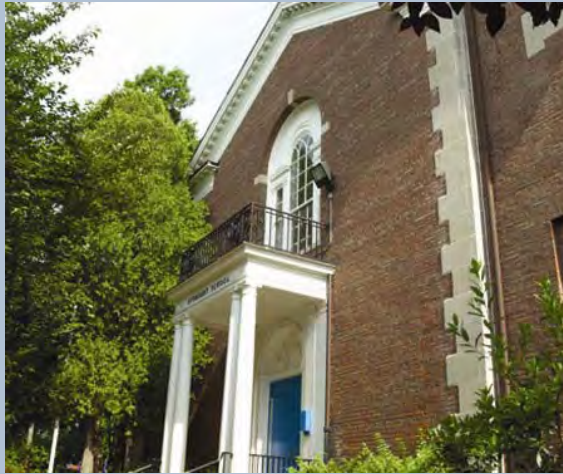
<i>Building System</i>	<i>2008 Rating</i>
ADA Compliance	Poor
Conveying Systems	Unsatisfactory
Electrical	Fair
Exterior Finish	Fair
HVAC	Fair
Interior Finish	Fair
Plumbing	Poor
Roof	Good
Structure	Fair
Technology	Good

<b>1 Conveying System</b>	There is no elevator, escalator, or lift system present.
<b>2 Electrical</b>	The fluorescent fixtures are equipped with T12 lamps, are not energy efficient, and are in poor condition. Teachers reported that circuit breakers trip when the full compliment of lamps is installed. The fire alarm system is in fair condition but can not support additional ADA fire alarm devices. There is no emergency generator. The existing electrical system is 120/208V, 3W and is in good condition. There is a substantial amount of surface-mounted conduit and electrical panels visible. The electrical equipment was installed as part of an electrical upgrade at an unknown date. Penetrations through walls and floors are not fire-stopped. In at least one classroom, floor-mounted receptacles and conduit are a tripping hazard.
<b>3 Exterior Finish</b>	The condition of the original building exterior envelope is fair. The thin brick veneer exterior of the modular addition is delaminating and will likely need to be replaced. <i>2007: Replaced exterior lighting.</i>

<b>4 Structure</b>	Structure of the modular addition has settled and has caused cracks in the building envelope. Structure elsewhere appears to be in fair condition.
<b>5 HVAC</b>	A large flue at the exterior is split and falling off the building. This is an immediate life safety hazard that must be fixed as soon as possible. Window type air conditioners are used in the main building and cabinet compact DX-air conditioners are used for the addition. The units in the main building are problematic. Roof exhaust fan serving bathrooms and classrooms is not balanced. Classroom exhaust should be separated from bathroom exhaust. <i>2008: Repairs to Boilers and Classroom heating units. Installed 13 window A/C units.</i>
<b>6 Interior Finish</b>	At exterior walls there were localized areas of water-damaged plaster. Potential lead paint at peeling plaster makes this a health and safety issue. <i>2007: Skin Replacement, Roofing, Flooring, Paint, Mechanical, Electrical work completed.</i>

<b>7 Plumbing</b>	There is no fire suppression system present. Plumbing fixtures are in fair condition. Domestic cold water distribution system is made of galvanized steel pipe and needs to be replaced.

<b>8 Roof</b>	Slate roof on the original portion of the building is in fair condition. Built-in gutters at the perimeter of the slate roof were relined with copper 2 1/2 years ago and are in good condition. Single-ply flat roofs over addition are in good condition.
<b>9 ADA Compliance</b>	The modular addition is generally ADA-compliant, though door hardware is not. There is no access to upper floor of original building.
<b>10 Technology</b>	The existing telephone and data system are in good condition. The school has a wireless network.
<b>11 Grounds</b>	Site water drainage is in poor condition. Water does not drain away from building. Lack of fence at parking is a school deficiency. There is adjacent land which is owned and managed by the DC Parks and Recreation Dept.
