TERRELL ELEMENTARY SCHOOL

MCGOGNEY AT TERRELL ELEMENTARY SCHOOL

3301 Wheeler Road, S.E., Washington, DC

CONDITION ASSESSMENT

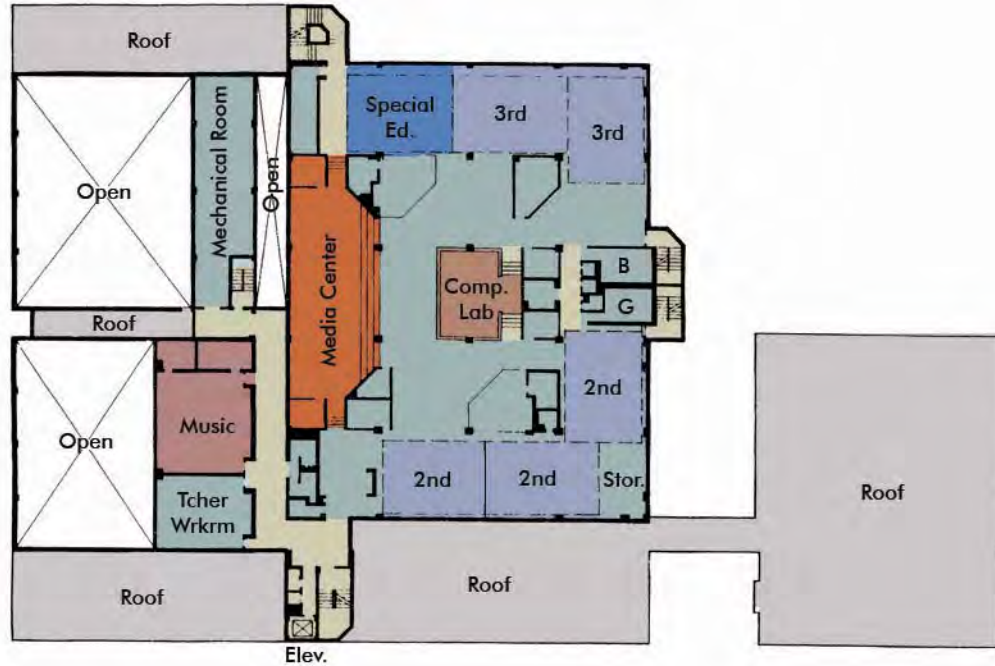
Second Floor

These floor plans represent planning concepts for proposed facility use, aligning the proposed program capacity, the proposed planning profiles, and the conceptual reconfiguration of the building. Each project is subject to a formal design process, incorporating input from the School Improvement team at the time of project initiation.
