THOMAS ELEMENTARY SCHOOL

650 Anacostia Avenue, N.E., Washington, DC

CONDITION ASSESSMENT

Condition Assessment

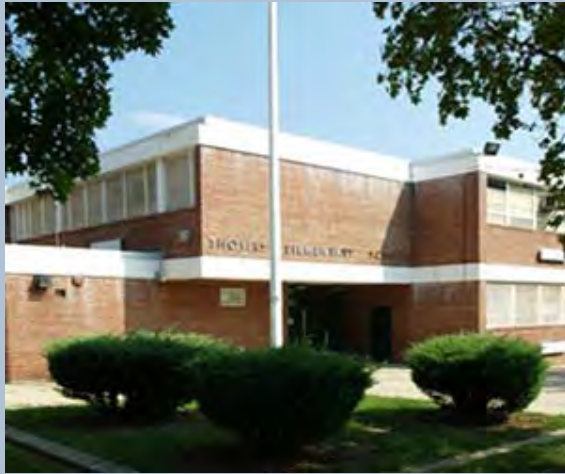
Condition Scorecard

Building System	2008 Rating
ADA Compliance	Unsatisfactory
Conveying Systems	Unsatisfactory
Electrical	Fair
Exterior Finish	Good
HVAC	Unsatisfactory
Interior Finish	Fair
Plumbing	Fair
Roof	Poor
Structure	Good
Technology	Poor

These ratings reflect the overall condition and level of replacement need for an entire system, in adherence with the **Facility Condition Index (FCI) System**, categorizing systems as "Good" (FCI < .25), "Fair" (FCI 0.25 – 0.50), "Poor" (FCI 0.51 – 0.85), or "Unsatisfactory" (FCI > .86).

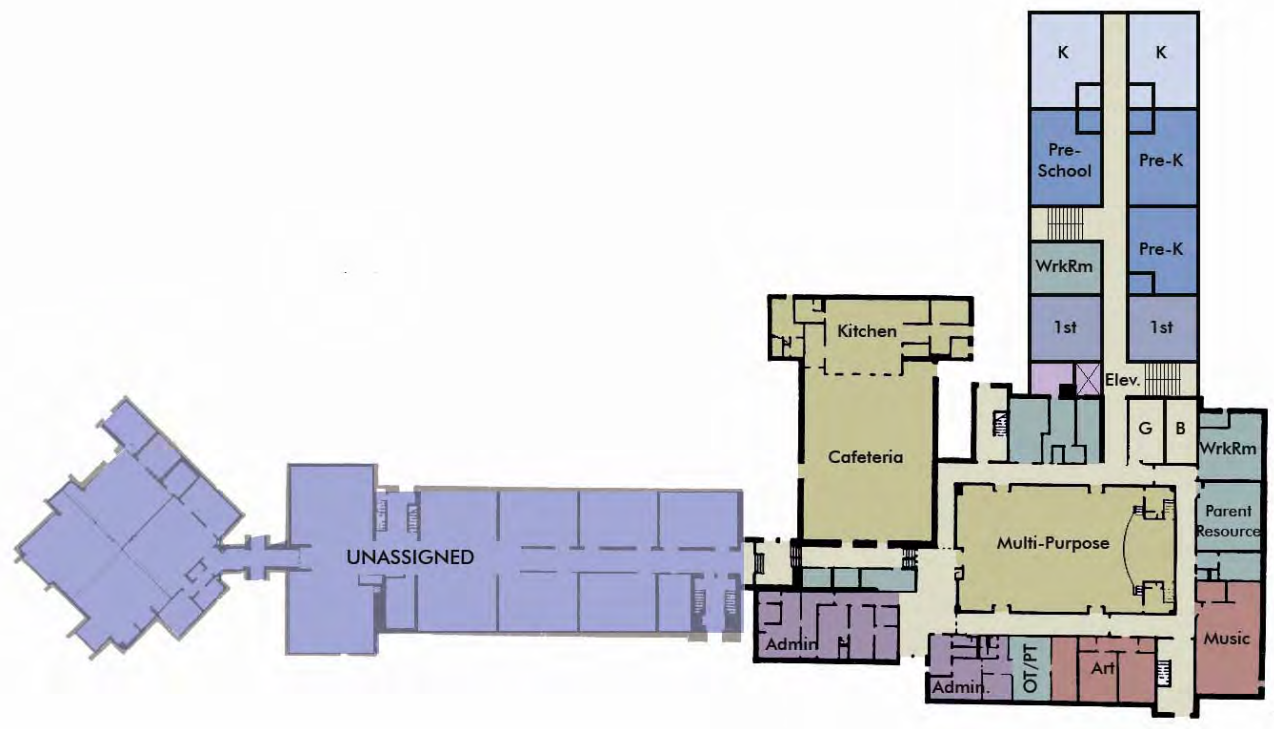
First Floor

These floor plans represent planning concepts for proposed facility use, aligning the proposed program capacity, the proposed planning profiles, and the conceptual reconfiguration of the building. Each project is subject to a formal design process, incorporating input from the School Improvement team at the time of project initiation.

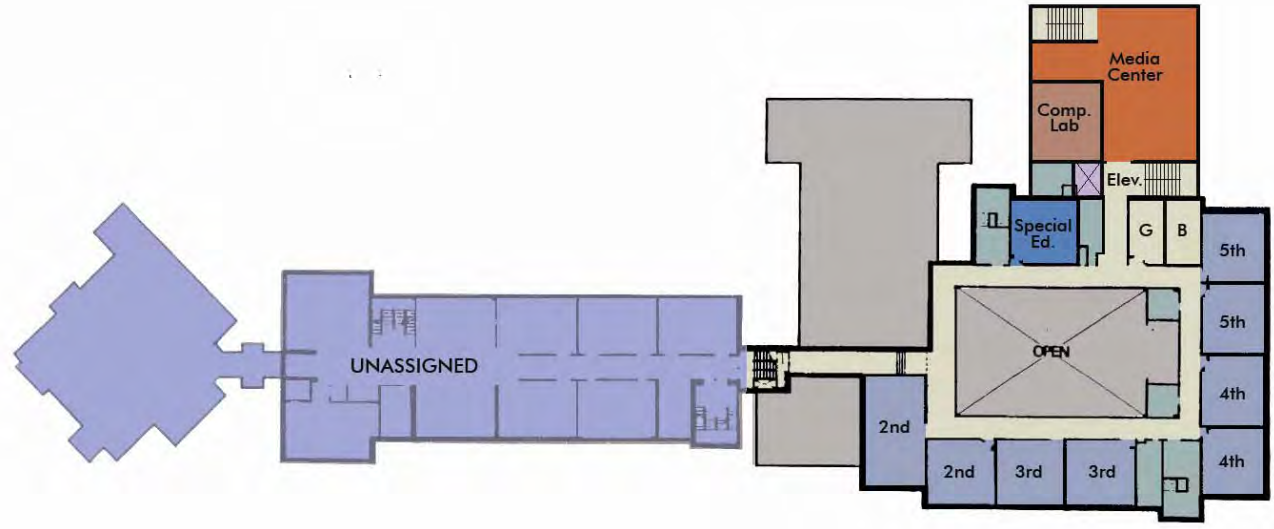
Second Floor

Concept Plans
 These floor plans represent planning concepts for proposed facility use, aligning the proposed program capacity, the proposed planning profiles, and the conceptual reconfiguration of the building. Each project is subject to a formal design process, incorporating input from the School Improvement team at the time of project initiation.
