# TRUESDELL EDUCATIONAL CAMPUS

800 Ingraham Street, N.W., Washington, DC

## CONDITION ASSESSMENT

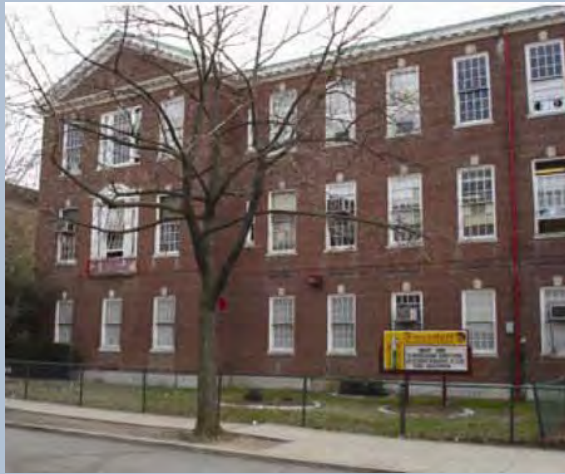
<i>Building System</i>	<i>2008 Rating</i>
ADA Compliance	Unsatisfactory
Conveying Systems	Unsatisfactory
Electrical	Fair
Exterior Finish	Poor
HVAC	Poor
Interior Finish	Good
Plumbing	Fair
Roof	Fair
Structure	Good
Technology	Fair

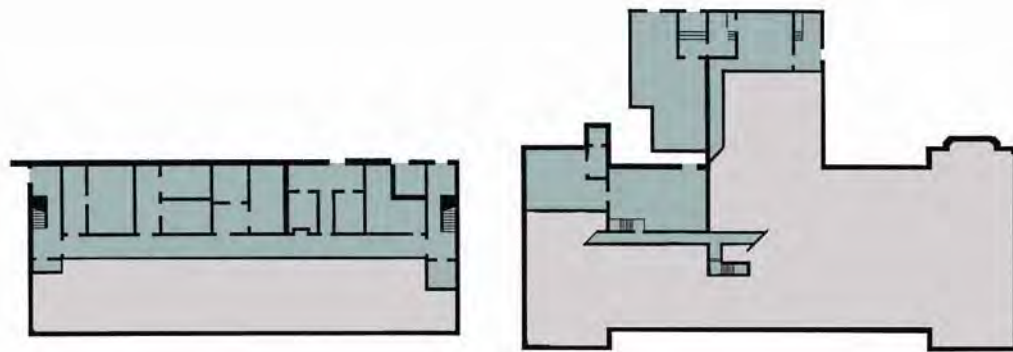
Basement

These floor plans represent planning concepts for proposed facility use, aligning the proposed program capacity, the proposed planning profiles, and the conceptual reconfiguration of the building. Each project is subject to a formal design process, incorporating input from the School Improvement team at the time of project initiation.

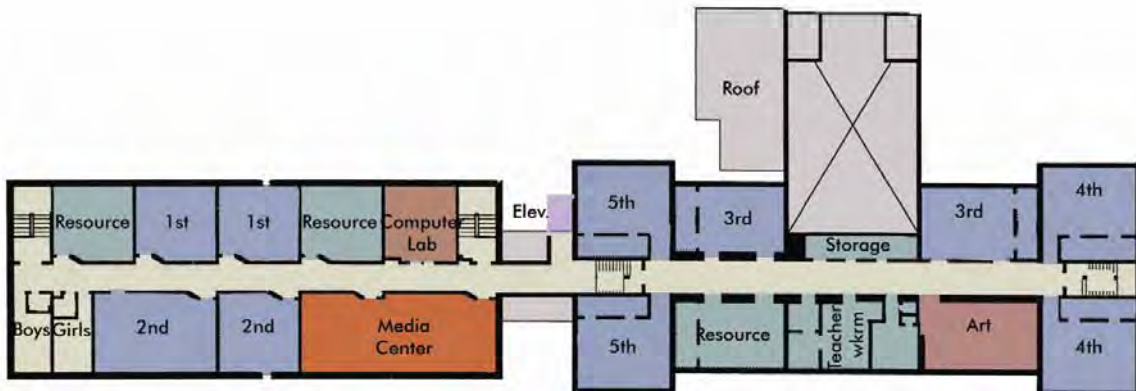
Second Floor

These floor plans represent planning concepts for proposed facility use, aligning the proposed program capacity, the proposed planning profiles, and the conceptual reconfiguration of the building. Each project is subject to a formal design process, incorporating input from the School Improvement team at the time of project initiation.
