WALKER-JONES EDUCATION CAMPUS

1950 BUILDING

100 L Street, N.W., Washington, DC

CONDITION ASSESSMENT

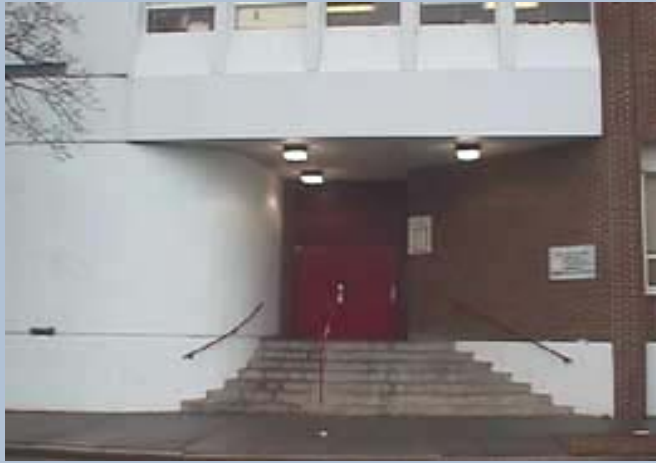
<i>Building System</i>	<i>2008 Rating</i>
ADA Compliance	Poor
Conveying Systems	Unsatisfactory
Electrical	Poor
Exterior Finish	Poor
HVAC	Fair
Interior Finish	Fair
Plumbing	Fair
Roof	Good
Structure	Good
Technology	Poor
