BROWN, RONALD MIDDLE SCHOOL

4800 Meade Street, S.E., Washington, DC

CONDITION ASSESSMENT

Condition Assessment

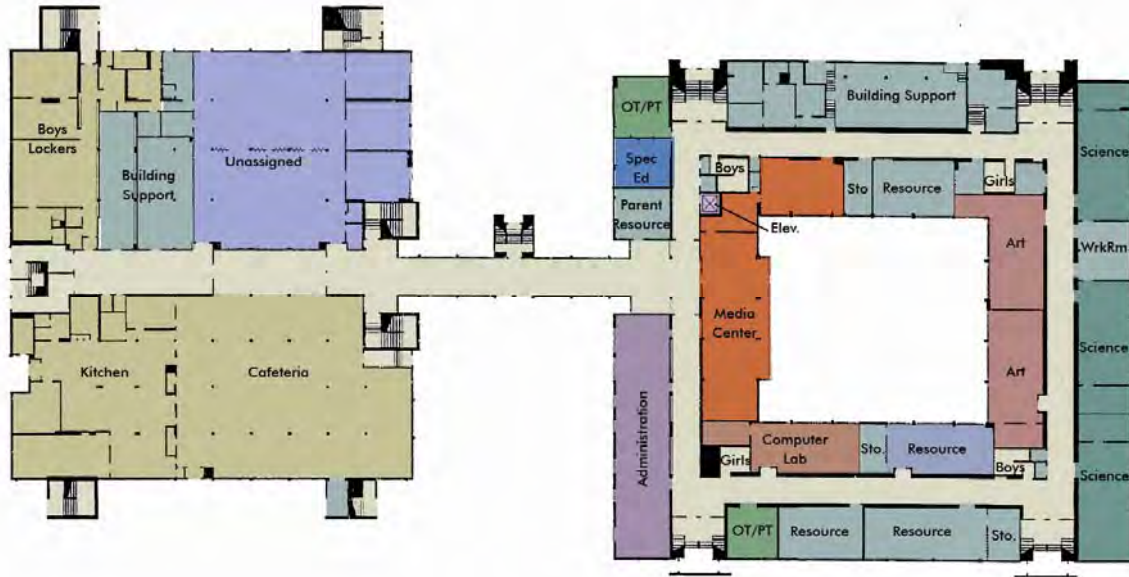
First Floor

These floor plans represent planning concepts for proposed facility use, aligning the proposed program capacity, the proposed planning profiles, and the conceptual reconfiguration of the building. Each project is subject to a formal design process, incorporating input from the School Improvement team at the time of project initiation.

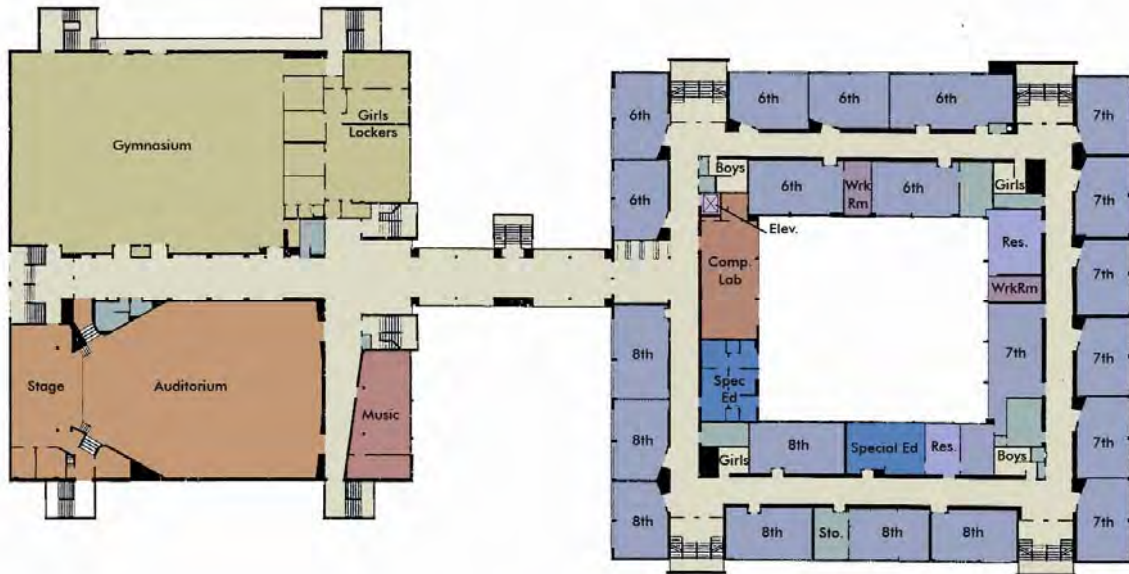
Second Floor

These floor plans represent planning concepts for proposed facility use, aligning the proposed program capacity, the proposed planning profiles, and the conceptual reconfiguration of the building. Each project is subject to a formal design process, incorporating input from the School Improvement team at the time of project initiation.
