JEFFERSON MIDDLE SCHOOL

801 7th Street, S.W., Washington, DC

CONDITION ASSESSMENT

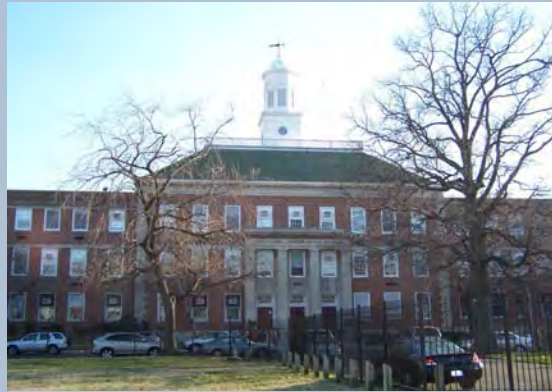
<i>Building System</i>	<i>2008 Rating</i>
ADA Compliance	Unsatisfactory
Conveying Systems	Unsatisfactory
Electrical	Poor
Exterior Finish	Fair
HVAC	Fair
Interior Finish	Fair
Plumbing	Poor
Roof	Poor
Structure	Poor
Technology	Fair

1 Conveying System	Original elevator cab and machinery is obsolete and represents a health safety issue. As it exists, it is not building code or ADA compliant.
2 Electrical	Numerous code violations observed. There is no source of emergency power. The fire alarm system is inadequate and not ADA compliant. Exposed, incandescent lighting is common and should be replaced with modern, energy efficient fluorescent lighting.
3 Exterior Finish	Limestone façade elements at building base and cornice require repainting. The masonry façade needs minor repointing as well. Exterior windows have been mostly replaced and are in good condition. The remaining windows should be replaced. 2007: Replaced exterior lighting, window hardware completed
4 Structure	The concrete appears to be in sound condition; however, signs of water infiltration suggest that a more thorough analysis be performed.
5 HVAC	Steam classroom ventilators, convectors, and radiators throughout the building should be modernized or updated. There is no chiller or building-wide cooling system in place. Window units are present in many classrooms and are generally in good shape, although they typically have a shorter service lifespan than a well maintained comprehensive system. 2007: Boiler repairs exhaust fans, heating unit repairs. All Classrooms have heat. 2008: Repairs to boilers and classroom heating units. Installed 1 A/C window unit.

6 Interior Finish	Asbestos composition tiles remain present on some of the floor surfaces, a clear health safety issue. Moisture damage is visible in one quarter of ceiling tiles, also a clear health safety issue. Half of all doors and door hardware are in disrepair and should be replaced. Interior finishes throughout are old and worn. 2007: Painting, window hardware completed. 2008: Cleaning, Ceiling, Floors, Paint, Plumbing and electrical work completed.
7 Plumbing	There is no fire sprinkler system present. Gym showers are in disrepair, lavatory fixtures are old and do not meet modern code requirements. 2007: Snaking of clogged drains.
8 Roof	Though about 40% of the roofing area is in fair condition, the other 60% is in unsatisfactory condition. The entire roof should be replaced at one time in order to minimize damage due to water infiltration. 2007: Roof leak repairs, skylight reglazing. 2008: Roof stabilized.

9 ADA Compliance	Building does not meet ADA requirements. Non ADA compliant fixtures are present throughout; drinking fountains, hand rails, ramps, doors, switches, alarms, and proper conveying are all absent from the building.
10 Technology	Visual inspection is a limited tool for technology assessments. Generally, the equipment observed appears to be in fair condition. Upgrades should include software, networking, and climate controlled spaces to house equipment.
11 Grounds	No compliant ADA accessible entrance. The majority of exit egress doors are bolted and locked shut. All steps from exit doors lack code compliant rails. The limestone steps require complete repainting with 20% requiring repair work as well; about 20% of all concrete should be repainted. The parking area needs to be completely repaved. The playground area at tennis court is vacant.
