JOHNSON MIDDLE SCHOOL

1400 Bruce Place., S.E., Washington, DC

CONDITION ASSESSMENT

Condition Assessment

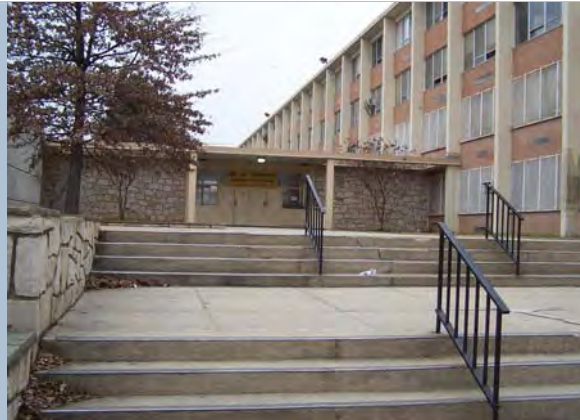
Building System	2008 Rating
ADA Compliance	Unsatisfactory
Conveying Systems	Unsatisfactory
Electrical	Poor
Exterior Finish	Poor
HVAC	Unsatisfactory
Interior Finish	Poor
Plumbing	Poor
Roof	Poor
Structure	Fair
Technology	Fair

These ratings reflect the overall condition and level of replacement need for an entire system, in adherence with the **Facility Condition Index (FCI) System**, categorizing systems as "Good" (FCI < .25), "Fair" (FCI 0.25 – 0.50), "Poor" (FCI 0.51 – 0.85), or "Unsatisfactory" (FCI > .86).
