MILLER, KELLY MIDDLE SCHOOL

215 49th Street, N.E., Washington, DC

CONDITION ASSESSMENT

Condition Assessment

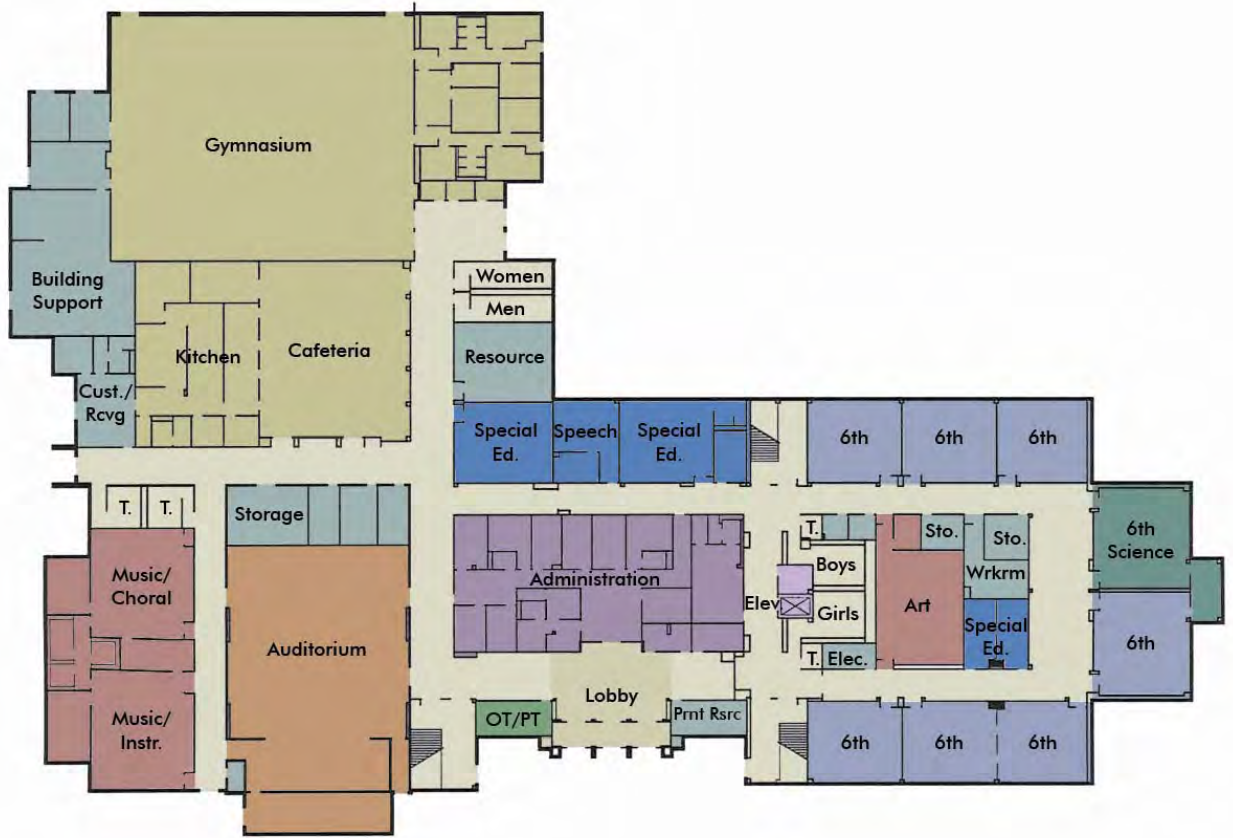
First Floor

These floor plans represent planning concepts for proposed facility use, aligning the proposed program capacity, the proposed planning profiles, and the conceptual reconfiguration of the building. Each project is subject to a formal design process, incorporating input from the School Improvement team at the time of project initiation.

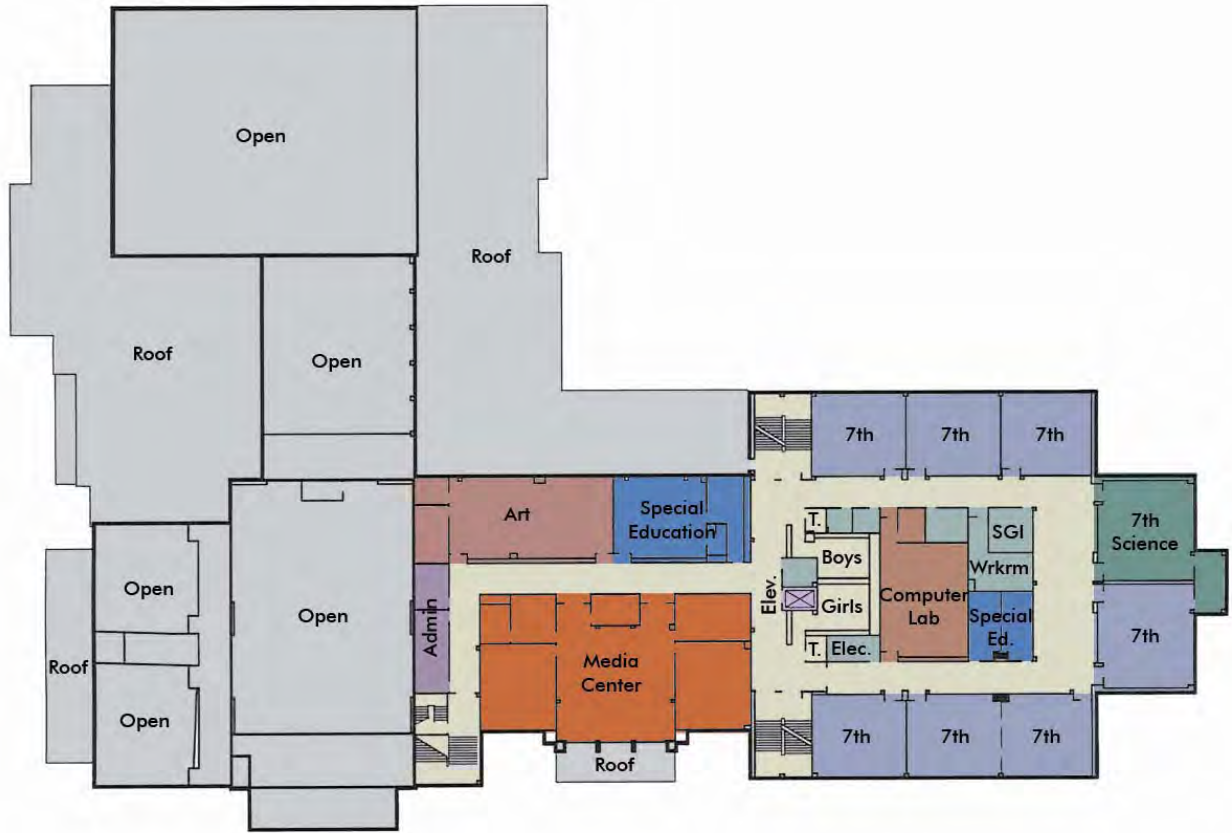
Second Floor

These floor plans represent planning concepts for proposed facility use, aligning the proposed program capacity, the proposed planning profiles, and the conceptual reconfiguration of the building. Each project is subject to a formal design process, incorporating input from the School Improvement team at the time of project initiation.

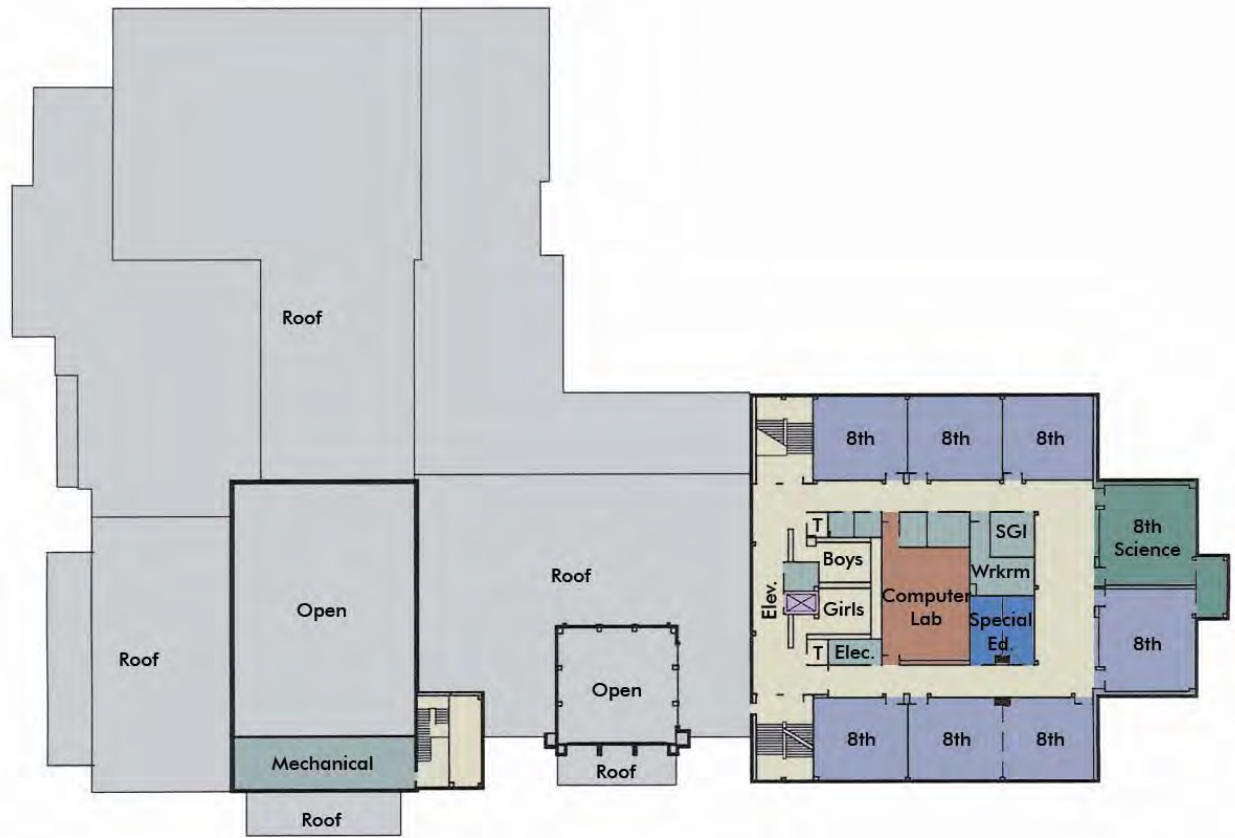
Third Floor

These floor plans represent planning concepts for proposed facility use, aligning the proposed program capacity, the proposed planning profiles, and the conceptual reconfiguration of the building. Each project is subject to a formal design process, incorporating input from the School Improvement team at the time of project initiation.
