ANACOSTIA SENIOR HIGH SCHOOL

1601 16th Street, S.E., Washington, DC

CONDITION ASSESSMENT

Condition Assessment

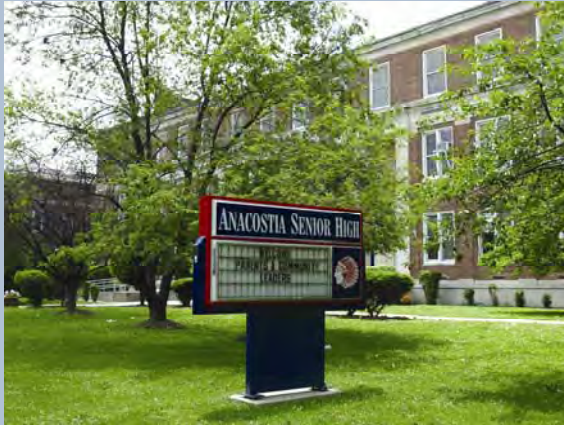
<i>Building System</i>	<i>2008 Rating</i>
ADA Compliance	Poor
Conveying Systems	Unsatisfactory
Electrical	Poor
Exterior Finish	Poor
HVAC	Fair
Interior Finish	Fair
Plumbing	Poor
Roof	Poor
Structure	Fair
Technology	Poor

1 Conveying System	There are no elevators, escalators, or lift systems in the building.
2 Electrical	The fire alarm system is antiquated and needs to be removed and replaced. The fire alarm system does not function consistently between the original building and addition. The lighting system is outdated. There are classrooms that have only incandescent light fixtures. The electrical system is old and needs to be replaced. Electrical equipment, i.e. transformers, electrical panels need to be removed from corridors, stairways, offices and storage rooms and placed in electrical closets. There is no emergency lighting in classrooms, paths of egress are not marked or are mis-marked; exit signs are missing or damaged.
3 Exterior Finish	The brick façade of the original building is in fair condition. There is some localized cracking and masonry displacement. The limestone trim, windows, and stairs are in fair condition. However they are in need of repair in a number of locations. All exterior doors should be replaced. The façade of the two story building addition is of concern. The concrete fascia panels are failing. The panels are cracked, spalled, and are displaced. A number of concrete fragments have already fallen to the ground, and there is a potential for this failure to continue. There is also some localized cracking of the brick. 2007: Replaced exterior lighting

4 Structure	Deficiencies are consistent with damage observed in building exterior. Some cracking can be repaired; additional structural inspection is recommended.
5 HVAC	Most large components are in poor condition. Piping systems appear to be in need of repair or replacement. Ductwork should be entirely replaced. Radiators are obsolete and should be removed. The temperature control system is antiquated and should be modernized. 2008: Repairs to boilers and classroom units.
6 Interior Finish	Plaster ceilings and walls have been damaged as a result of water infiltration from windows, roofing, and leaking fan coil units; numerous pipe leaks were also observed. VCT flooring is in generally fair condition; however the wood sub flooring below is failing in numerous locations. Asbestos tiles exist in a number of locations and should be removed. The CMU walls in the building addition have numerous and significant cracks throughout. 2008: Various roof, flooring, plumbing, paint and plaster repairs completed.

7 Plumbing	The two incoming water services do not have back flow preventers which is a code violation. All of the domestic water piping is corroded. Plumbing fixtures are very poor. Toilet rooms are not properly. There is an open pit in the crawl space that appears to have sewage drained into it. The entire system should be replaced.

8 Roof	The pitched slate roofs set on a wood substrate are in very poor condition. There are numerous loose and missing tiles. Existing gutters and downspouts are either badly damaged or not present. Modified bitumen assemblies exist on the flat roofs. The concrete roof deck substrate is covered with a modified bituminous membrane that appears to be in fair to good condition; a number of blisters were observed.
9 ADA Compliance	The building is not fully ADA compliant. Access is limited to the first floor level only via an exterior ramp at the front entrance and a temporary wooden interior ramp at the building addition. Door hardware, drinking fountains, signage, handrails and toilet fixtures/clearances are not compliant throughout. The lighting levels, the lack of fire alarm devices in toilet rooms and classrooms is a hazard to people with disabilities.
10 Technology	The telephone/data is hodge-podge, most of which is old and outdated; cabling runs are shoddily put together and are falling apart; telephone cable is being run in plenums, and is hazard to occupants in the building. Some computer equipment is not being used due to insufficient infrastructure. Communication is limited, such that a number of classrooms cannot communicate with the administration or security in the event of an emergency.

11 Grounds	The athletic fields, track, bleachers, and field house are relatively new and are in good condition. The running track requires some remedial work. The sidewalks and landscaped areas are in fair condition. The parking areas are in fair condition. The fencing around the fields is in good condition. The remaining fencing around the rest of the complex is fair to poor. Drainage seems to be adequate; however the surface adjacent to the building addition rear wall requires regrading. Parking is not adequate. Retaining walls, steps and landings at the rear of the complex are in a state of disrepair and in some cases require replacement. 2008: Athletic Field fully renovated.

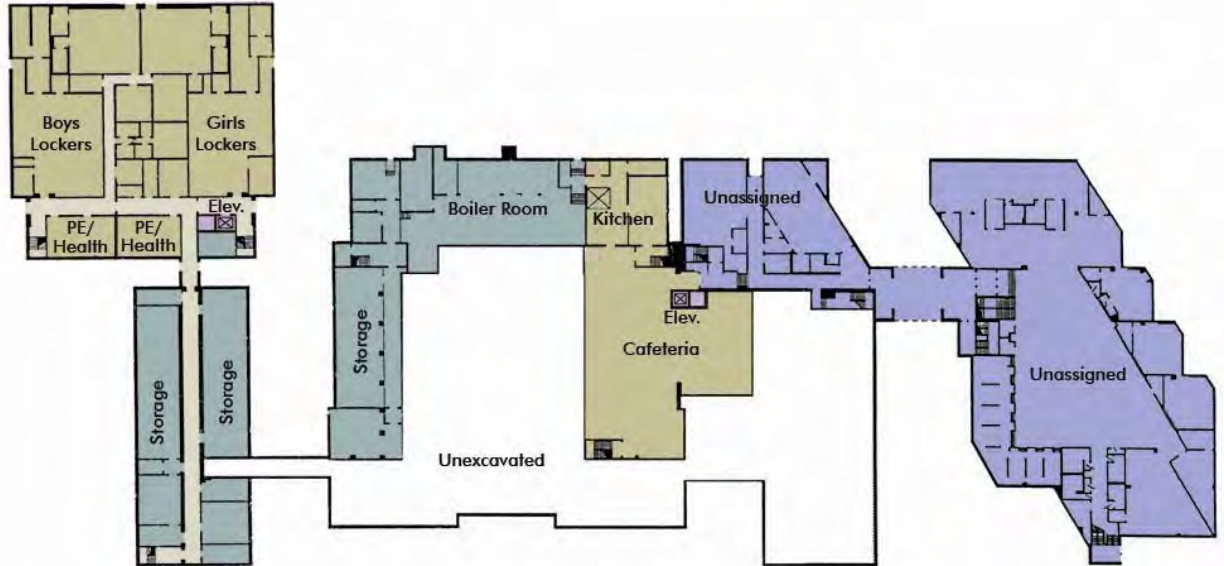
Basement

These floor plans represent planning concepts for proposed facility use, aligning the proposed program capacity, the proposed planning profiles, and the conceptual reconfiguration of the building. Each project is subject to a formal design process, incorporating input from the School Improvement team at the time of project initiation.

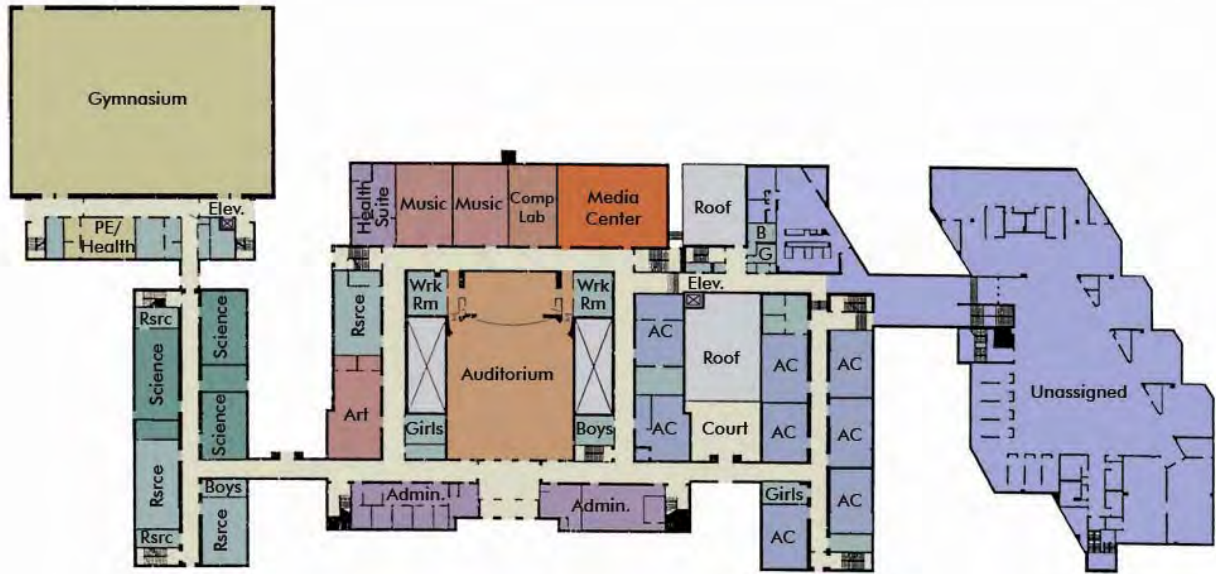
First Floor

These floor plans represent planning concepts for proposed facility use, aligning the proposed program capacity, the proposed planning profiles, and the conceptual reconfiguration of the building. Each project is subject to a formal design process, incorporating input from the School Improvement team at the time of project initiation.

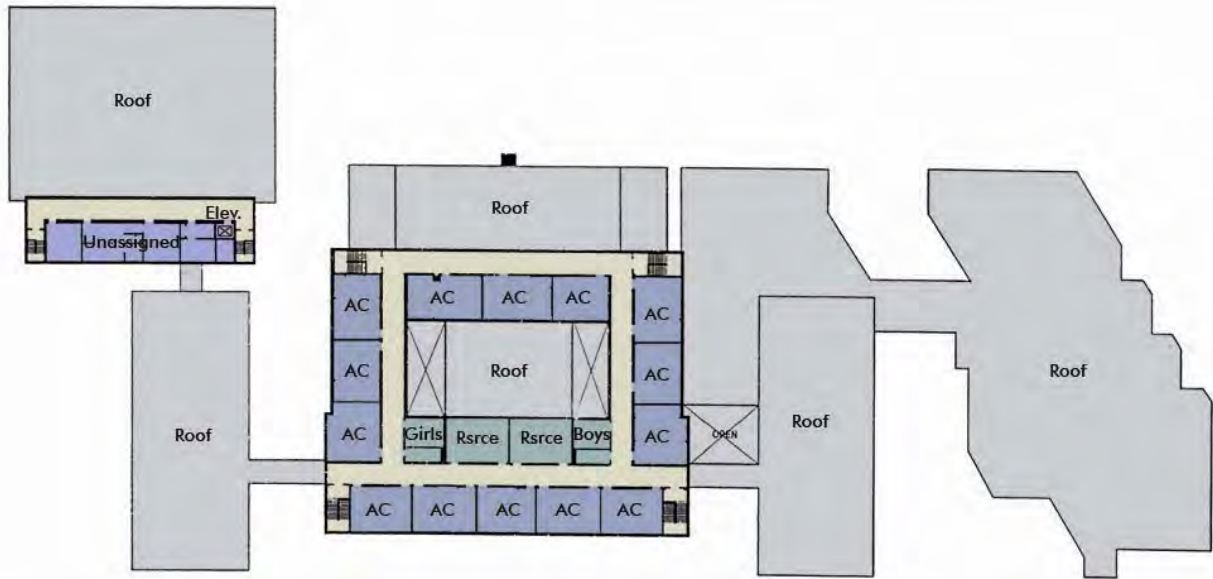
Third Floor

These floor plans represent planning concepts for proposed facility use, aligning the proposed program capacity, the proposed planning profiles, and the conceptual reconfiguration of the building. Each project is subject to a formal design process, incorporating input from the School Improvement team at the time of project initiation.
