BALLOU SENIOR HIGH SCHOOL

3401 4th Street, S.E., Washington, DC

CONDITION ASSESSMENT

Condition Assessment

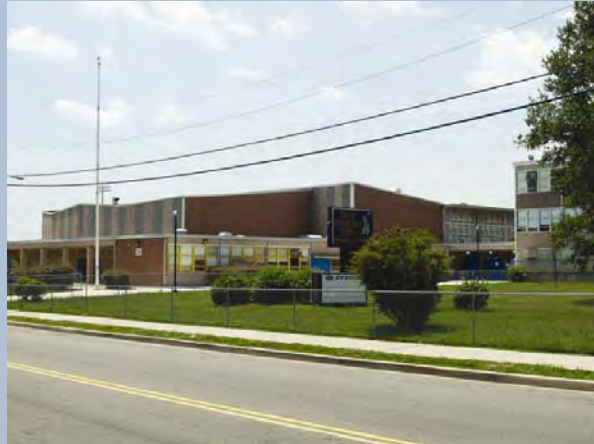
Condition Scorecard

Building System	2008 Rating
ADA Compliance	Unsatisfactory
Conveying Systems	Unsatisfactory
Electrical	Poor
Exterior Finish	Unsatisfactory
HVAC	Fair
Interior Finish	Unsatisfactory
Plumbing	Fair
Roof	Fair
Structure	Good
Technology	Poor

These ratings reflect the overall condition and level of replacement need for an entire system, in adherence with the Facility Condition Index (FCI) System, categorizing systems as "Good" (FCI < .25), "Fair" (FCI 0.25 – 0.50), "Poor" (FCI 0.51 – 0.85), or "Unsatisfactory" (FCI > .86).

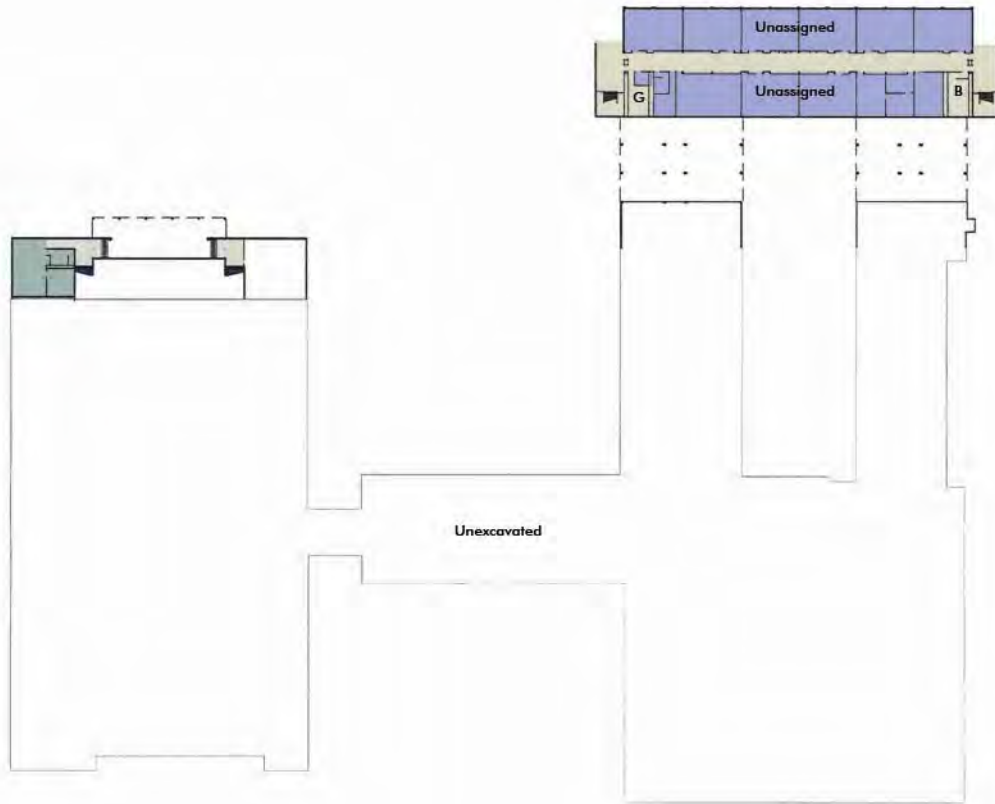
Sub-Basement

These floor plans represent planning concepts for proposed facility use, aligning the proposed program capacity, the proposed planning profiles, and the conceptual reconfiguration of the building. Each project is subject to a formal design process, incorporating input from the School Improvement team at the time of project initiation.

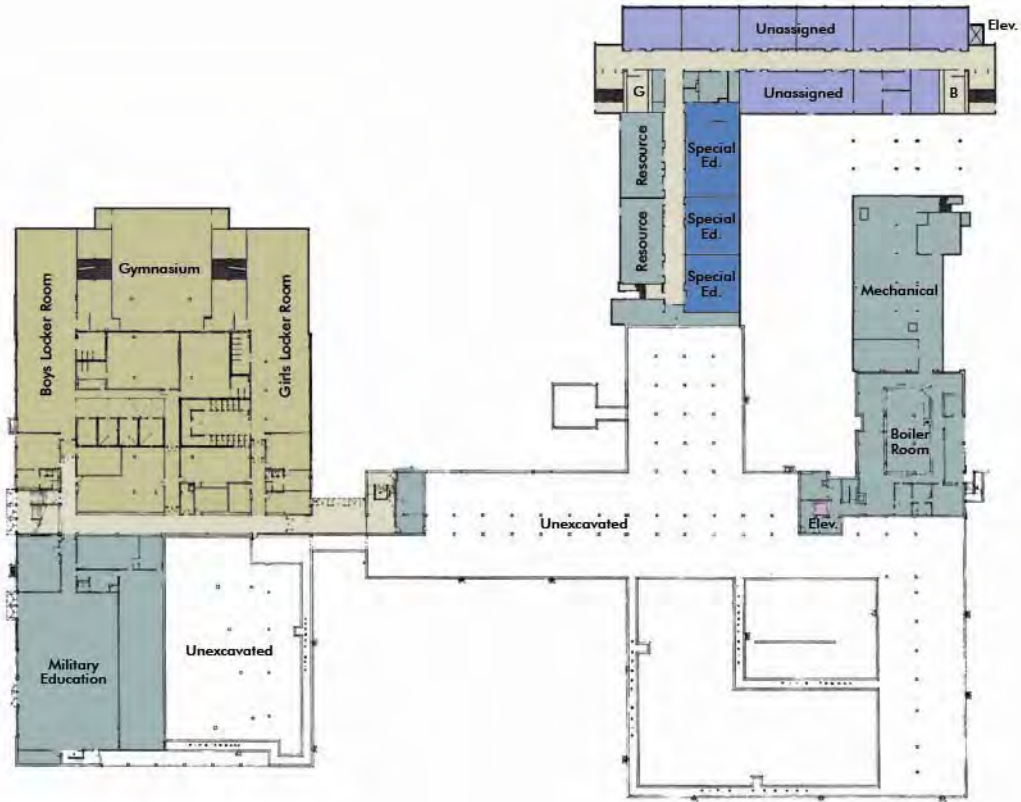
Basement

These floor plans represent planning concepts for proposed facility use, aligning the proposed program capacity, the proposed planning profiles, and the conceptual reconfiguration of the building. Each project is subject to a formal design process, incorporating input from the School Improvement team at the time of project initiation.

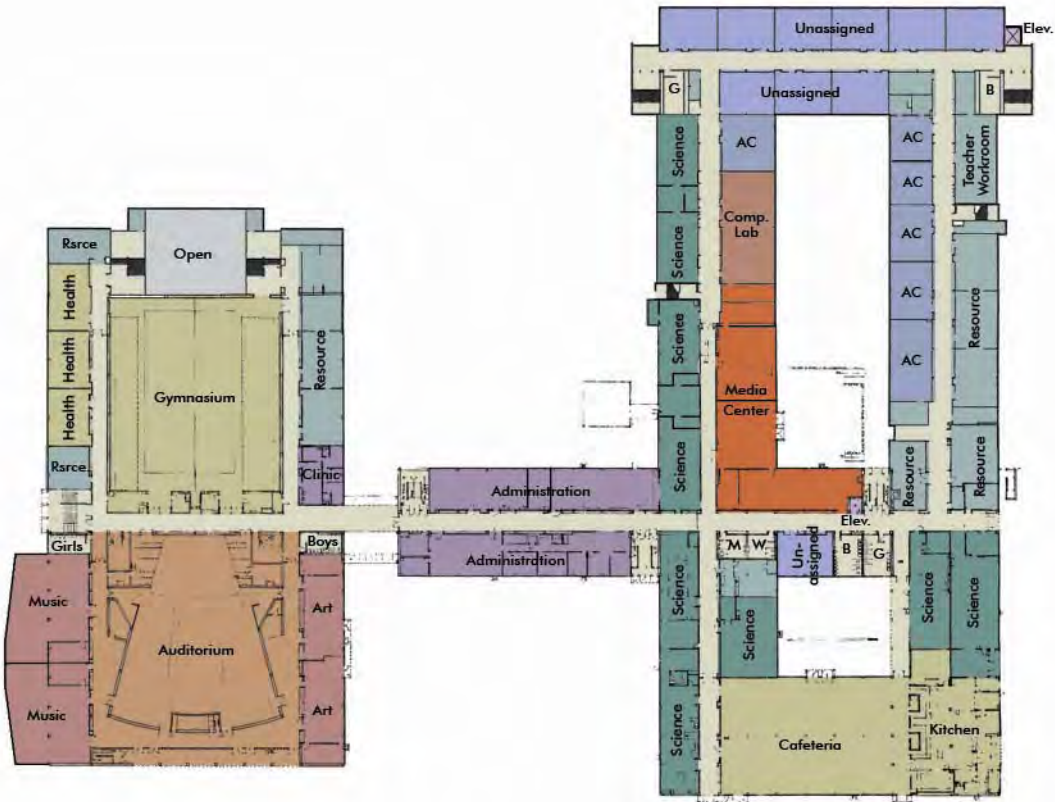
First Floor

These floor plans represent planning concepts for proposed facility use, aligning the proposed program capacity, the proposed planning profiles, and the conceptual reconfiguration of the building. Each project is subject to a formal design process, incorporating input from the School Improvement team at the time of project initiation.

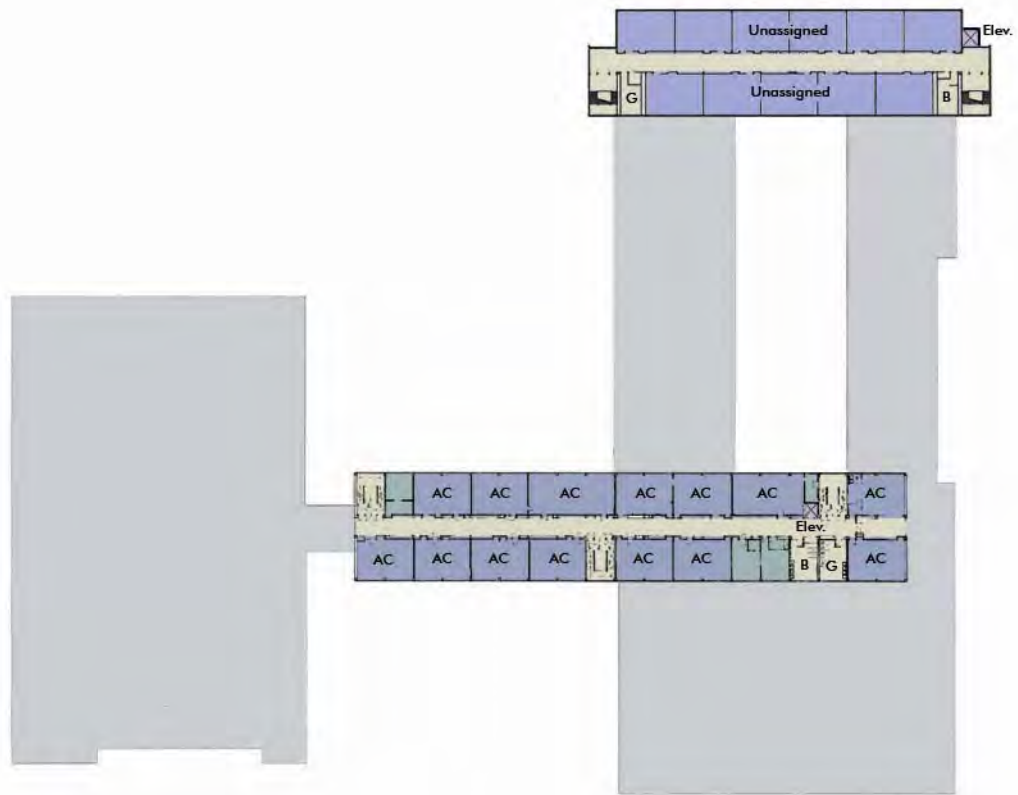
Second Floor

These floor plans represent planning concepts for proposed facility use, aligning the proposed program capacity, the proposed planning profiles, and the conceptual reconfiguration of the building. Each project is subject to a formal design process, incorporating input from the School Improvement team at the time of project initiation.

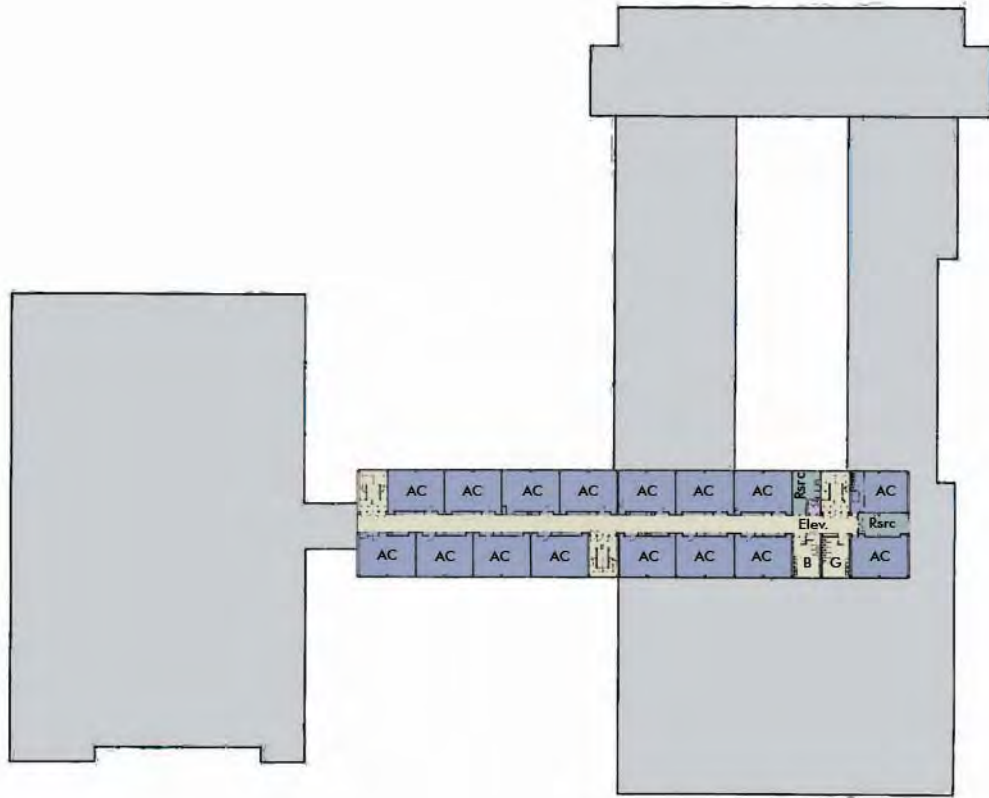
Third Floor

These floor plans represent planning concepts for proposed facility use, aligning the proposed program capacity, the proposed planning profiles, and the conceptual reconfiguration of the building. Each project is subject to a formal design process, incorporating input from the School Improvement team at the time of project initiation.
