BANNEKER SENIOR HIGH SCHOOL

800 Euclid Street, N.W., Washington, DC

CONDITION ASSESSMENT

Condition Assessment

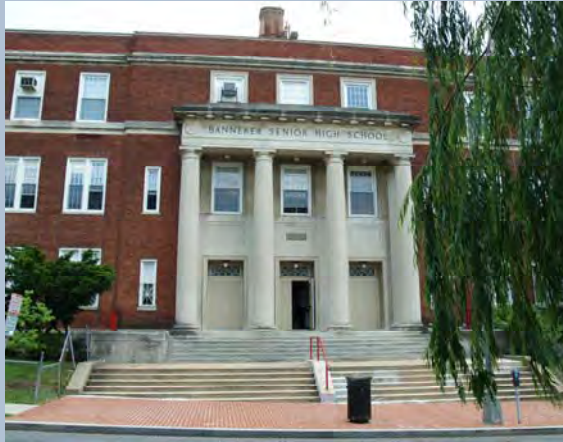
Building System	2008 Rating
ADA Compliance	Unsatisfactory
Conveying Systems	Unsatisfactory
Electrical	Fair
Exterior Finish	Fair
HVAC	Poor
Interior Finish	Good
Plumbing	Fair
Roof	Fair
Structure	Good
Technology	Fair

1 Conveying System	There are no elevators, escalators, or lift systems in the building.
2 Electrical	Lighting throughout is inadequate. The original electrical system is present and needs to be upgraded. Load capacity should be increased and all wiring replaced. Fire alarm, public address, security, and telephone systems should be replaced with modern systems.
3 Exterior Finish	The exterior facade needs some general cleaning, caulking, and sealing. Windows are inoperable for ventilation. Numerous exterior doors require repairs or replacement. <i>2007: Replaced Exterior lighting. Replaced exterior doors.</i>
4 Structure	Concrete structure is in good condition. Minor repairs may be required.
5 HVAC	Window units are used for cooling and are in poor condition. Radiators are in disrepair and should be removed. Ductwork needs to be repaired. Distribution piping is in poor condition in limited areas. The hot water system is inadequate. <i>2008: Repairs to boilers and classrooms units. Installed 7 A/C window units.</i>

6 Interior Finish	The typical interior plaster finishes need some moderate upgrade and repair. Wood flooring needs to be repaired. Large areas of carpeting need to be replaced.
7 Plumbing	Sinks and toilets appear to be functional but are largely outdated and not up to code. Several shower rooms need significant repairs. Drinking fountains need to be repaired or replaced.
8 Roof	Ok
9 ADA Compliance	The building does not comply with code requirements as follows: there are no ADA accessible toilets on the second and third floors; there is no accessible route from the street to inside the building; there is no elevator; handrails at stairs do not meet code; no ADA water fountains.
10 Technology	The equipment appears to be in fair condition overall. However, extensive hardware problems are reported. Some equipment is obsolete, and networking should be improved. Adding dedicated rooms for equipment that are climate controlled and secure is recommended.

11 Grounds	Drainage is the main deficiency. Sidewalk and pavement repairs and resurfacing are recommended. ADA access should be improved with additional curb cuts and ramps.
