CARDOZO SENIOR HIGH SCHOOL

1300 Clifton Street, N.W., Washington, DC

CONDITION ASSESSMENT

Condition Assessment

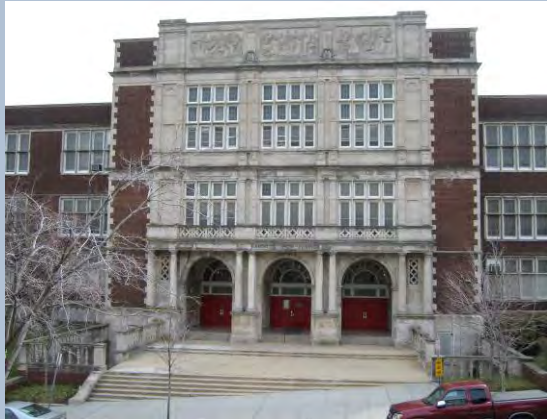
<i>Building System</i>	<i>2008 Rating</i>
ADA Compliance	Poor
Conveying Systems	Unsatisfactory
Electrical	Poor
Exterior Finish	Poor
HVAC	Poor
Interior Finish	Fair
Plumbing	Poor
Roof	Poor
Structure	Good
Technology	Fair

These ratings reflect the overall condition and level of replacement need for an entire system, in adherence with the **Facility Condition Index (FCI) System**, categorizing systems as "Good" (FCI < .25), "Fair" (FCI 0.25 – 0.50), "Poor" (FCI 0.51 – 0.85), or "Unsatisfactory" (FCI > .86).
