FEREBEE-HOPE ELEMENTARY SCHOOL

3999 8th Street, S.E., Washington, DC

CONDITION ASSESSMENT

Concept Plans

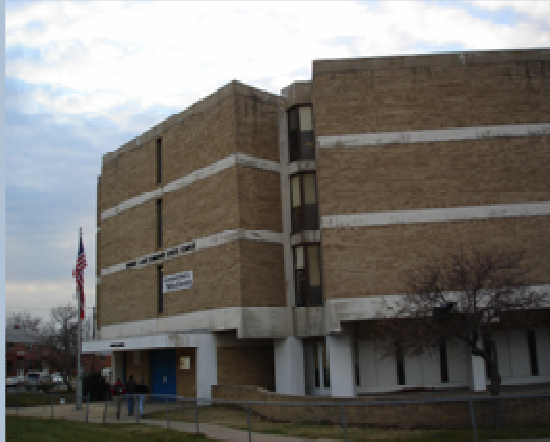
Condition Assessment

Building System	2008 Rating
ADA Compliance	Unsatisfactory
Conveying Systems	Poor
Electrical	Fair
Exterior Finish	Fair
HVAC	Unsatisfactory
Interior Finish	Fair
Plumbing	Fair
Roof	Poor
Structure	Good
Technology	Fair

These ratings reflect the overall condition and level of replacement need for an entire system, in adherence with the **Facility Condition Index (FCI) System**, categorizing systems as "Good" (FCI < .25), "Fair" (FCI 0.25 – 0.50), "Poor" (FCI 0.51 – 0.85), or "Unsatisfactory" (FCI > .86).

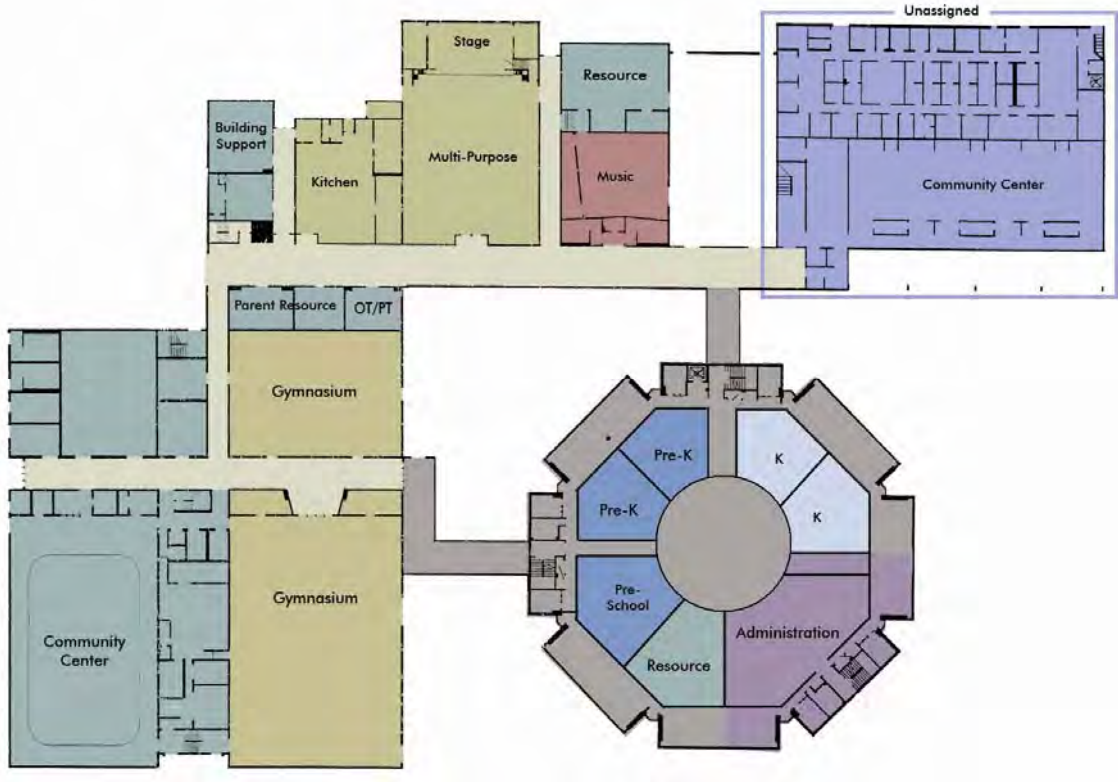
First Floor

These floor plans represent planning concepts for proposed facility use, aligning the proposed program capacity, the proposed planning profiles, and the conceptual reconfiguration of the building. Each project is subject to a formal design process, incorporating input from the School Improvement team at the time of project initiation.
