GARFIELD ELEMENTARY SCHOOL

2435 Alabama Avenue, S.E., Washington, DC

CONDITION ASSESSMENT

Concept Plans

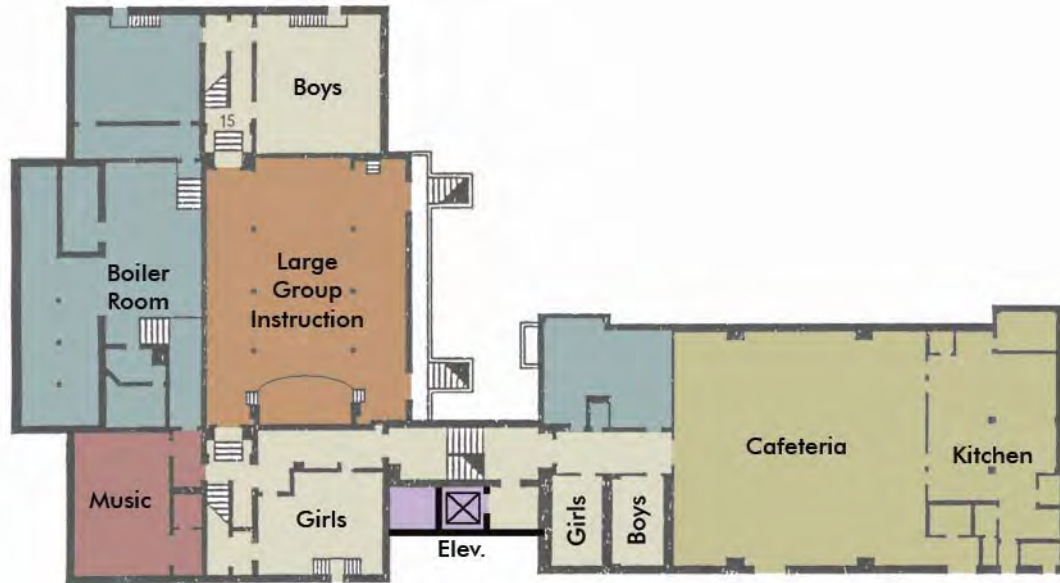
Basement

These floor plans represent planning concepts for proposed facility use, aligning the proposed program capacity, the proposed planning profiles, and the conceptual reconfiguration of the building. Each project is subject to a formal design process, incorporating input from the School Improvement team at the time of project initiation.
