KIMBALL ELEMENTARY SCHOOL

3375 Minnesota Avenue, S.E., Washington, DC

CONDITION ASSESSMENT

Concept Plans

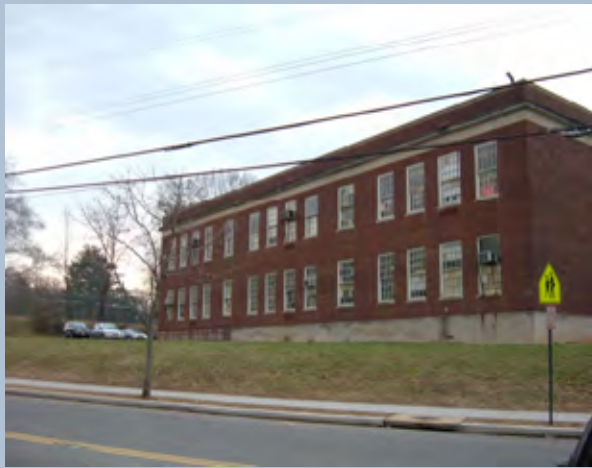
Condition Assessment

Building System	2008 Rating
ADA Compliance	Unsatisfactory
Conveying Systems	Unsatisfactory
Electrical	Poor
Exterior Finish	Poor
HVAC	Fair
Interior Finish	Fair
Plumbing	Fair
Roof	Good
Structure	Good
Technology	Poor

These ratings reflect the overall condition and level of replacement need for an entire system, in adherence with the **Facility Condition Index (FCI) System**, categorizing systems as "Good" (FCI < .25), "Fair" (FCI 0.25 – 0.50), "Poor" (FCI 0.51 – 0.85), or "Unsatisfactory" (FCI > .86).

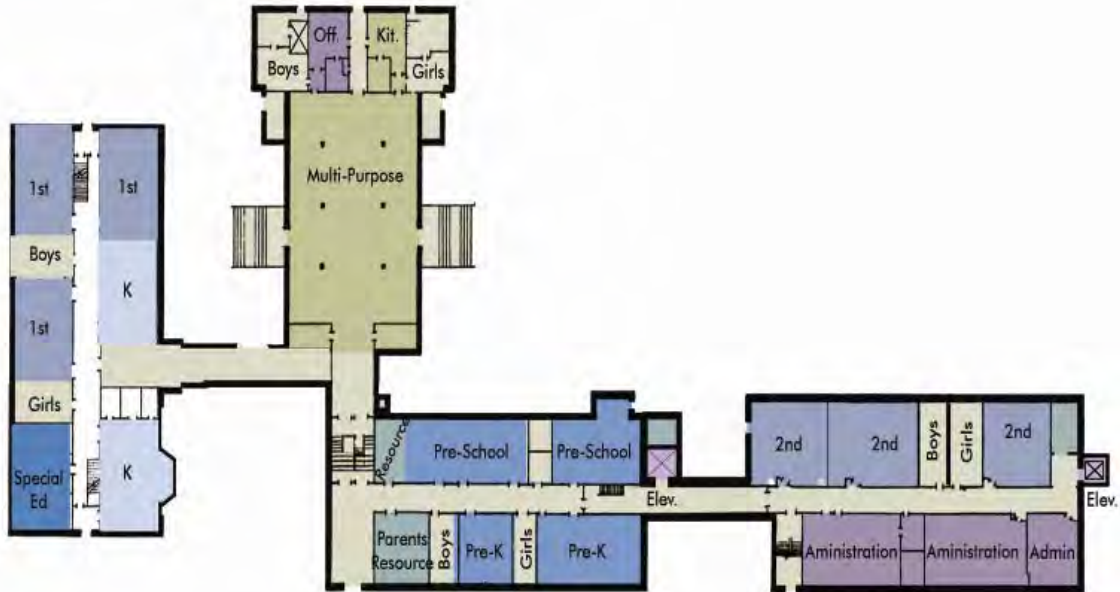
First Floor

Concept Plans

These floor plans represent planning concepts for proposed facility use, aligning the proposed program capacity, the proposed planning profiles, and the conceptual reconfiguration of the building. Each project is subject to a formal design process, incorporating input from the School Improvement team at the time of project initiation.
