ORR ELEMENTARY SCHOOL

2200 Minnesota Avenue, S.E., Washington, DC

PROPOSED PROGRAM PROFILE

CONDITION ASSESSMENT

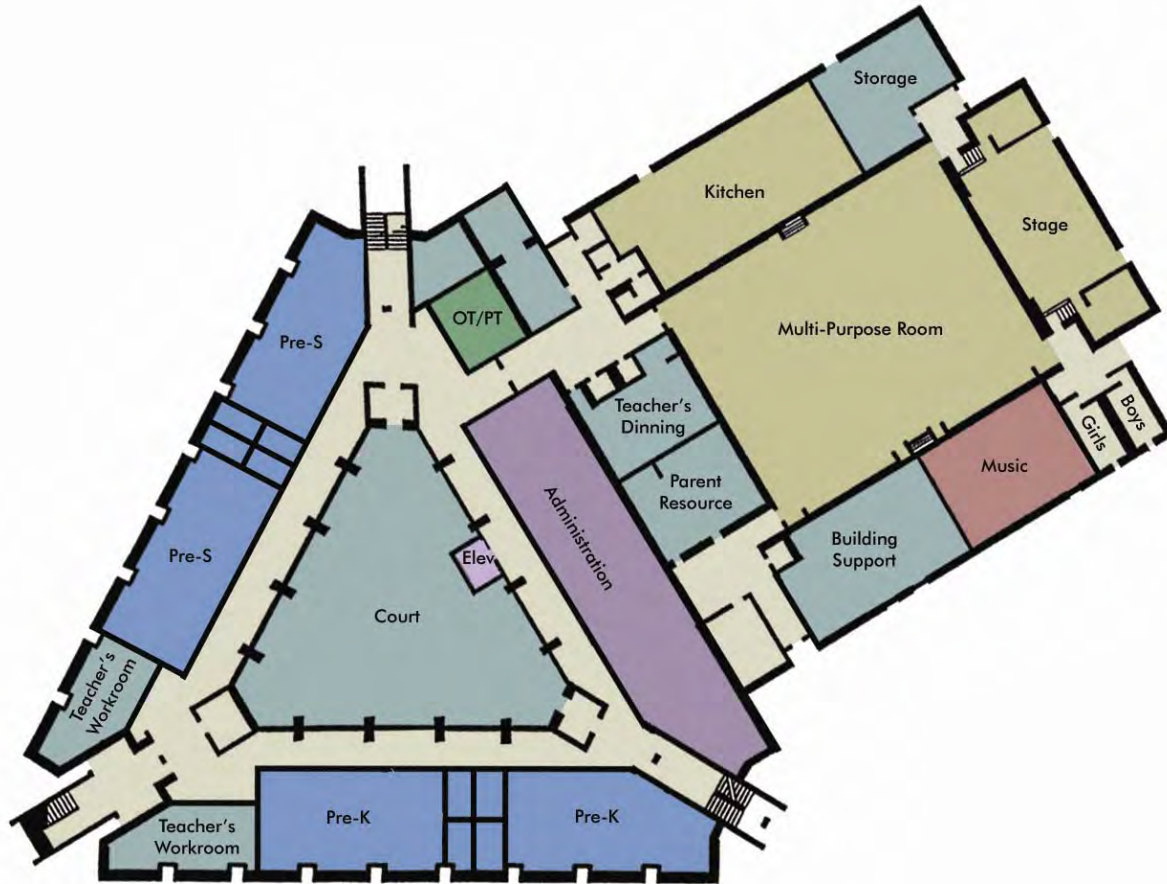
First Floor

Concept Plans

These floor plans represent planning concepts for proposed facility use, aligning the proposed program capacity, the proposed planning profiles, and the conceptual reconfiguration of the building. Each project is subject to a formal design process, incorporating input from the School Improvement team at the time of project initiation.
