2801 Calvert Street, N.W., Washington, DC

INITIAL YEAR BUILT	2002
BUILDING AREA	47,984 SF
CURRENT PROGRAM CAPACITY	306
ENROLLMENT 2008	342
WARD	3
PROPOSED PROGRAM CAPACITY	500

CONDITION ASSESSMENT

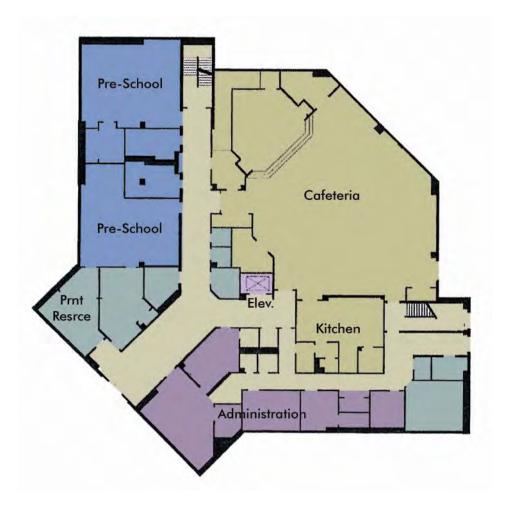
First Floor

Administration/Health Auditorium Gymnasium/Cafeteria Other Classrooms Media Center Kindergarten Computer Lab Pre-K/Pre-School OT/PT Music/Art Special Education Science Lab Unassigned Lobby Elevator Addition

Concept Plans

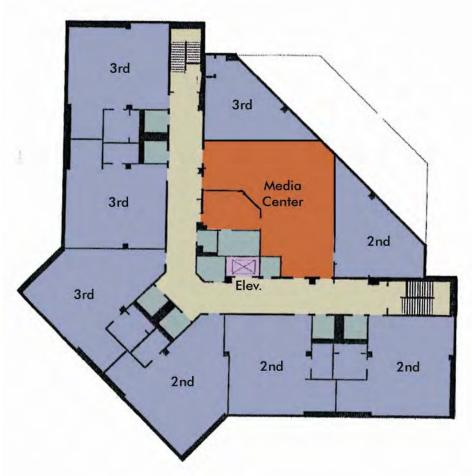
Fourth Floor

Administration/Health Auditorium Gymnasium/Cafeteria Other Classrooms Media Center Kindergarten Computer Lab Pre-K/Pre-School OT/PT Music/Art Special Education Science Lab Unassigned Lobby Elevator Addition
