PEABODY ELEMENTARY SCHOOL

425 C Street, N.E., Washington, DC

INITIAL YEAR BUILT	1880
BUILDING AREA	37,800 SF
CURRENT PROGRAM CAPACITY	210
ENROLLMENT 2008	165
WARD	6
PROPOSED PROGRAM CAPACITY	220

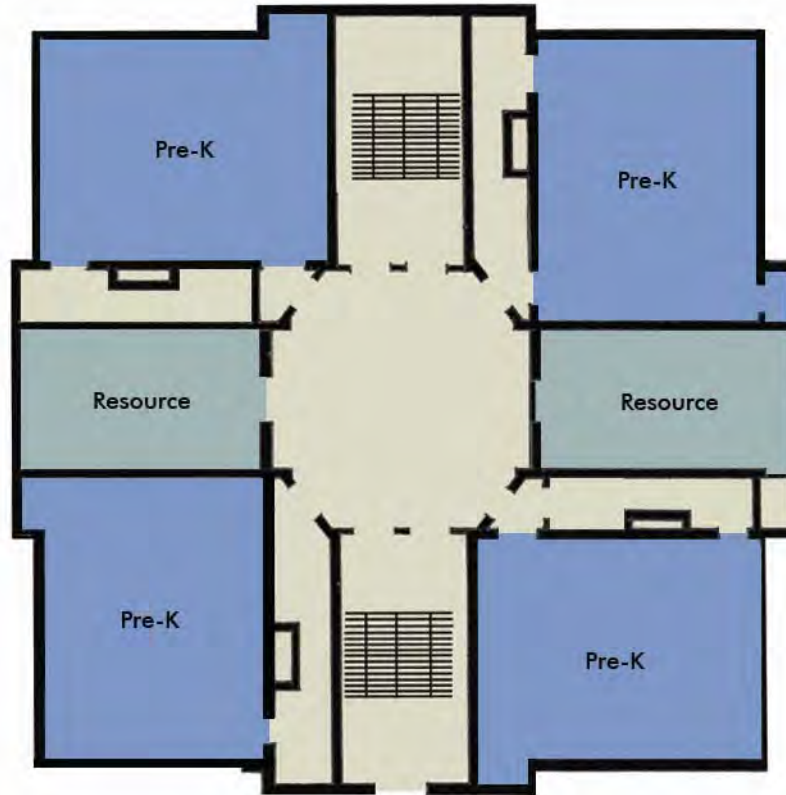
Second Floor

Concept Plans

These floor plans represent planning concepts for proposed facility use, aligning the proposed program capacity, the proposed planning profiles, and the conceptual reconfiguration of the building. Each project is subject to a formal design process, incorporating input from the School Improvement team at the time of project initiation.
