CAPITOL HILL CLUSTER

420 12th Street, S.E., Washington, DC

INITIAL YEAR BUILT	1962
BUILDING AREA	69,300 SF
CURRENT PROGRAM CAPACITY	578
ENROLLMENT 2008	550
WARD	6
PROPOSED PROGRAM CAPACITY	550

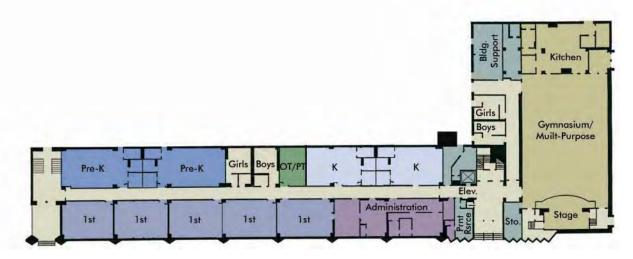
First Floor

Administration/Health Auditorium Gymnasium/Cafeteria Other Classrooms Media Center Kindergarten Computer Lab Pre-K/Pre-School OT/PT Music/Art Special Education Science Lab Unassigned Lobby Elevator Addition

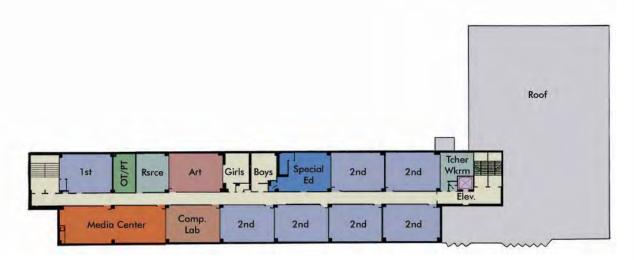
Second Floor

Administration/Health Auditorium Gymnasium/Cafeteria Other Classrooms Media Center Kindergarten Computer Lab Pre-K/Pre-School OT/PT Music/Art Special Education Science Lab Unassigned Lobby Elevator Addition

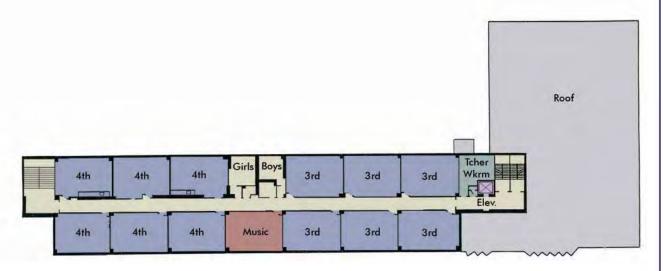
Third Floor

Administration/Health Auditorium Gymnasium/Cafeteria Other Classrooms Media Center Kindergarten Computer Lab Pre-K/Pre-School OT/PT Music/Art Special Education Science Lab Unassigned Lobby Elevator Addition
