WEST EDUCATION CENTER

1338 Farragut Street, N.W., Washington, DC

INITIAL YEAR BUILT	1978
BUILDING AREA	69,600 SF
CURRENT PROGRAM CAPACITY	231
ENROLLMENT 2008	231
WARD	4
PROPOSED PROGRAM CAPACITY	280

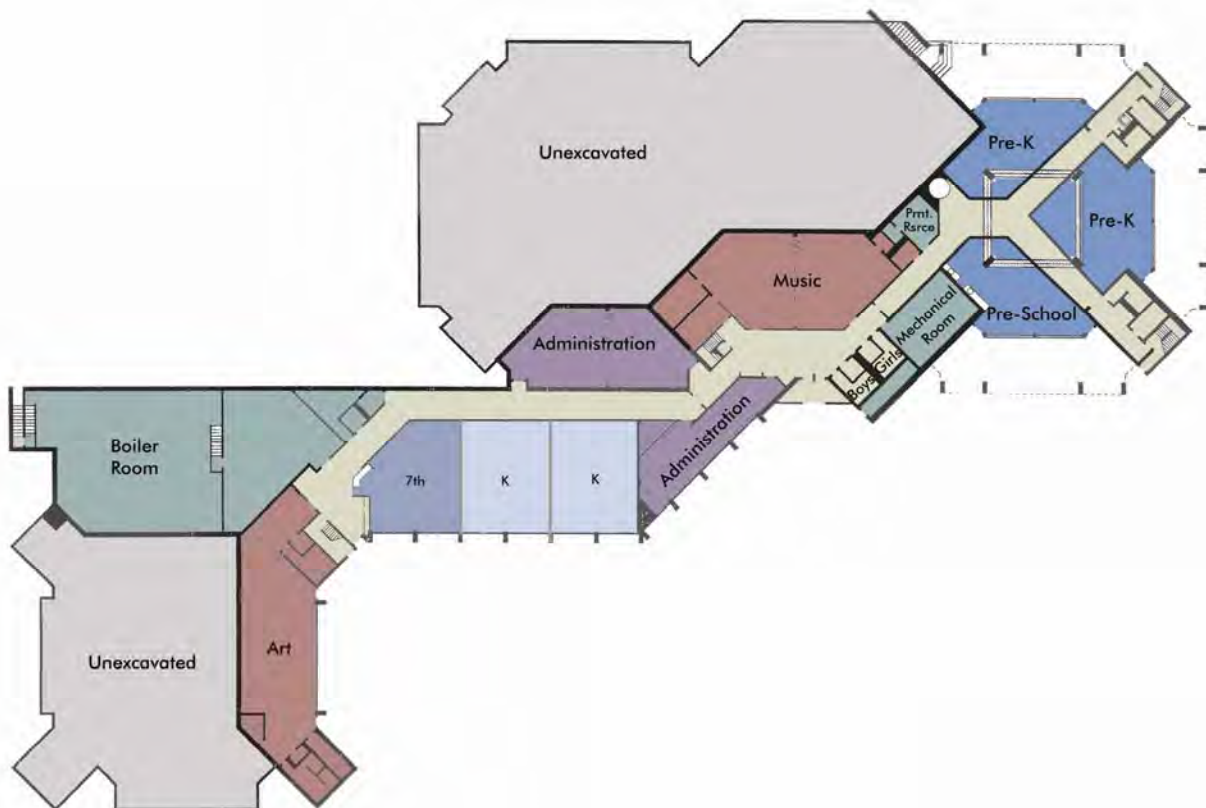
Ground Floor

Concept Plans

These floor plans represent planning concepts for proposed facility use, aligning the proposed program capacity, the proposed planning profiles, and the conceptual reconfiguration of the building. Each project is subject to a formal design process, incorporating input from the School Improvement team at the time of project initiation.

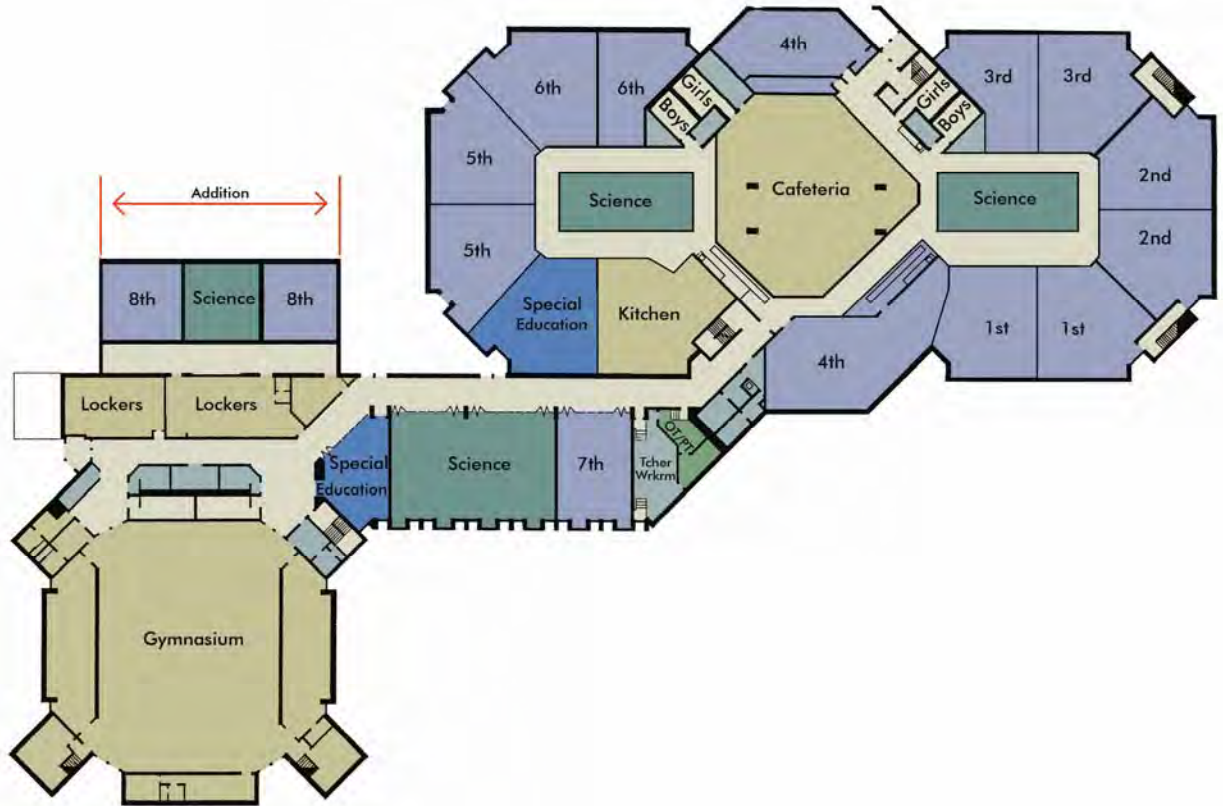
First Floor

Concept Plans

These floor plans represent planning concepts for proposed facility use, aligning the proposed program capacity, the proposed planning profiles, and the conceptual reconfiguration of the building. Each project is subject to a formal design process, incorporating input from the School Improvement team at the time of project initiation.
