6201 5th Street, N.E., Washington, DC

INITIAL YEAR BUILT	1926
BUILDING AREA	66,600 SF
CURRENT PROGRAM CAPACITY	517
ENROLLMENT 2008	410
WARD	4
PROPOSED PROGRAM CAPACITY	600

#### **Proposed Planning Profiles**

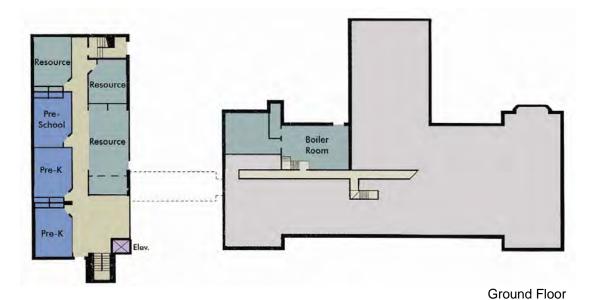
**Concept Plans**

Administration/Health Auditorium Gymnasium/Cafeteria Other Classrooms Media Center Kindergarten Computer Lab Pre-K/Pre-School OT/PT Music/Art Special Education Science Lab Unassigned Lobby Elevator Addition

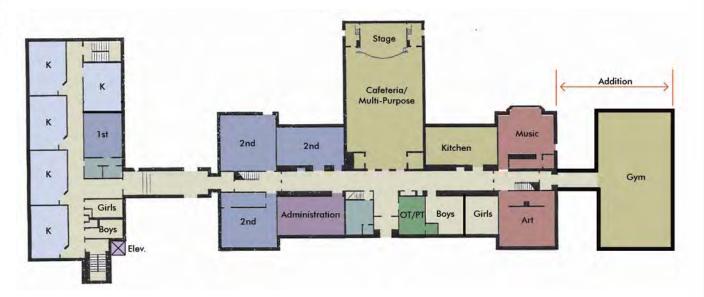
First Floor

Administration/Health Auditorium Gymnasium/Cafeteria Other Classrooms Media Center Kindergarten Computer Lab Pre-K/Pre-School OT/PT Music/Art Special Education Science Lab Unassigned Lobby Elevator Addition

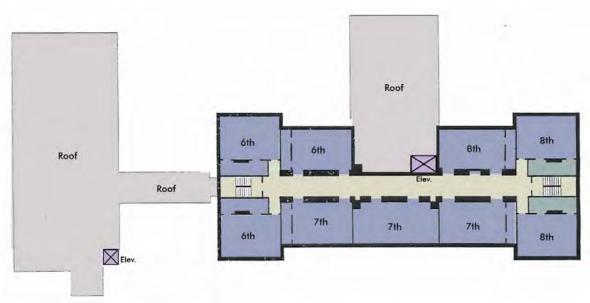
Third Floor

Administration/Health Auditorium Gymnasium/Cafeteria Other Classrooms Media Center Kindergarten Computer Lab Pre-K/Pre-School OT/PT Music/Art Special Education Science Lab Unassigned Lobby Elevator Addition
