ROOSEVELT SENIOR HIGH SCHOOL

4301 13th Street, N.W., Washington, DC

CONDITION ASSESSMENT

Condition Assessment
The body of information summarized below is based on a detailed facility condition assessment completed in 2006 and updated by visual observations conducted in 2007. Improvement initiatives completed by OPEFM in 2007 and 2008 are noted in red text in each section. An overall summary of work completed under various OPEFM programs is provided at the end of the condition assessment.

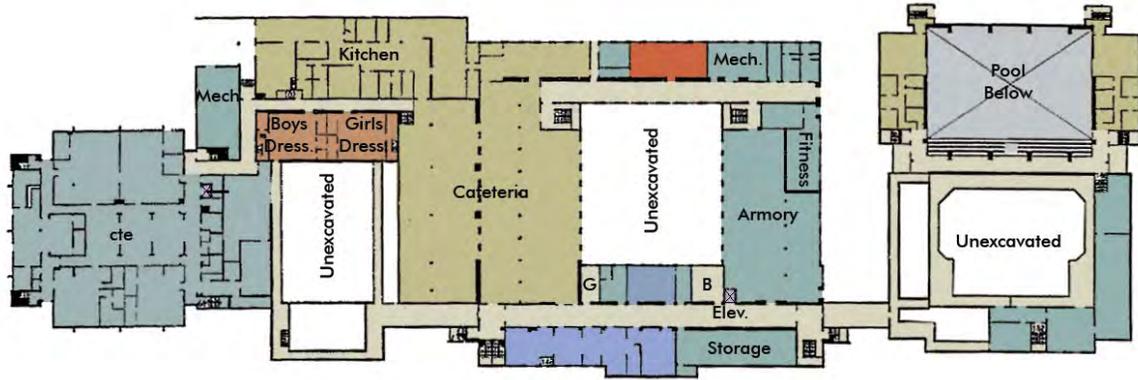
Basement

Administration/Health

Auditorium

Gymnasium/Cafeteria

Other

Classrooms

Media Center

Kindergarten

Computer Lab
