# LASALLE - BACKUS EDUCATION CAMPUS

501 Riggs Road, N.E., Washington, DC

## CONDITION ASSESSMENT

**Condition Assessment**

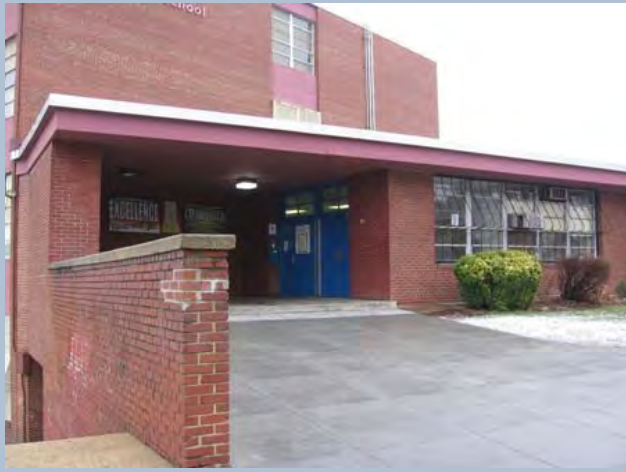
<i>Building System</i>	<i>2008 Rating</i>
ADA Compliance	Poor
Conveying Systems	Unsatisfactory
Electrical	Fair
Exterior Finish	Fair
HVAC	Fair
Interior Finish	Fair
Plumbing	Fair
Roof	Fair
Structure	Good
Technology	Fair

<b>1 Conveying System</b>	There is no elevator, lift, or escalator present. <b>2008 Receiving School (R/S): Elevator planned but on hold due to NPS easement issue.</b>
<b>2 Electrical</b>	The panelboard and switchboard are too old and have exceeded their life expectancy. Inadequate receptacles in the classrooms. Fixtures very old and need replacement of missing or damaged lenses. Receptacles do not have proper ground. No strobes in fire alarms; no smoke detectors in storage areas. Too many computers on one circuit, causing breakers to trip. <b>Installed 38 AC Window Units &amp; Electrical Upgrades. 2008 R/S: Upgraded electrical outlets, replaced expired fluorescent ballast, tubes, replaced cracked, missing or broken light lens covers. Repaired and or installed new lighting fixtures in lavatories, classrooms, and other locations.</b>
<b>3 Exterior Finish</b>	Single pane glass windows leak and need to be replaced. Some window wall panels missing and others are damaged. Some brick re-pointing needed. <b>2008 R/S: Repointing &amp; repair of brick walls, general exterior elevation cleaning.</b>

<b>4 Structure</b>	Cracks in concrete wall banding above windows. No lightning protection for tall chimney. Cracking may be repaired as part of routine building maintenance.
<b>5 HVAC</b>	The existing heating system needs to be replaced. Two hot water boilers, which have 16 years of service life left, can be salvaged. The existing ventilation systems are beyond the service life and need to be replaced. There is no central cooling system. Most of the window air conditioners and portable air conditioners installed in some spaces cannot satisfy the cooling and outdoor air requirements. <b>2008: Repairs to boiler(s) and Classroom heating units. 2008 R/S: Repair selected unit ventilators &amp; radiators, install new 680,000 BTU heater.</b>
<b>6 Interior Finish</b>	Asbestos floor tiles are hazardous and not permitted. Acoustic ceiling tiles are either obsolete or damaged. Obsolete ceiling tiles are no longer manufactured. Replace wood doors. <b>2007: Painting, plaster repair, flooring and ceiling replacement completed. 2008 R/S: Patch and plaster with painting as required, new VCT flooring, new ceiling tiles, replaced damaged/defective doors and hardware.</b>

<b>7 Plumbing</b>	Most of the plumbing fixtures are working, but the existing plumbing piping need to be replaced. There is no fire suppression (sprinkler) system in this building. <b>2008 R/S: New science rooms installed, existing restrooms and fixtures repaired and renovated.</b>

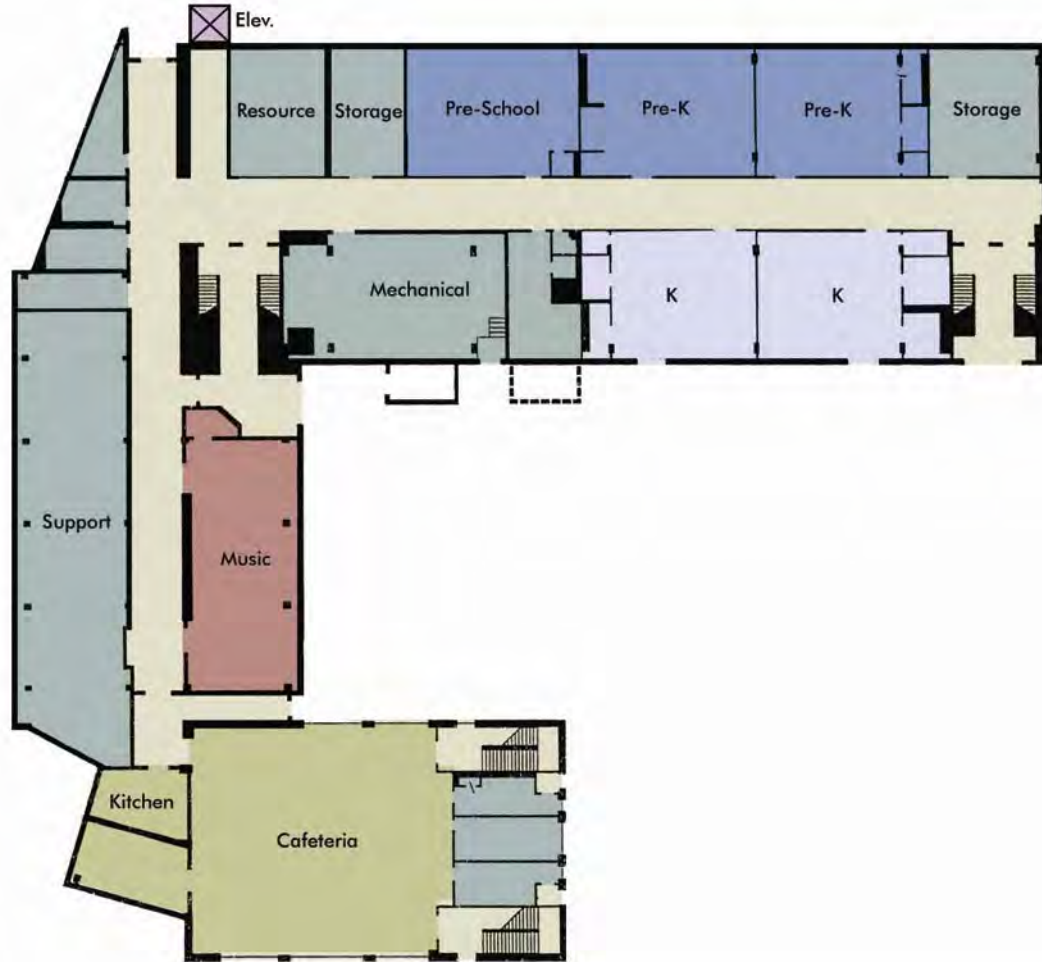
Ground Floor

These floor plans represent planning concepts for proposed facility use, aligning the proposed program capacity, the proposed planning profiles, and the conceptual reconfiguration of the building. Each project is subject to a formal design process, incorporating input from the School Improvement team at the time of project initiation.

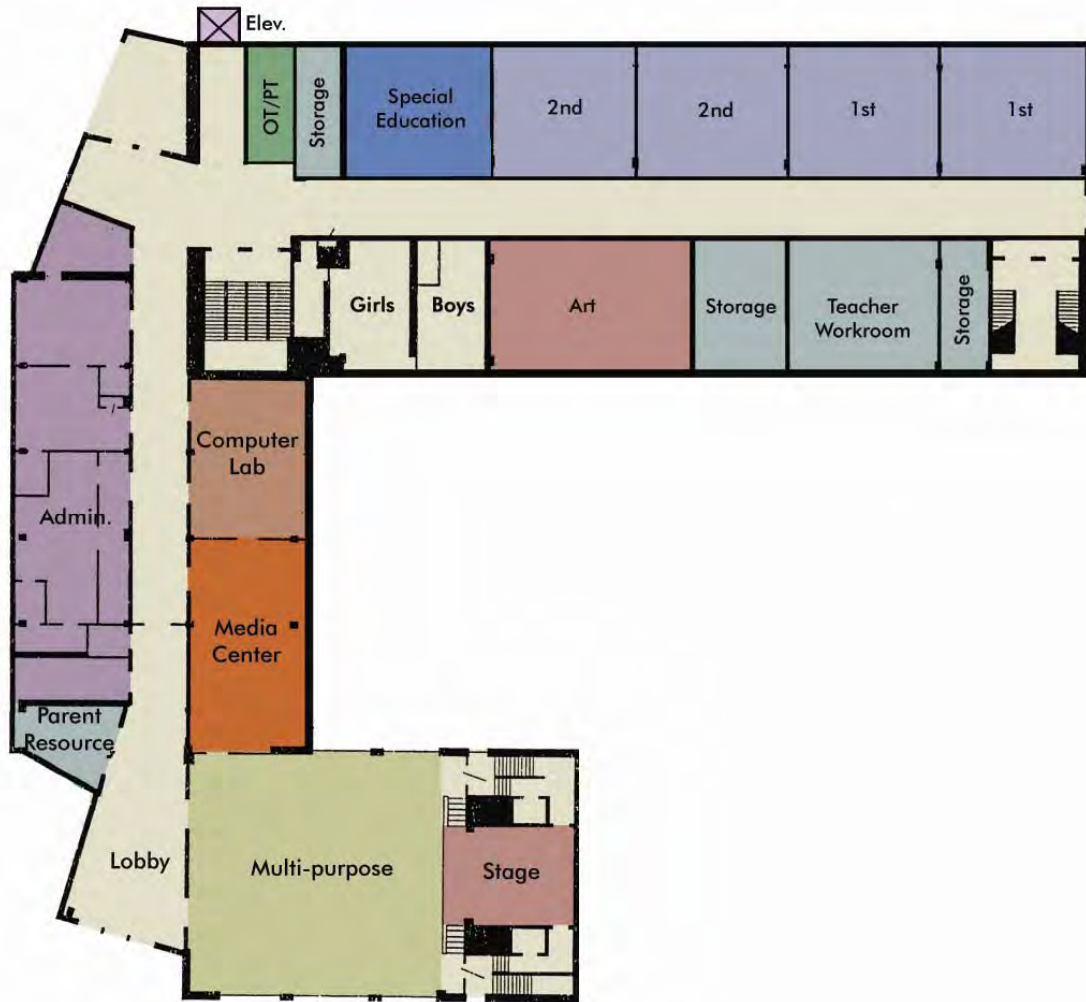
First Floor

These floor plans represent planning concepts for proposed facility use, aligning the proposed program capacity, the proposed planning profiles, and the conceptual reconfiguration of the building. Each project is subject to a formal design process, incorporating input from the School Improvement team at the time of project initiation.

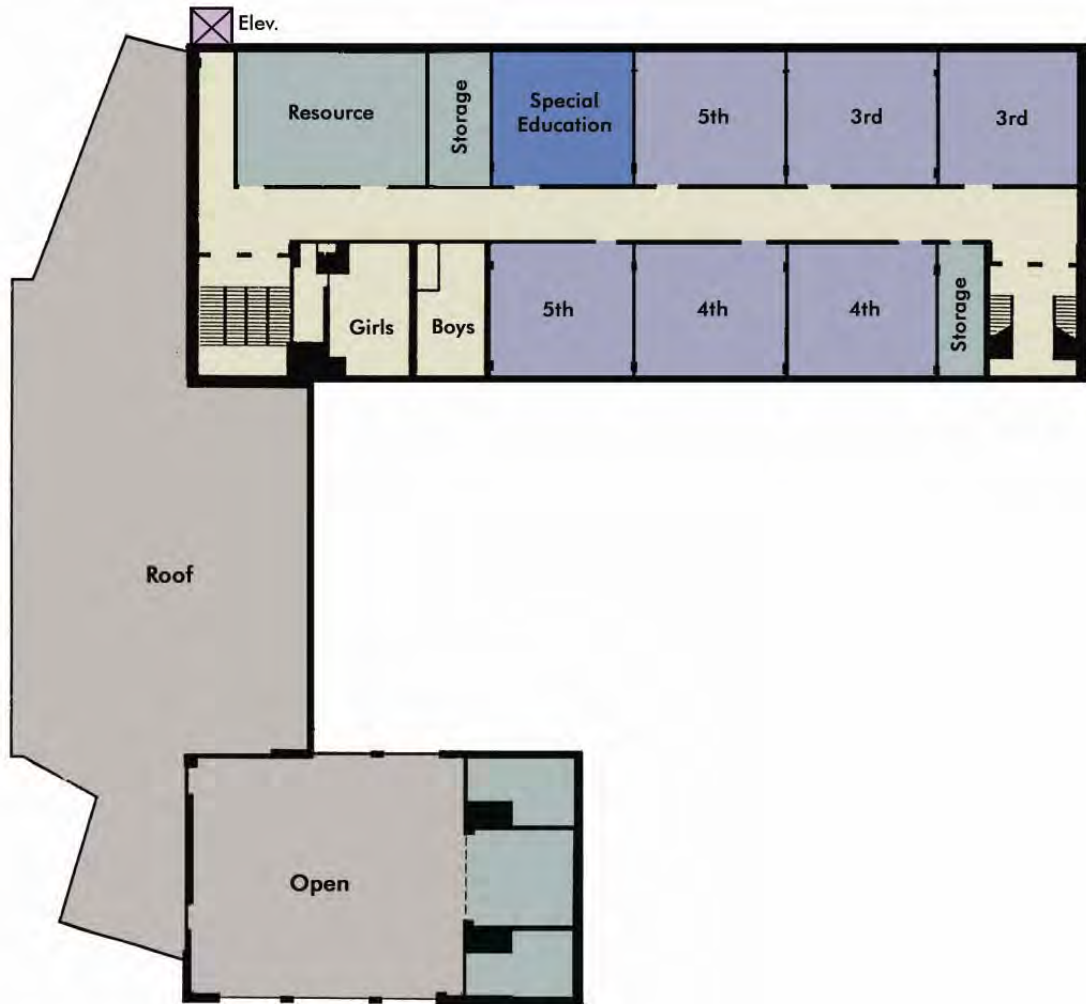
Second Floor

These floor plans represent planning concepts for proposed facility use, aligning the proposed program capacity, the proposed planning profiles, and the conceptual reconfiguration of the building. Each project is subject to a formal design process, incorporating input from the School Improvement team at the time of project initiation.

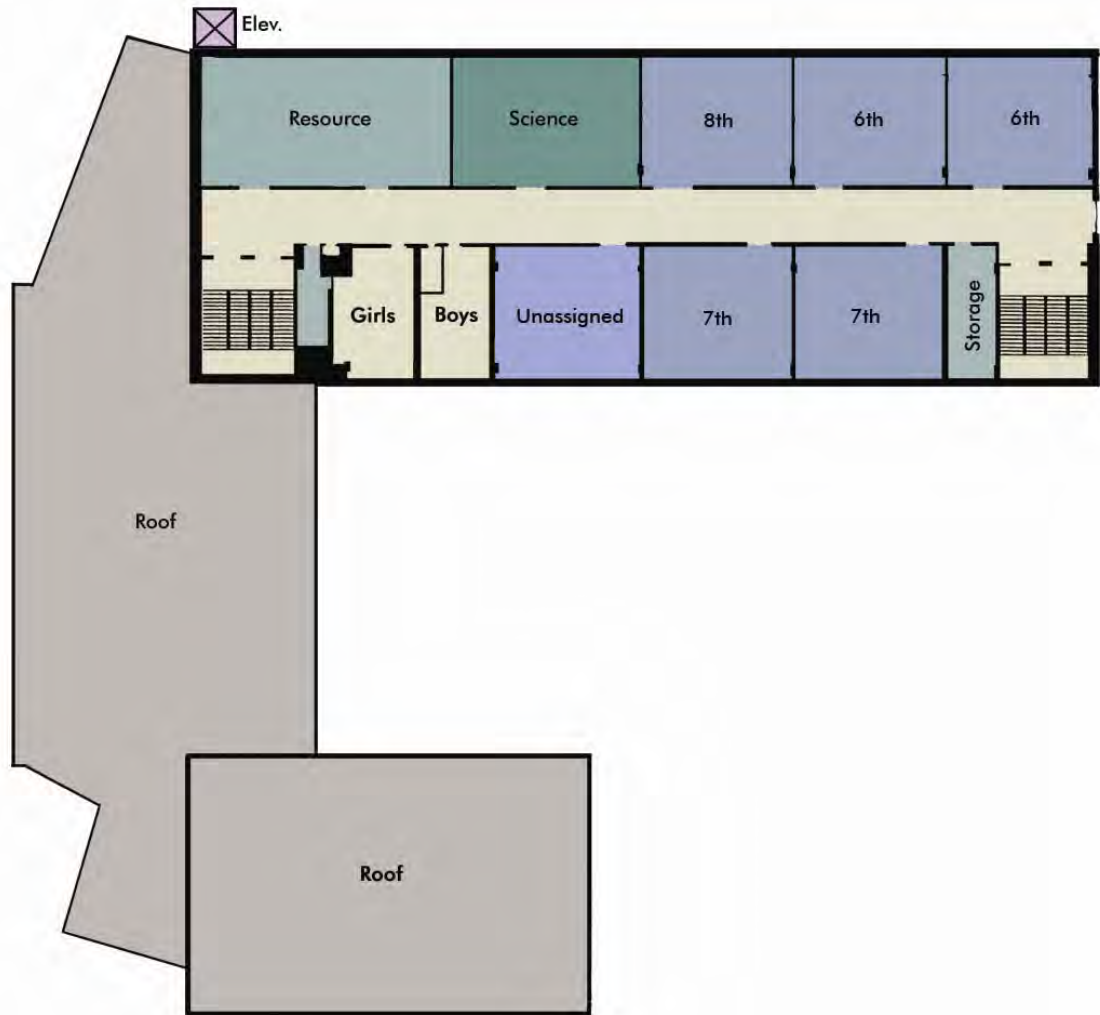
Third Floor

These floor plans represent planning concepts for proposed facility use, aligning the proposed program capacity, the proposed planning profiles, and the conceptual reconfiguration of the building. Each project is subject to a formal design process, incorporating input from the School Improvement team at the time of project initiation.
